Test report of NISP dedicated test activities during the CSL campaign

Ref : EUCL-IBO-TR-7-007
Issue : 1.0
Date: 09/06/2021
Page: 1/37

TITLE:	Test Report of NISP dedicated test activities during the CSL campaign - DCU-SCE Communication issue		
Date:	09/06/2021	Issue:	1.0
Reference:	EUCL-IBO-TR-7-007		
Custodian:	Eduardo Medinaceli

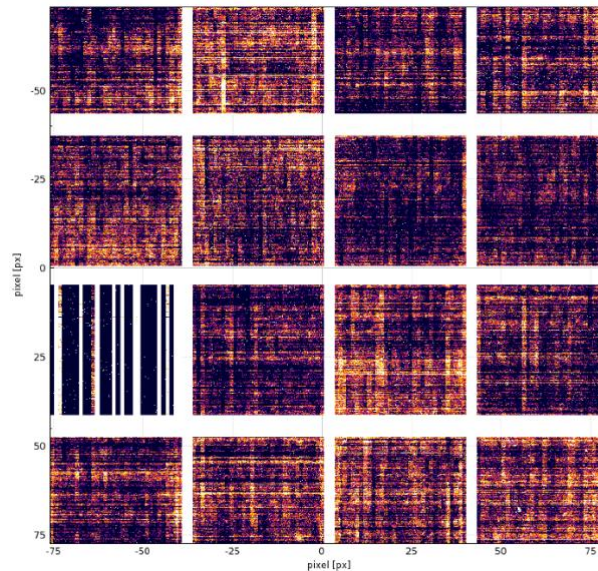
Then, during the second test run an artifact was seen only in detector SCS#31 (detector SCS#22 was recovered from the image quality point of view) as shown below.

'Artifacts' are related to high dishomogeneities between readout channels, that vary from one acquisition to another (no systematic repetitions has been done, but a single case is presented here). By comparing the reference pixels signal from two full Raw Lines of detector SCS#31 was concluded that the signal level (ref pxs) was homogeneous in both images. The signal compatibility also applies to SCS#22 even if the 'artifact' in the second case disappeared during the second MACC. Below, are shown the two consecutive acquisitions taken with SCS#22 (on the left with the 'image artifact' and at the center without it); on the right of

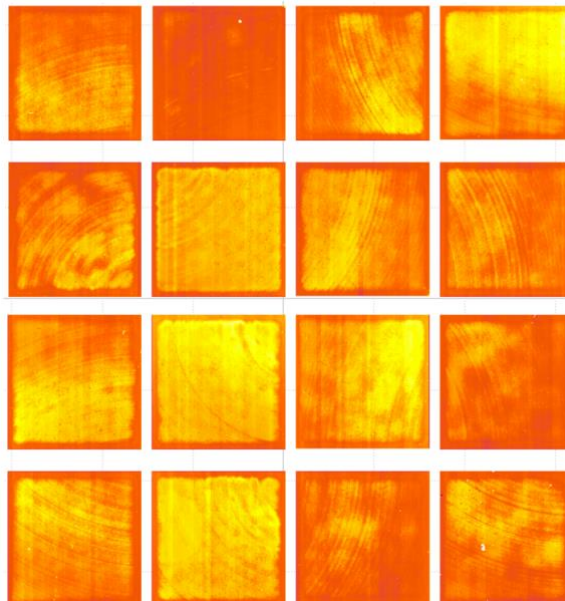
Again in this case the same kind of errors were reported by the DCUs but without artifacts in the images as shown below.

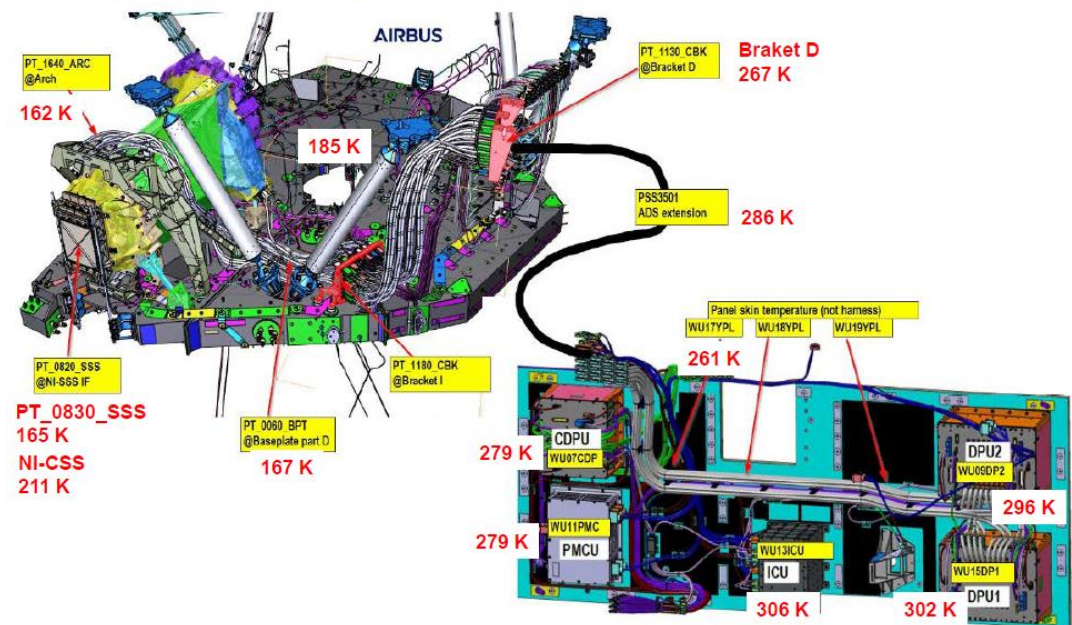
First Occurrence: 02/07/2021 – 07:46 UTC Phase 70

DCU	STATUS
DCU1	OK
DCU2	OK
DCU3	OK
DCU4	OK
DCU5	OK
DUC6	OK
DUC7	OK
DCU8	FAULTY
DCU9	FAULTY
DCU10	OK
DCU11	FAULTY
DCU12	OK
DCU13	OK
DCU14	OK
DCU15	OK
DCU16	OK

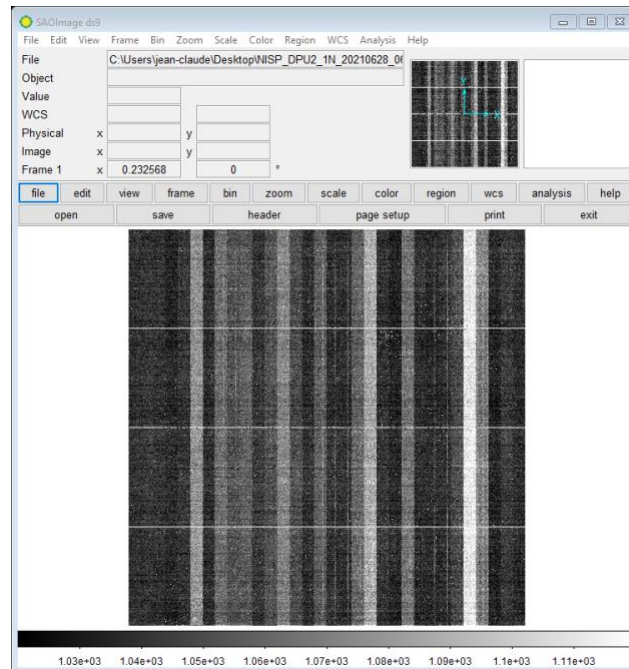
- Only in 6 out of the 10 stable DCUs does not show an error during the 1st exposure, indicating a "degradation" of a stable initial configuration (of 10 DCUs) for the engineering raw mode data acquisition. Several images were showing "non-nominal rows" (artifacts), and in some case multiple ones, for example on data from DCU4(12) are present 3 lines:
