Test report of NISP dedicated test activities during the CSL campaign

Ref : EUCL-IBO-TR-7-007
Issue : 1.0
Date: 09/06/2021
Page: 1/37

TITLE:	Test Report of NISP dedicated test activities during the CSL campaign - DCU-SCE Communication issue		
Date:	09/06/2021	Issue:	1.0
Reference:	EUCL-IBO-TR-7-007		
Custodian:	Eduardo Medinaceli

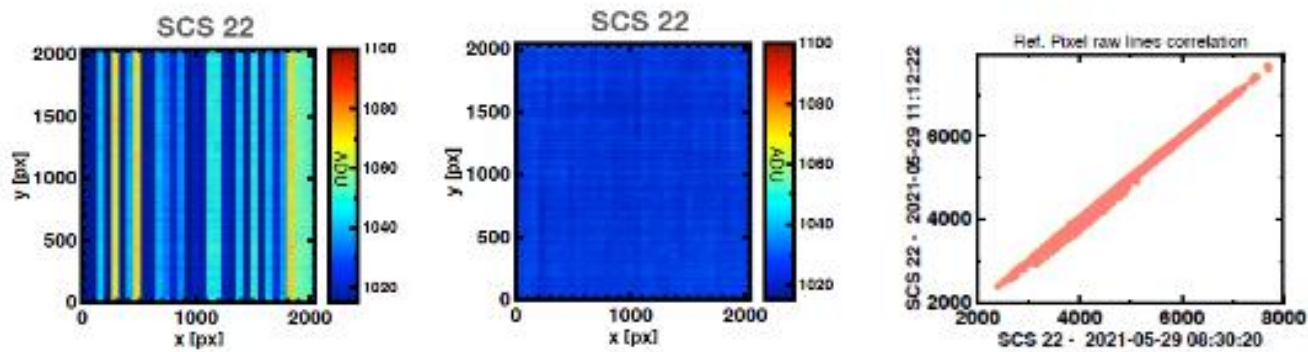
Reference pixels signal from raw lines comparison

the same figure is plotted the comparison of reference pixels signal from raw lines showing the expected correlation (same values).

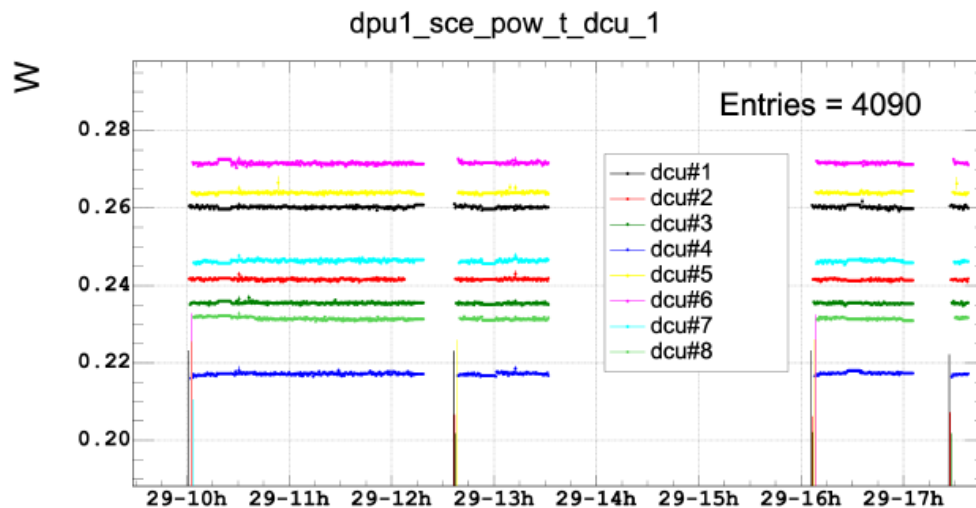
SCE's total power down for DPU1, no abnormal power consumption was detected.

ASIC's power consumption never shows anomalies before, and while starting the acquisitions. For example, in the next figure are plotted SCE's total power for DPU1; to be noticed that even when SCEs enters in the "non-nominal" state a power drop is not seen. No power reduction is also evident in DCU power lines nor in the DPU main power supply.

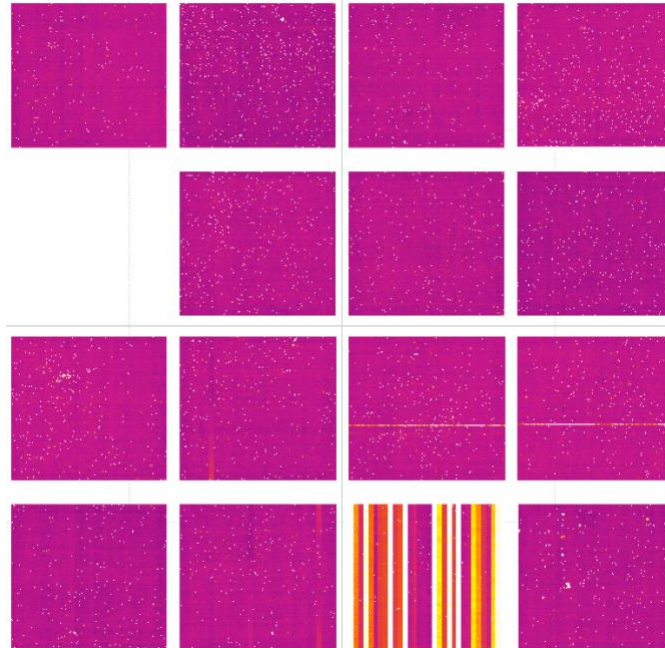
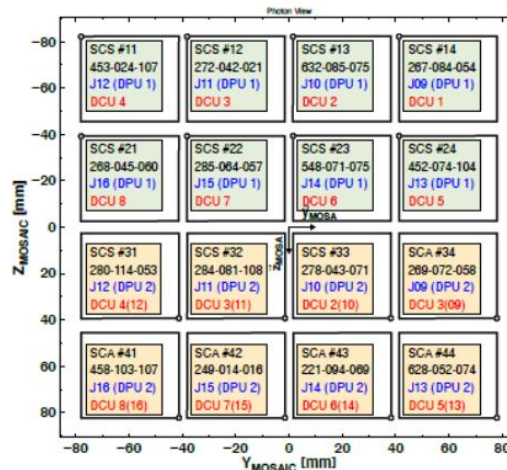
The image below (left) shows the data acquired during the 1st exposure (errors and artifacts can be seen in the plot), DPU1-DCU8 failed to transmit the data due to the SCE line errors. (On the right is the map of the DCU/SCE IDs).

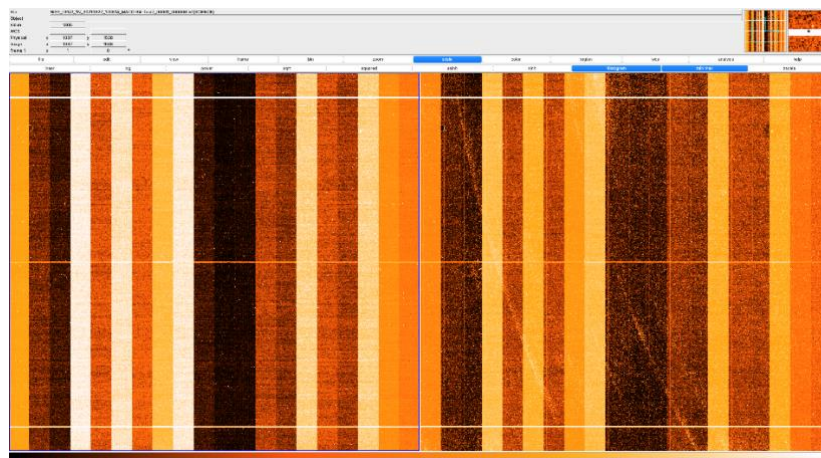
SCE’s telemetry is not available just after the start of the MACC acquisition. In some cases when the DCU signal a transmission error, in the image can be seen “artifacts”, for example lines with non-nominal values as:

Images from two different detectors showing “horizontal lines” (artifacts) in the same rows.

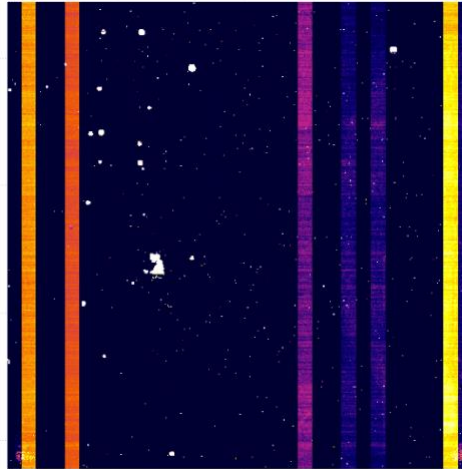
This kind of “strange” lines were also found in the reference pixels. In these cases, the reference pixel correction performed by the DPU-ASW creates an artifact showing channel-to-channel patterns in the image, like:

Vertical structure induced by the reference pixel correction when a non-nominal row of reference pixel is acquired. This image was acquired at the DPU's lowest operative temperature.

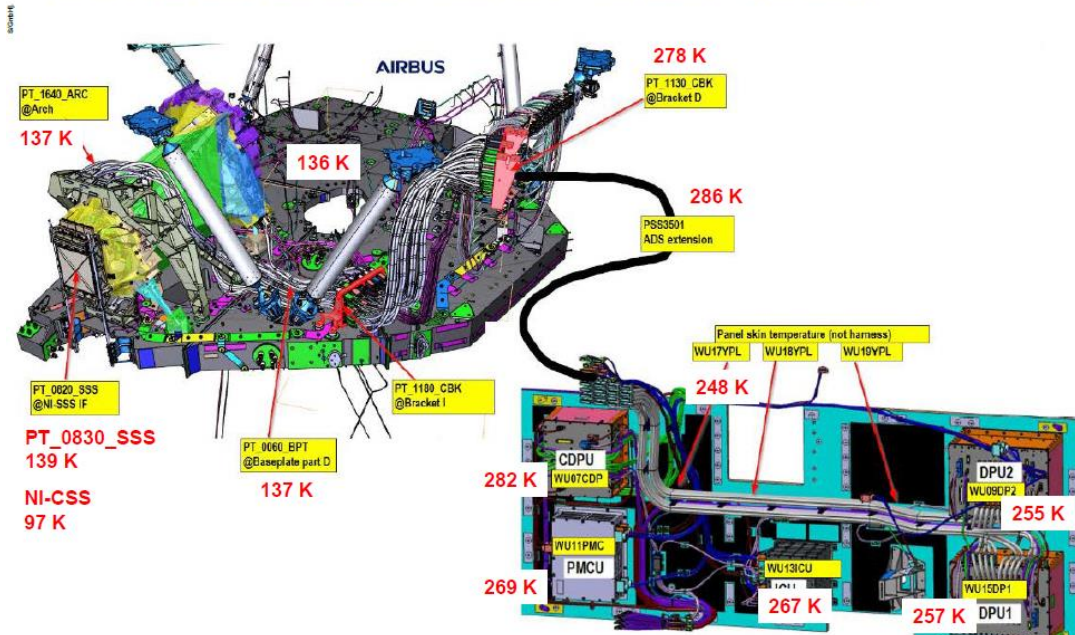
First Occurrence: 29/06/2021 – 11:10 UTC – PHASE 61 – (Test#08)

DCU	STATUS
DCU1	OK
DCU2	FAULTY
DCU3	OK
DCU4	FAULTY
DCU5	OK
DUC6	FAULTY
DUC7	FAULTY
DCU8	FAULTY
DCU9	FAULTY
DCU10	FAULTY
DCU11	FAULTY
DCU12	FAULTY
DCU13	FAULTY
DCU14	FAULTY
DCU15	OK
DCU16	FAULTY

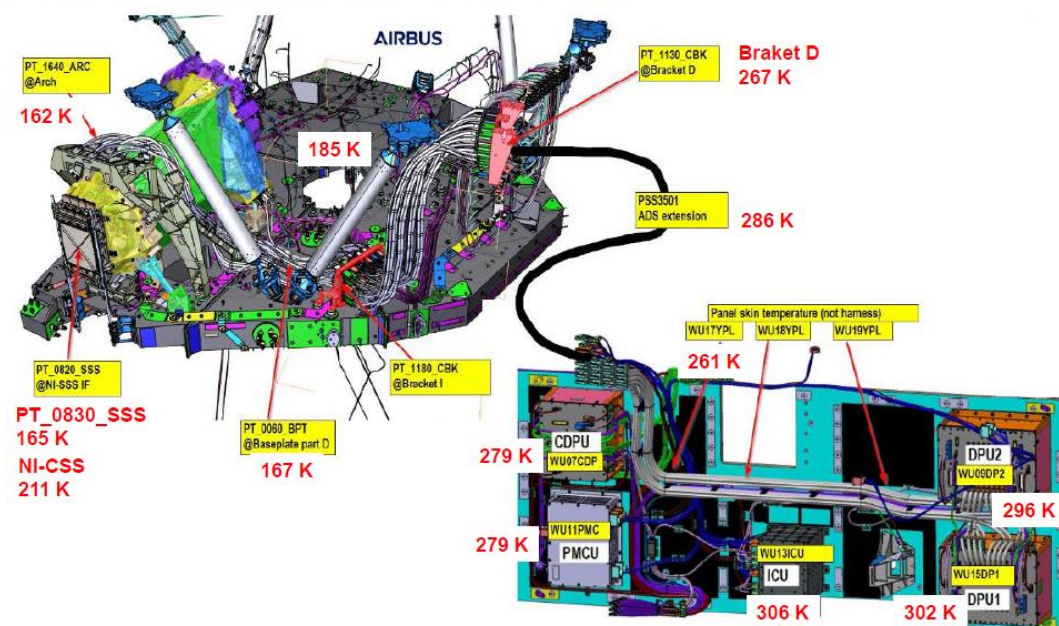
First Occurrence: 02/07/2021 – 07:46 UTC Phase 70

DCU	STATUS
DCU1	OK
DCU2	OK
DCU3	OK
DCU4	OK
DCU5	OK
DUC6	OK
DUC7	OK
DCU8	FAULTY
DCU9	FAULTY
DCU10	OK
DCU11	FAULTY
DCU12	OK
DCU13	OK
DCU14	OK
DCU15	OK
DCU16	OK

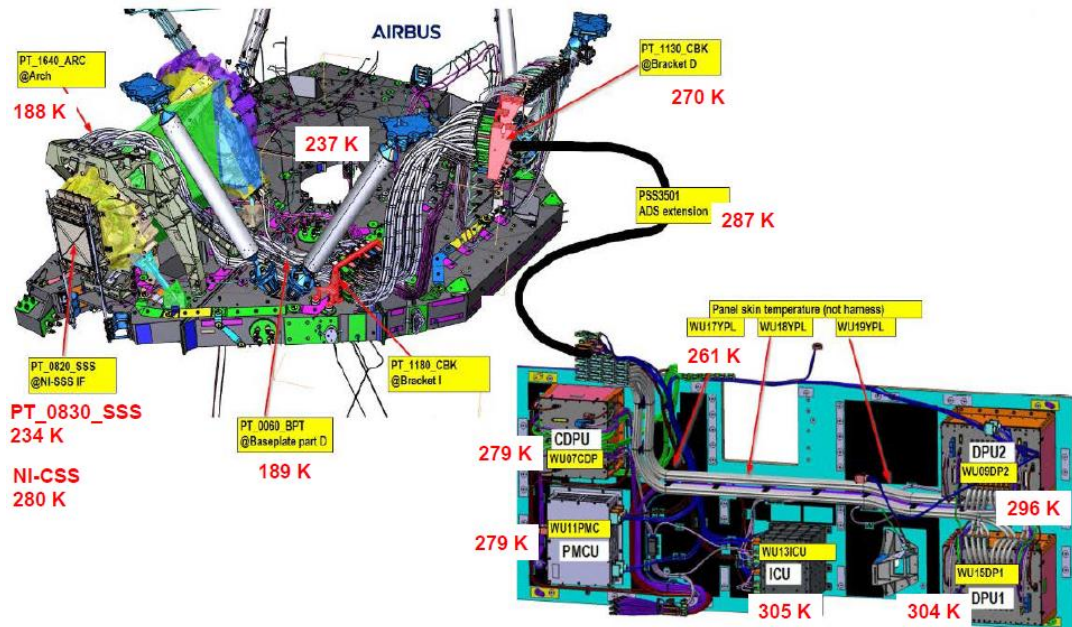
First Occurrence: 04/07/2021 – 08:40 UTC Phase 80

Confidential	
DCU	STATUS
DCU1	OK
DCU2	OK
DCU3	OK
DCU4	OK
DCU5	OK
DCU6	OK
DCU7	OK
DCU8	OK
DCU9	OK
DCU10	OK
DCU11	OK
DCU12	OK
DCU13	OK
DCU14	OK
DCU15	OK
DCU16	OK

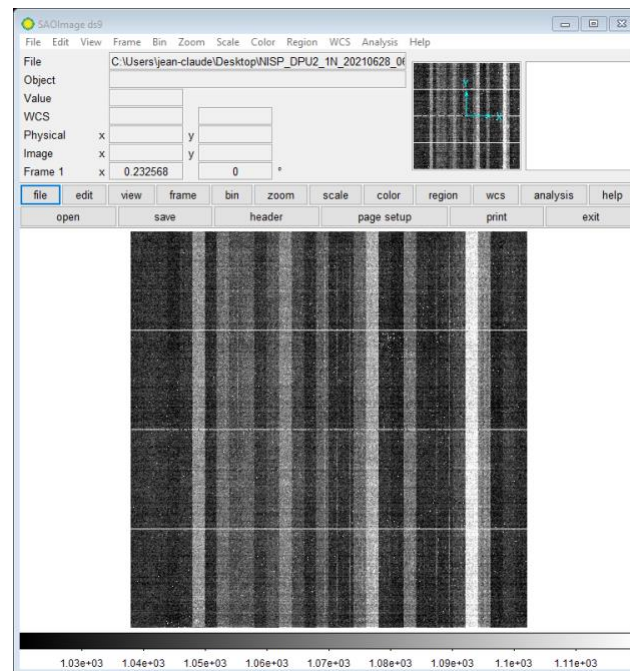
- Only in 6 out of the 10 stable DCUs does not show an error during the 1st exposure, indicating a "degradation" of a stable initial configuration (of 10 DCUs) for the engineering raw mode data acquisition. Several images were showing "non-nominal rows" (artifacts), and in some case multiple ones, for example on data from DCU4(12) are present 3 lines:

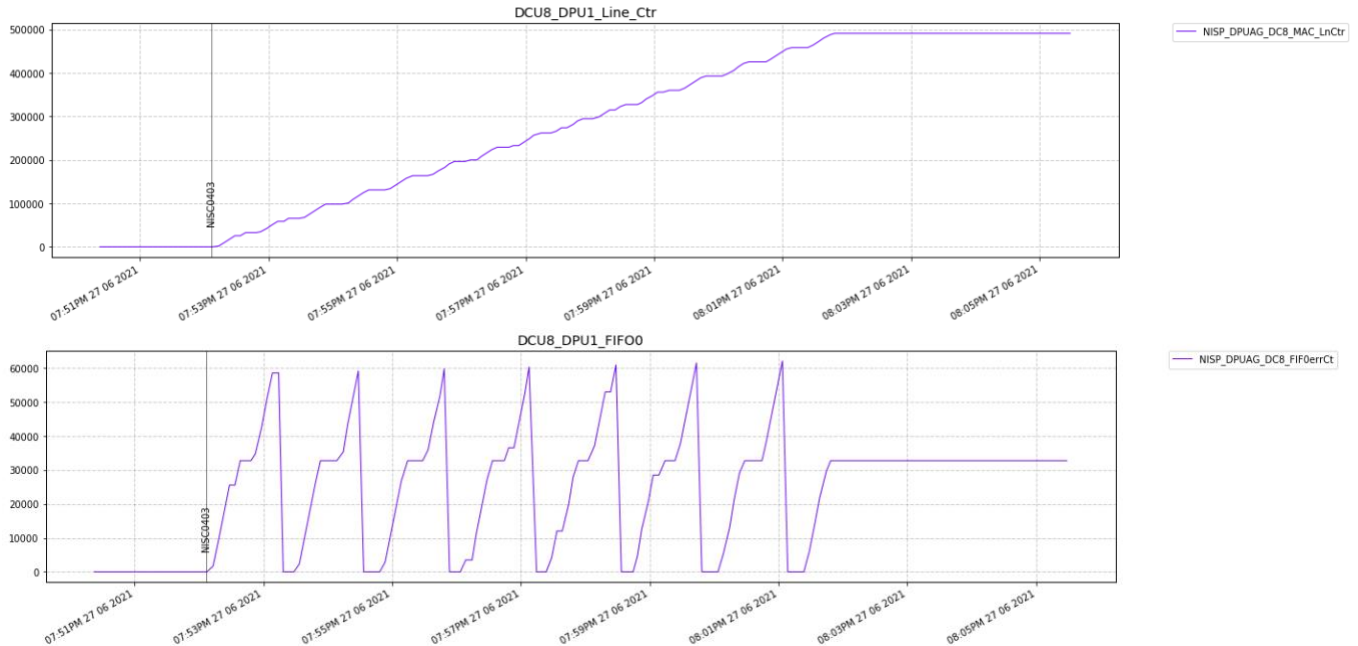
This DCU failed to perform a second consecutive exposure; even if the above condition showing a wrong communication using FIFO_0 was “recovered” using FIFO_1 (no errors related to FIFO_1 signalled by the DCU).

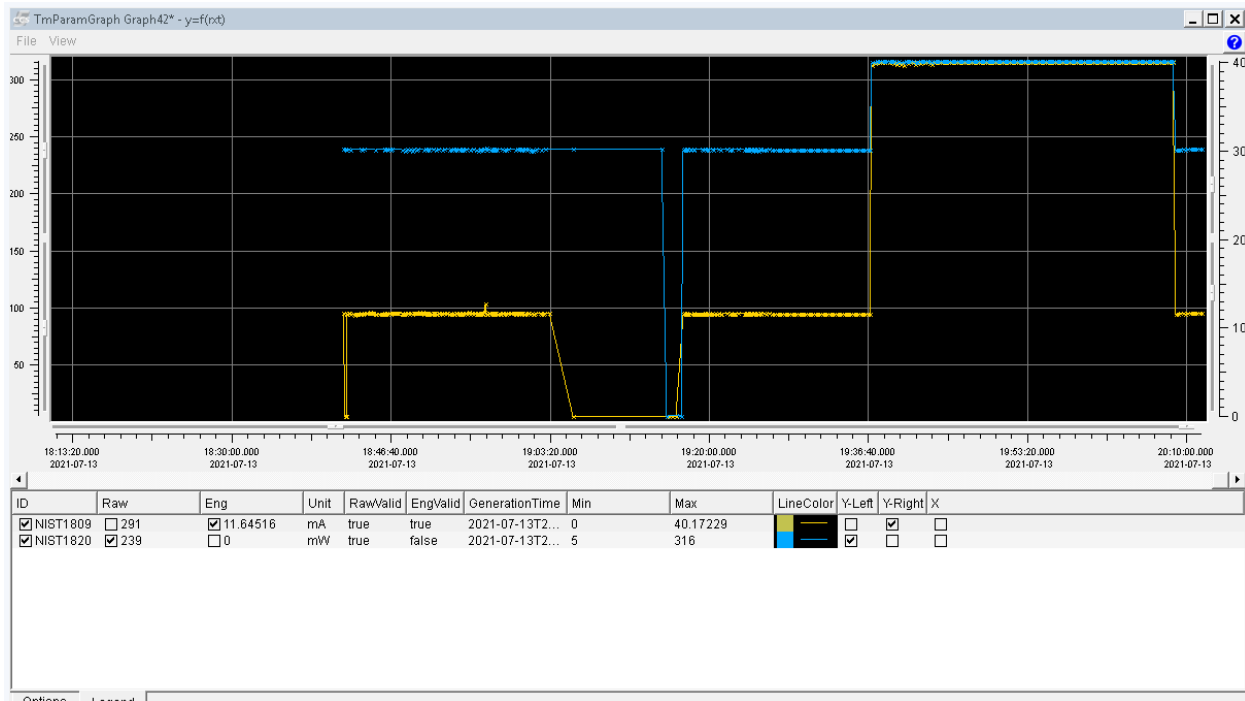
To test the state of the SCE a MEM DUMP (which implements a SCE read instruction) was done without success – due to the so-called 'loss of communication condition'. Nevertheless, a second SCE write operation was done successfully executing DPU-ASW command SCE_Awake. This last command restarts the ASIC firmware by writing at register address = 0x6903 the value = 0x1900; and as a consequence, the current decreases to the nominal value – see Figure 1.

Fig. 1, NISP (DCU) telemetry showing the increase at around 19:36:40.0 and successive decrease at around 20:20:00.0 of the V2P5_V current - NIST1809 (yellow) and total power – NIST1820 (blue), associated to the execution of SCE_CONFIG and SCE_AWAKE commands respectively.

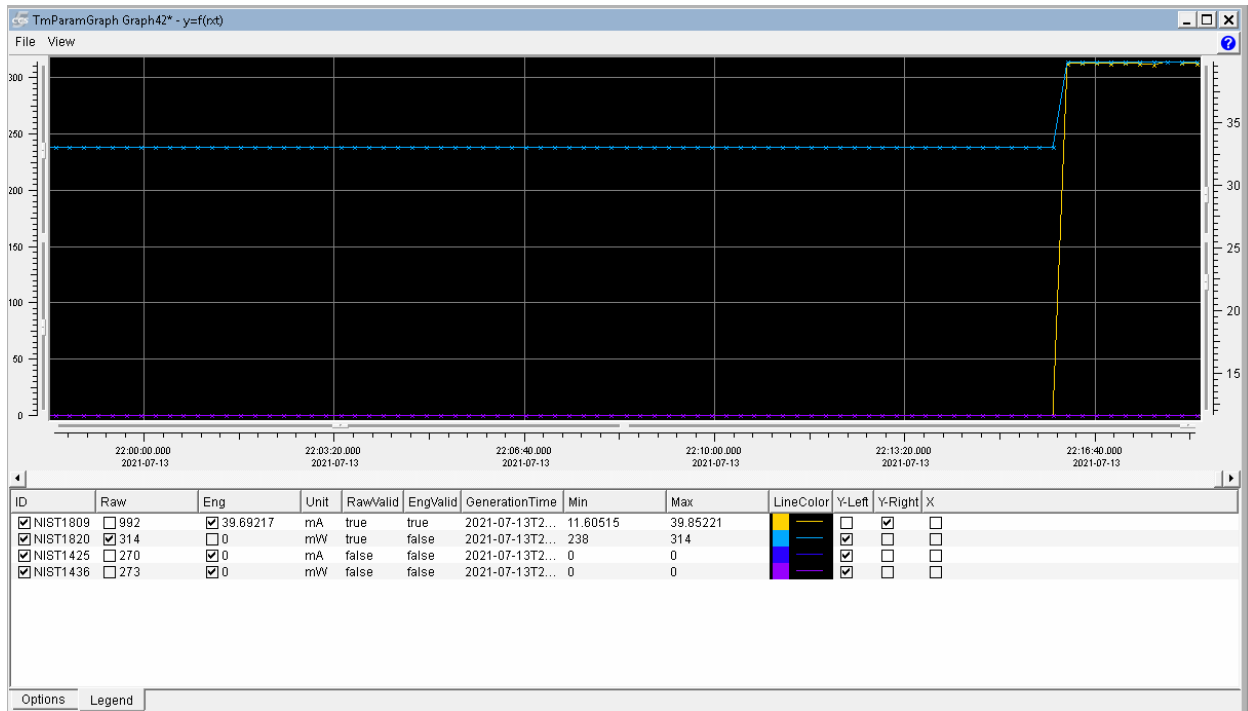
Fig. 2, NISP (DCU) telemetry showing the increase at around 22:16:40.0 of the V2P5_V current - NIST1809 (yellow) and total power – NIST1820 (blue), associated to the execution of SCE write executed with a low-level access.
