**TITLE: PLANCK OPTICAL SHIELD 2:  
CRYO TESTS ON  
REPRESENTATIVE PANELS**

**DOC. TYPE: Test Report**

**PROJECT REF.: PL-LFI-PST-RP-026 PAGE: I of III, 26**

**ISSUE/REV.: 1.0 DATE: January 2008**

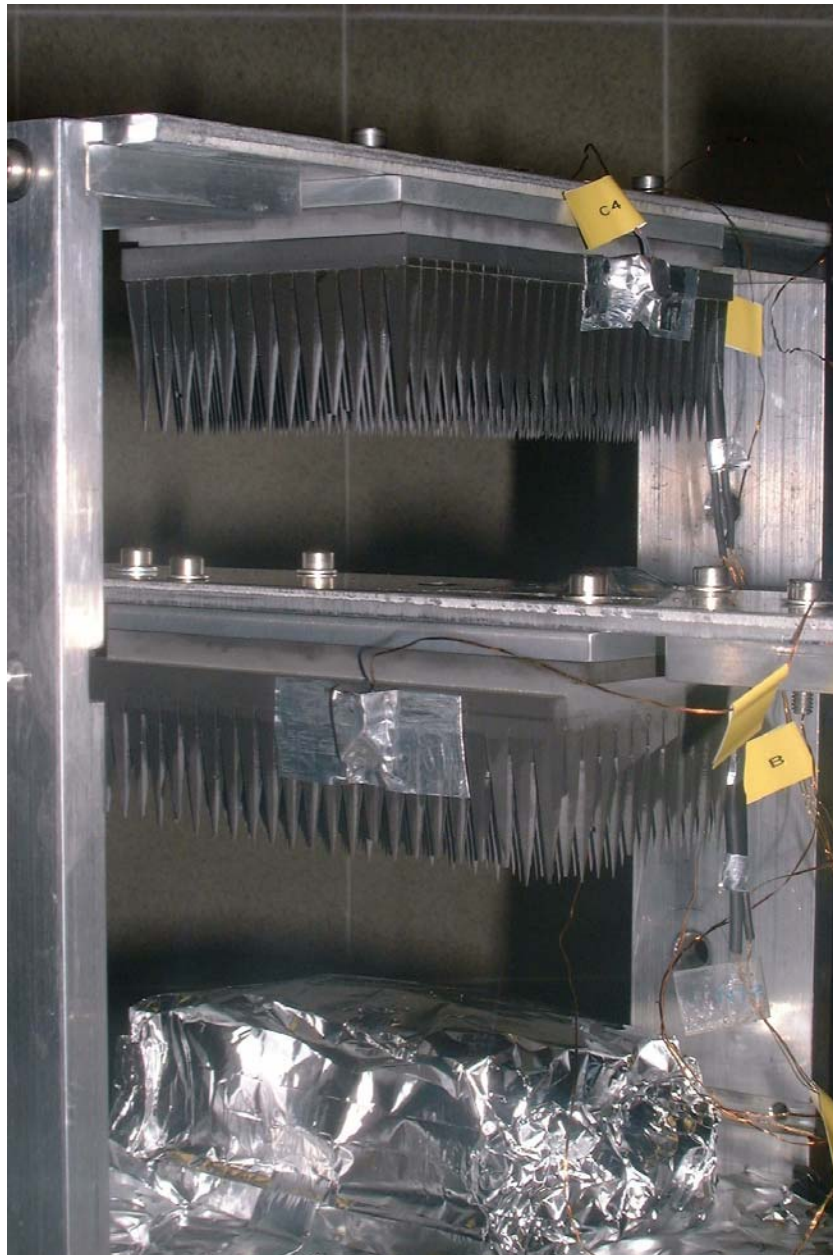
No evidence of change was observed in the panels: no broken parts (example Eccosorb tips) have been found on the aluminium foil put on the flange in order to collect eventual parts falling down from the panels.

Figure 14 panels after the facility has been opened. Everything looks fine, no broken parts on the aluminium tape covering the cryo 4K flange.

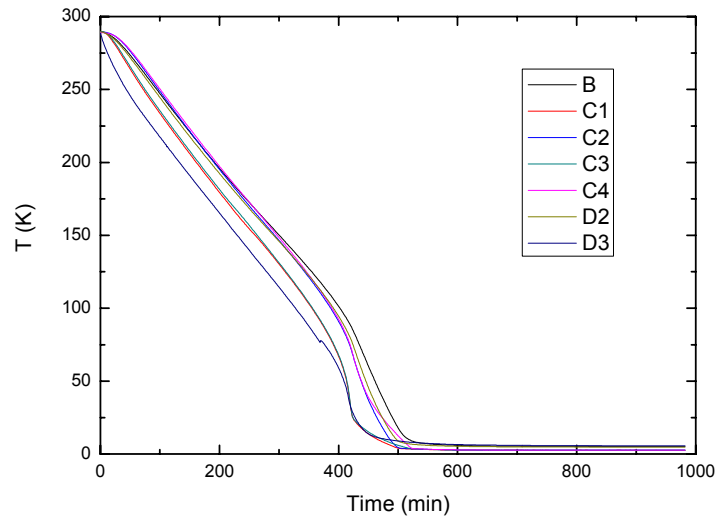
A non ideal behaviour of the sensor put on the 2.7K flange was recorded: it was probably due to a bad solder in the connector wiring it with the Lakeshore controller. However, since this sensor was put on the coldest part of the facility, and not used to monitor the panels but only the cryostat, this lack did not affect in anything results and full validity of measurements.

Figure 19 6<sup>th</sup> cooldown: a problem is evident in one sensor ( outermost trace on the left)

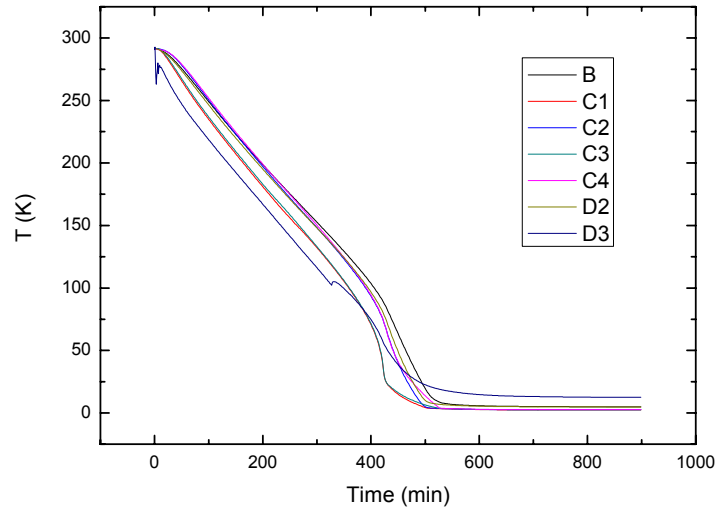
Figure 21 8<sup>th</sup> cooldown: the suffering sensor put on the flange does not thermalise anymore

During cycles, from 7<sup>th</sup> to 9<sup>th</sup>, one of the 7 thermal sensors showed instabilities and in the last two cycles did not reach the temperature foreseen. However, this sensor was used just to monitor the cold flange of the cryostat: hence, this failure did not affect the validity of the test.

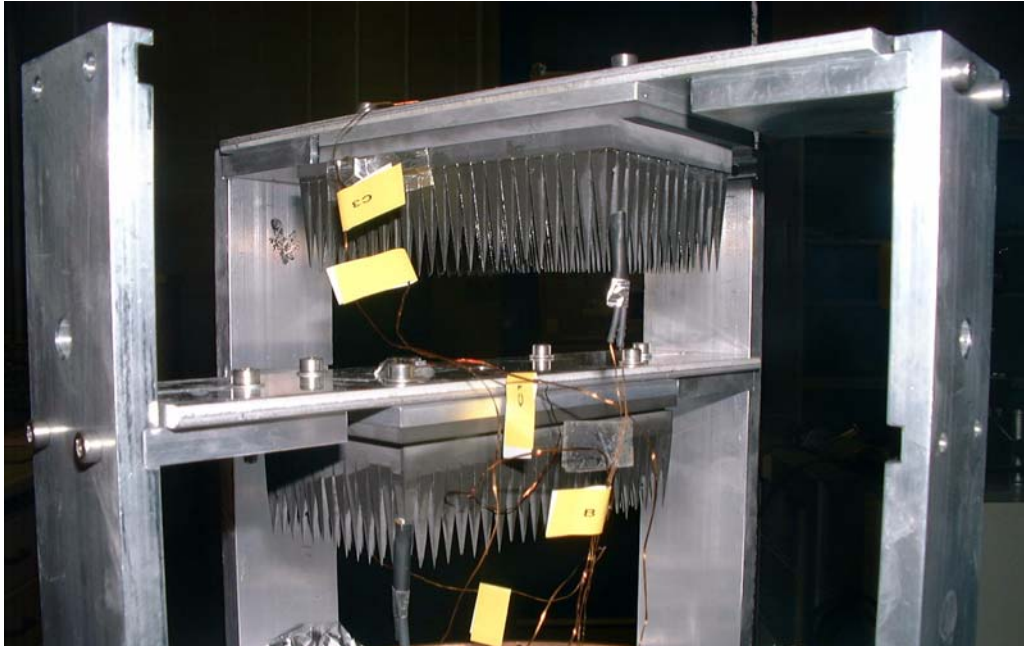
A first inspection was done just after opening the chamber, with panels still mounted on their supports. Nothing relevant was observed.

Figure 27 panels mounted on supports before dismounting

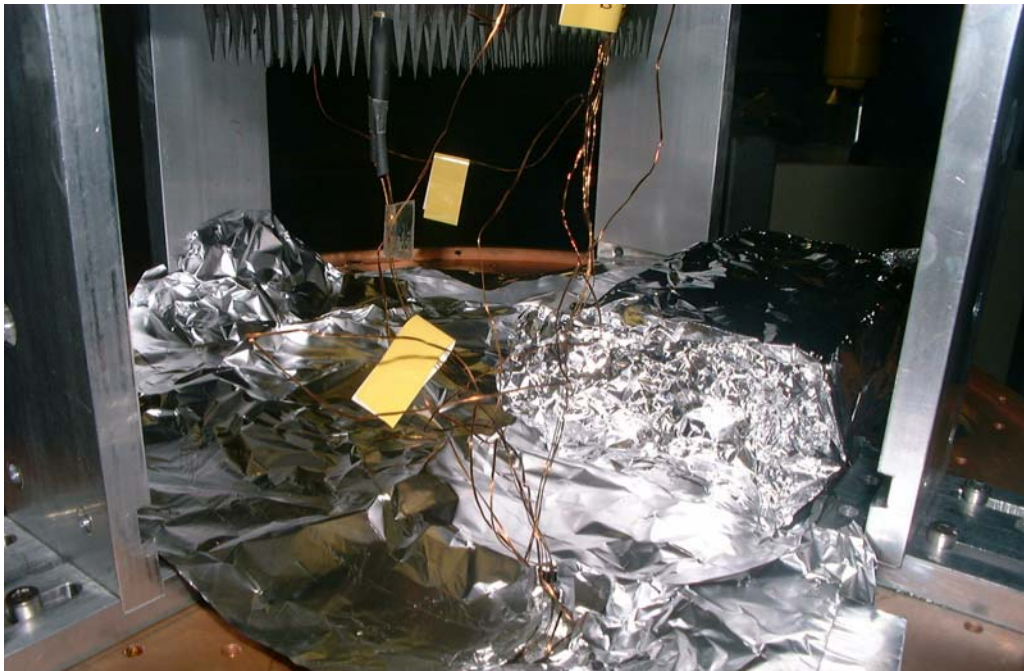
The aluminium foil was removed from the cold flange to search for eventual parts detached from panels: nothing was found on the foil.

Figure 28 aluminium foil put on the cold flange to collect eventual parts detaching from panels: nothing found on it

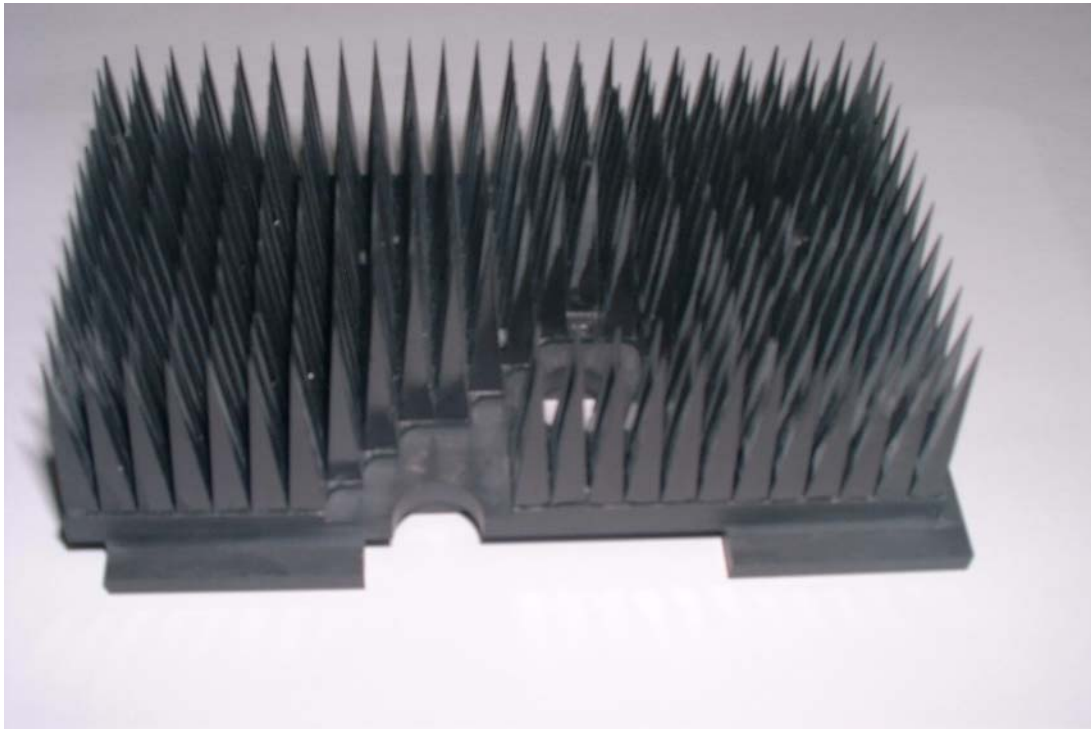
Panels have been then inspected by binocular: nothing new seems to be observed. Comparison with the initial map reporting broken tips and other defects seems to confirm this result.

**Figure 29 special panel after inspection**

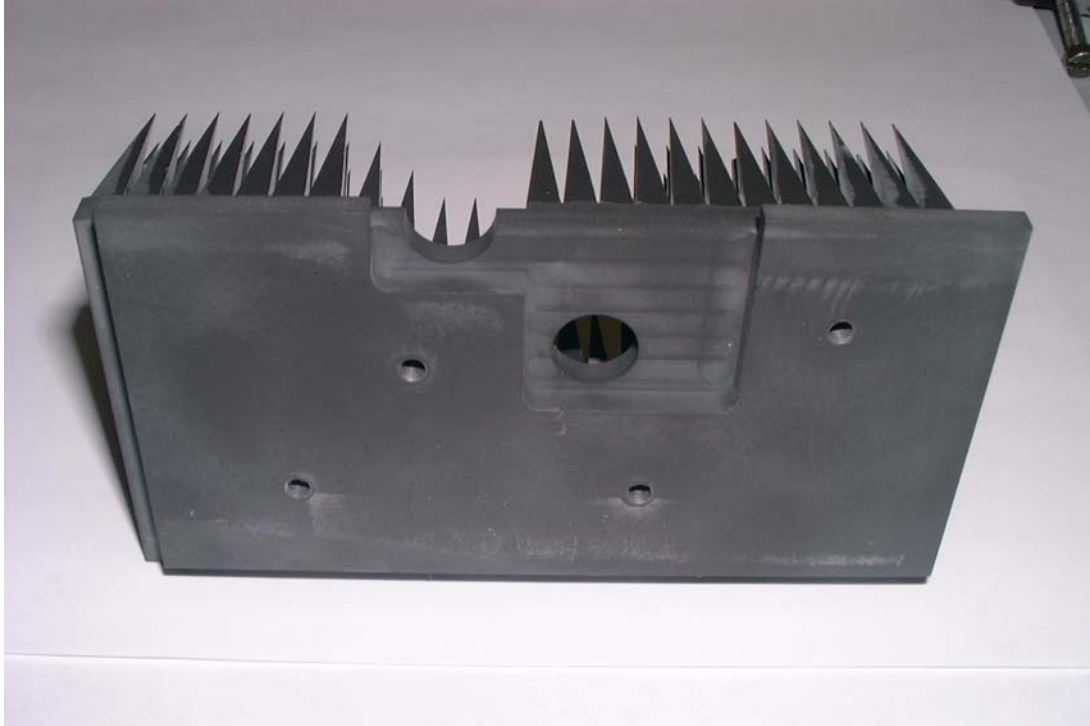
Metal backs have been removed: It allowed to observe the back of ECCOSORB panels for the first time since tests started: everything looked nice, as before cryo tests.

**Figure 30 special panel (back)**

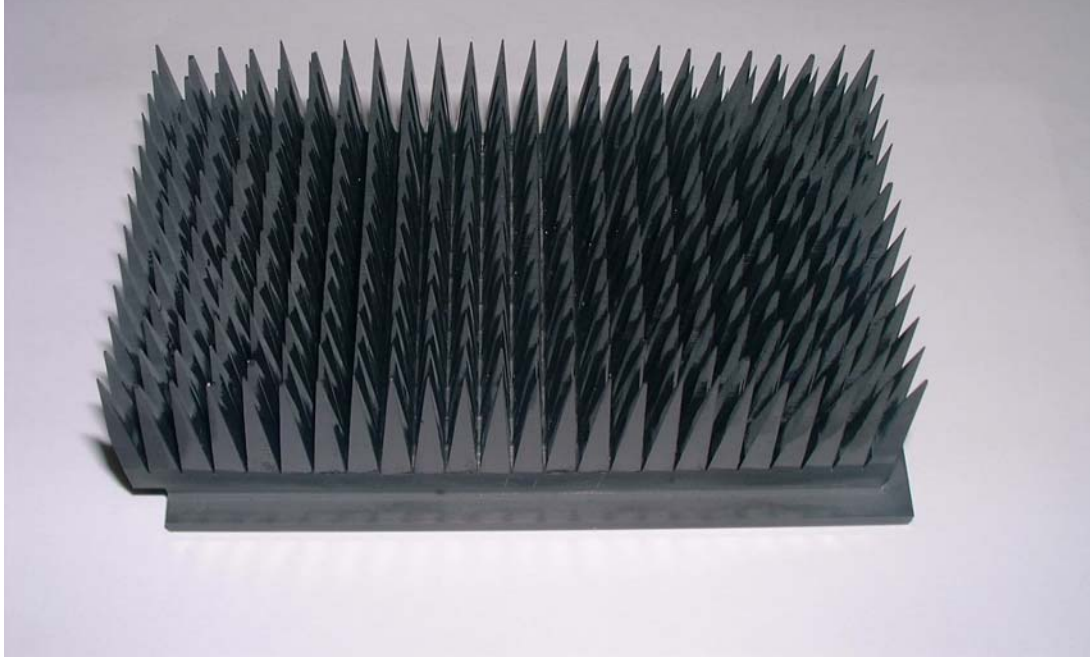
Figure 32 standard panel after inspection

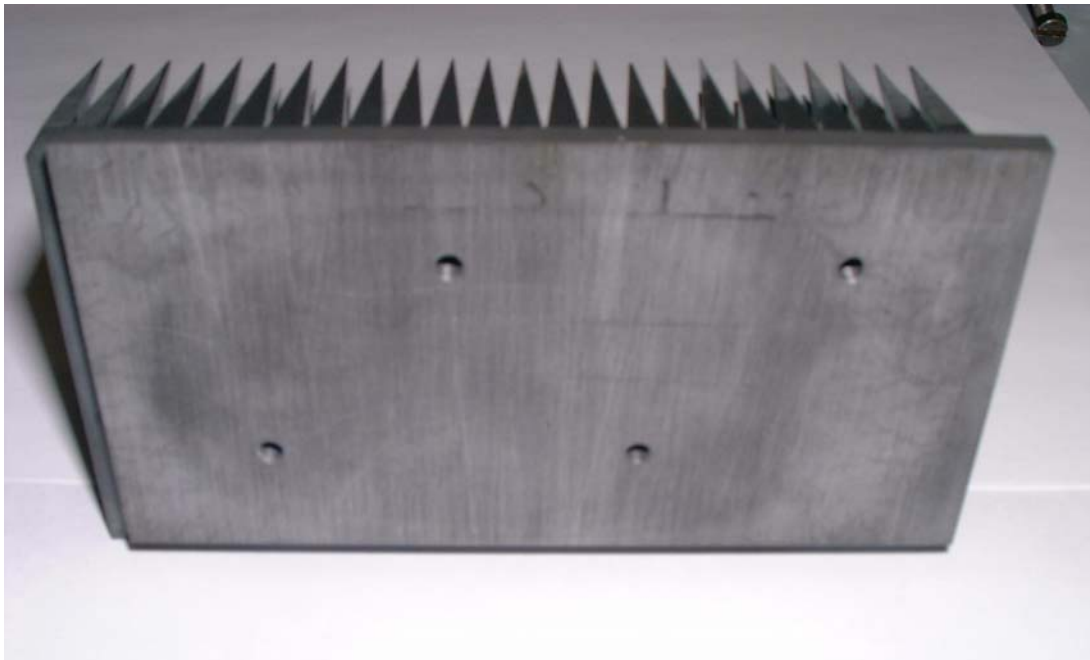
Figure 33 standard panel (back)
