**TITLE:** **ECCOSORB failure analysis**

**DOC. TYPE:** TECHNICAL NOTE

**PROJECT REF.:** PL-LFI-TES-TN-015

**DATE:** May 2005

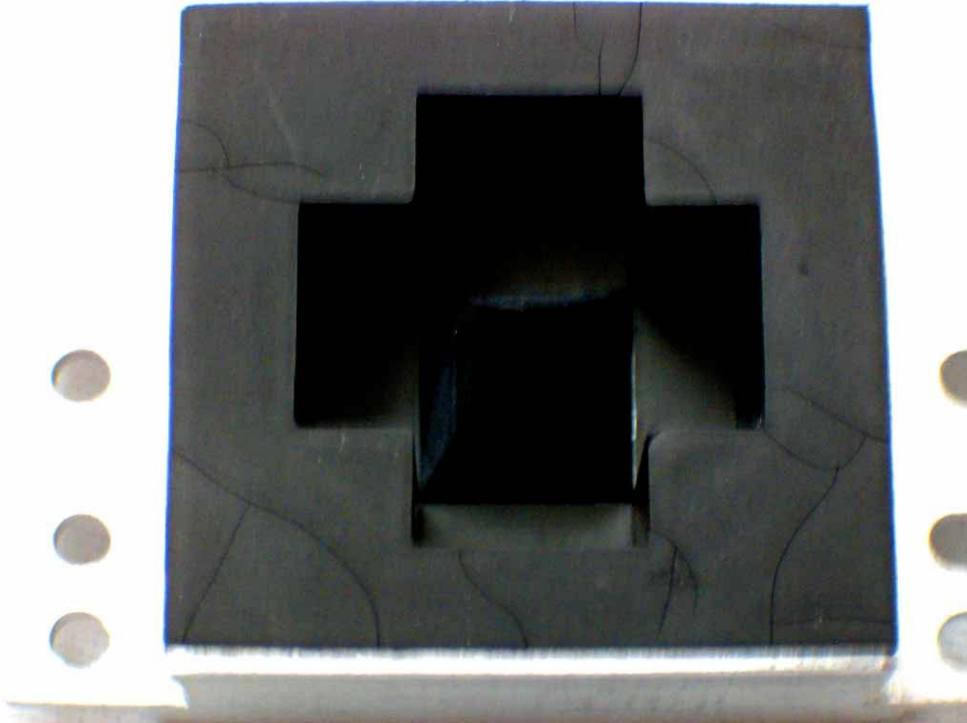
Figure 3: Another view of the damaged 30GHz target

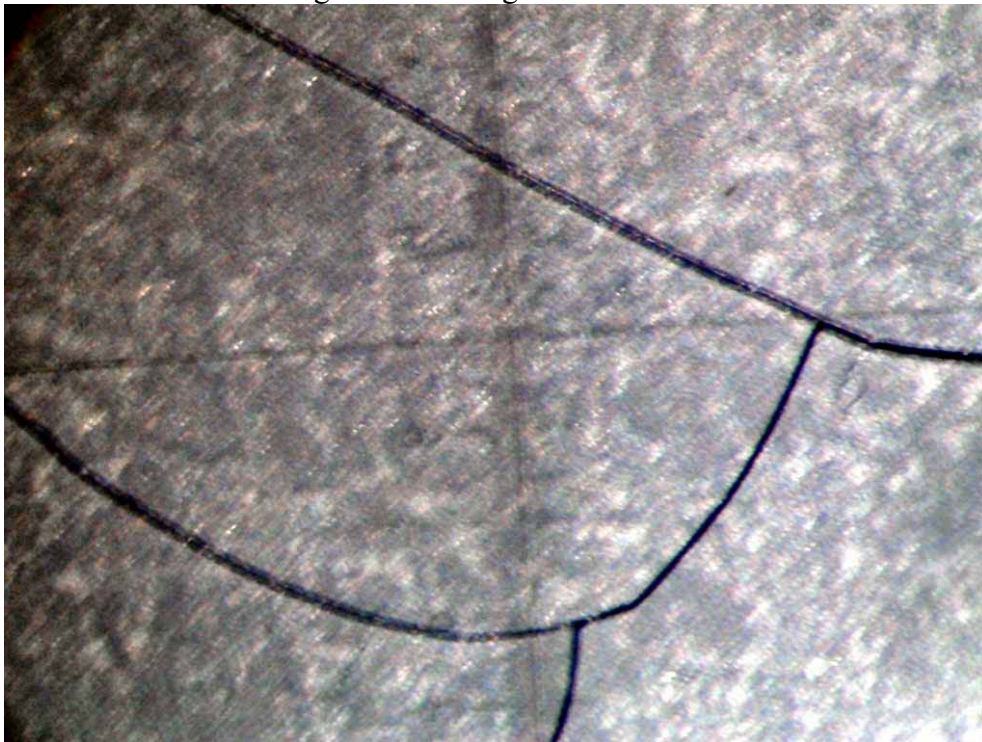
Figure 4: Details of some of the cracks view through a microscope.

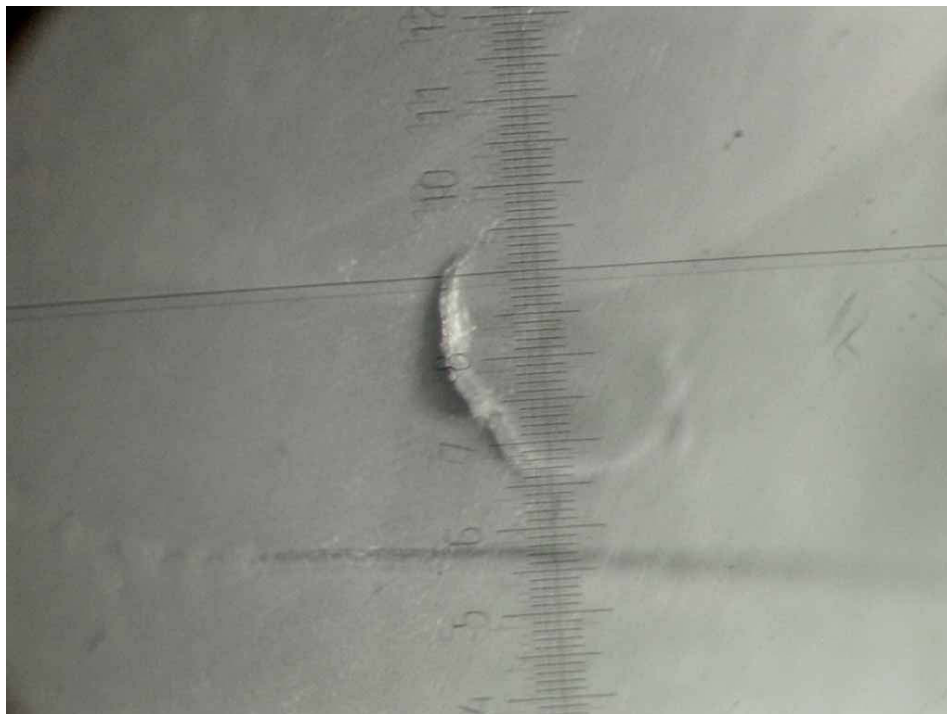
Figure 6: Details of one of the flakes view through a microscope

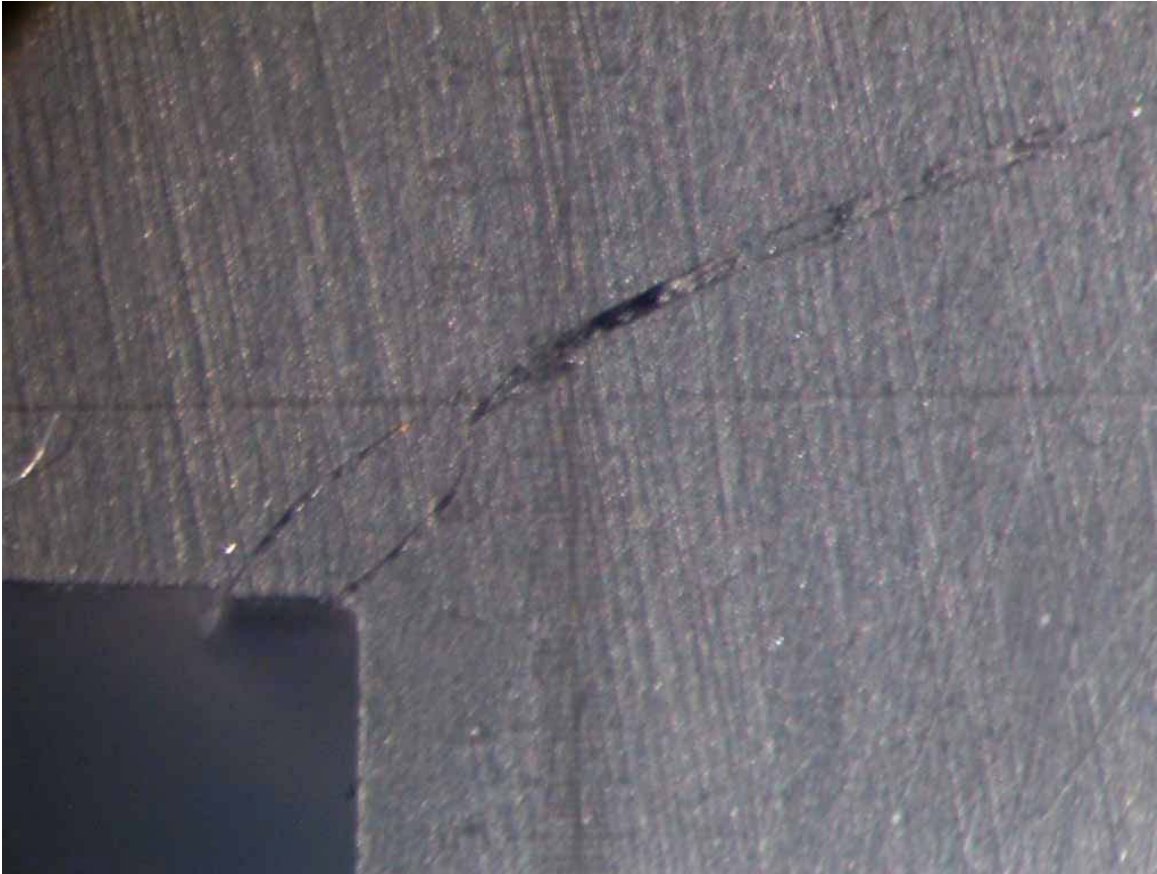
Figure 7: Details View through a microscope of the crack on the 44 GHz target (id parte)

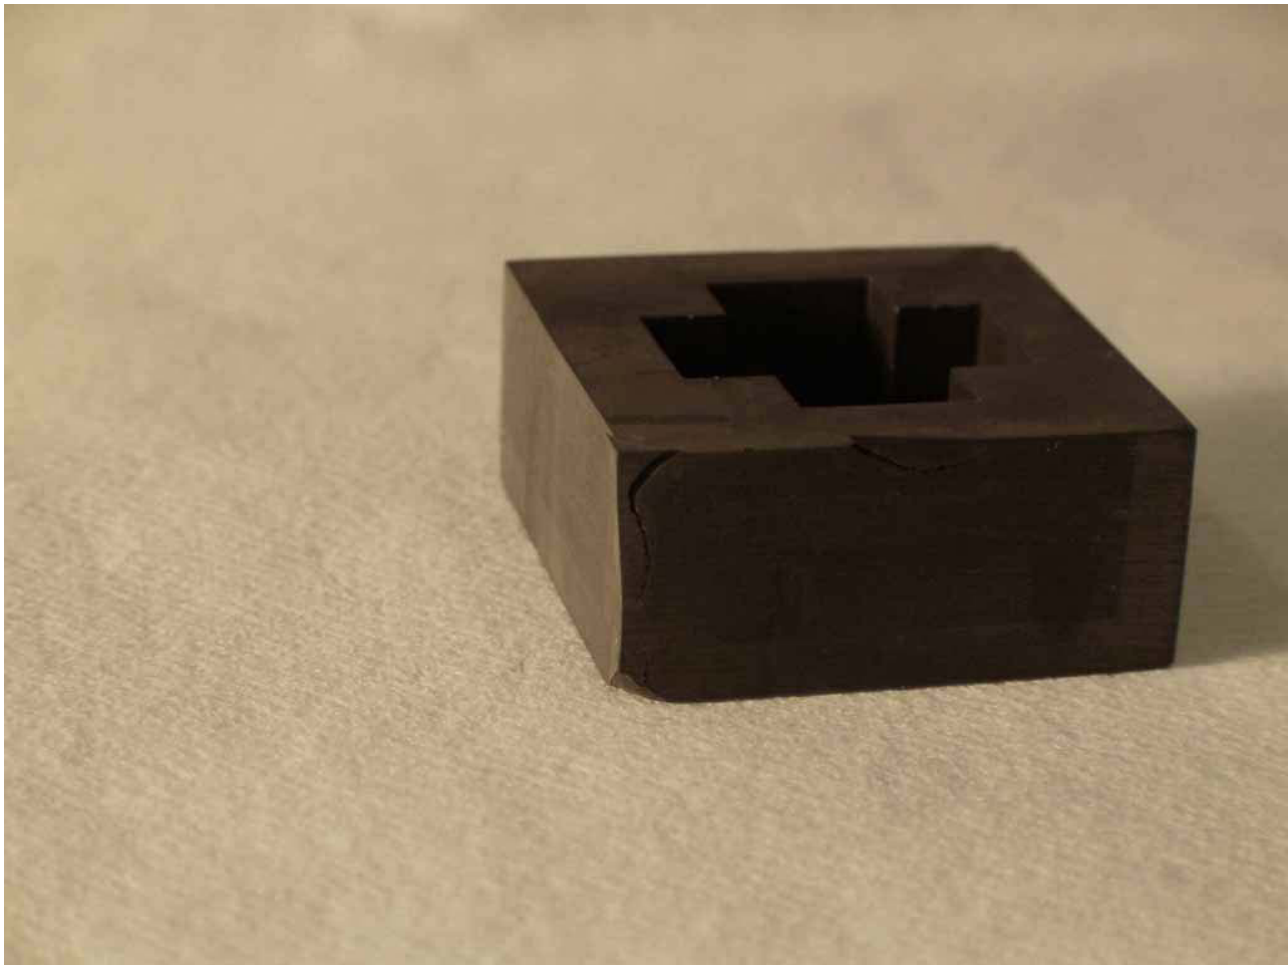
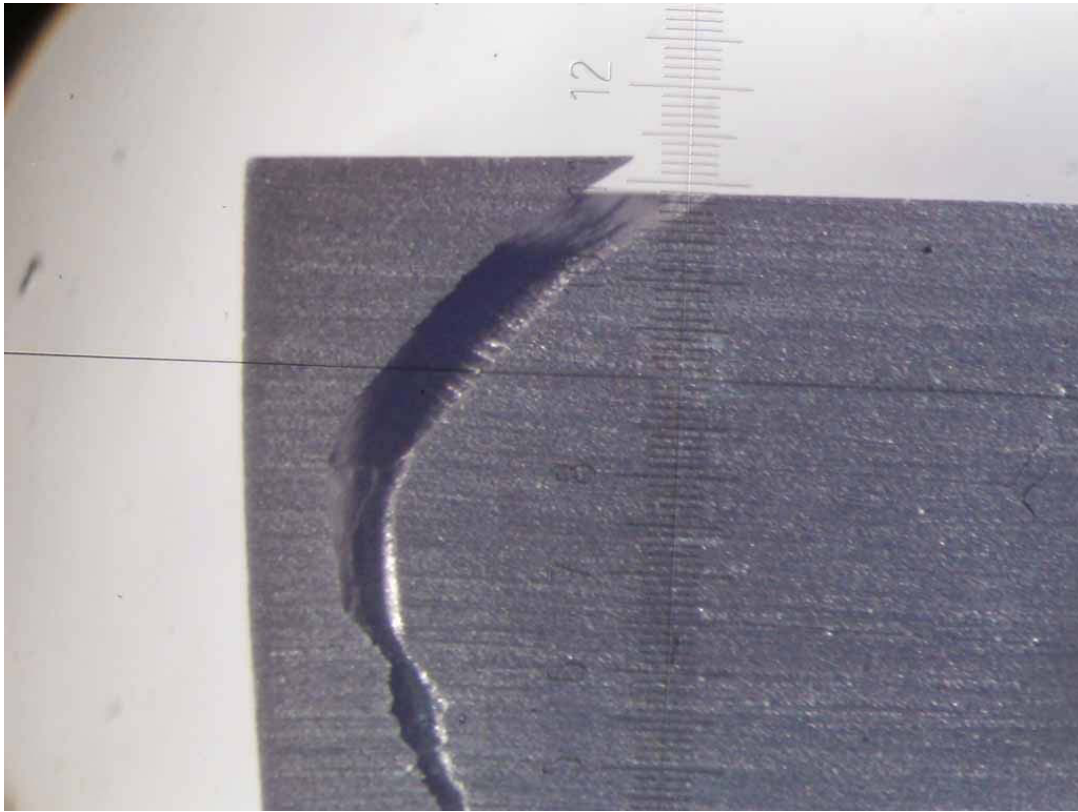
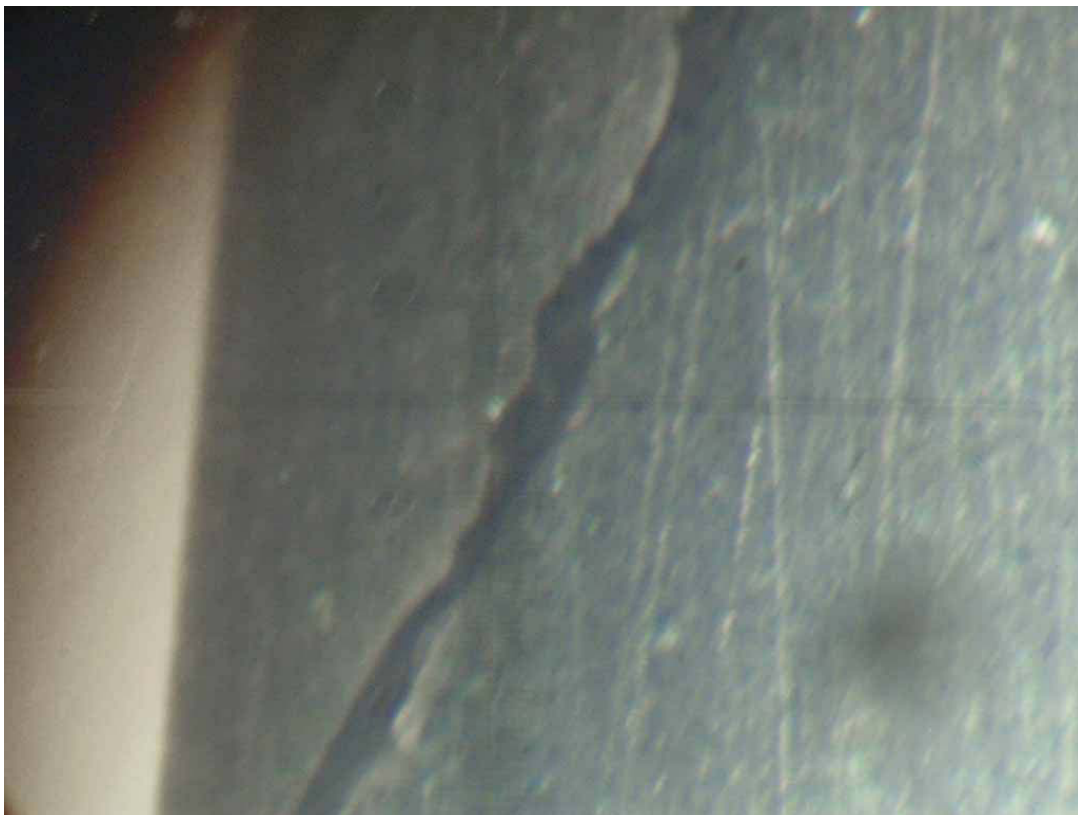
### 10.1 Specimen 1a – Cross @44GHz acetone&ultrasound

DATE	TIME	TEST CONDITION	NOTE
09/03/05	11.00	21.4°C40%HR	<b>Visual Inspection:</b> There are 2 bubble one on the external edge and the other on the internal edge. <b>Mass:</b> 5.7[g]
09/03/05	11.20		<b>Start a battery of 3 cycles of ultrasonic cleaning bath</b>
09/03/05	12.30		<b>End of cycles.</b> <b>Visual Inspection:</b> The specimen has several cracks on all the edge. <b>Mass:</b> 5.7[g]

In the followings images is visible the specimens after all the test.

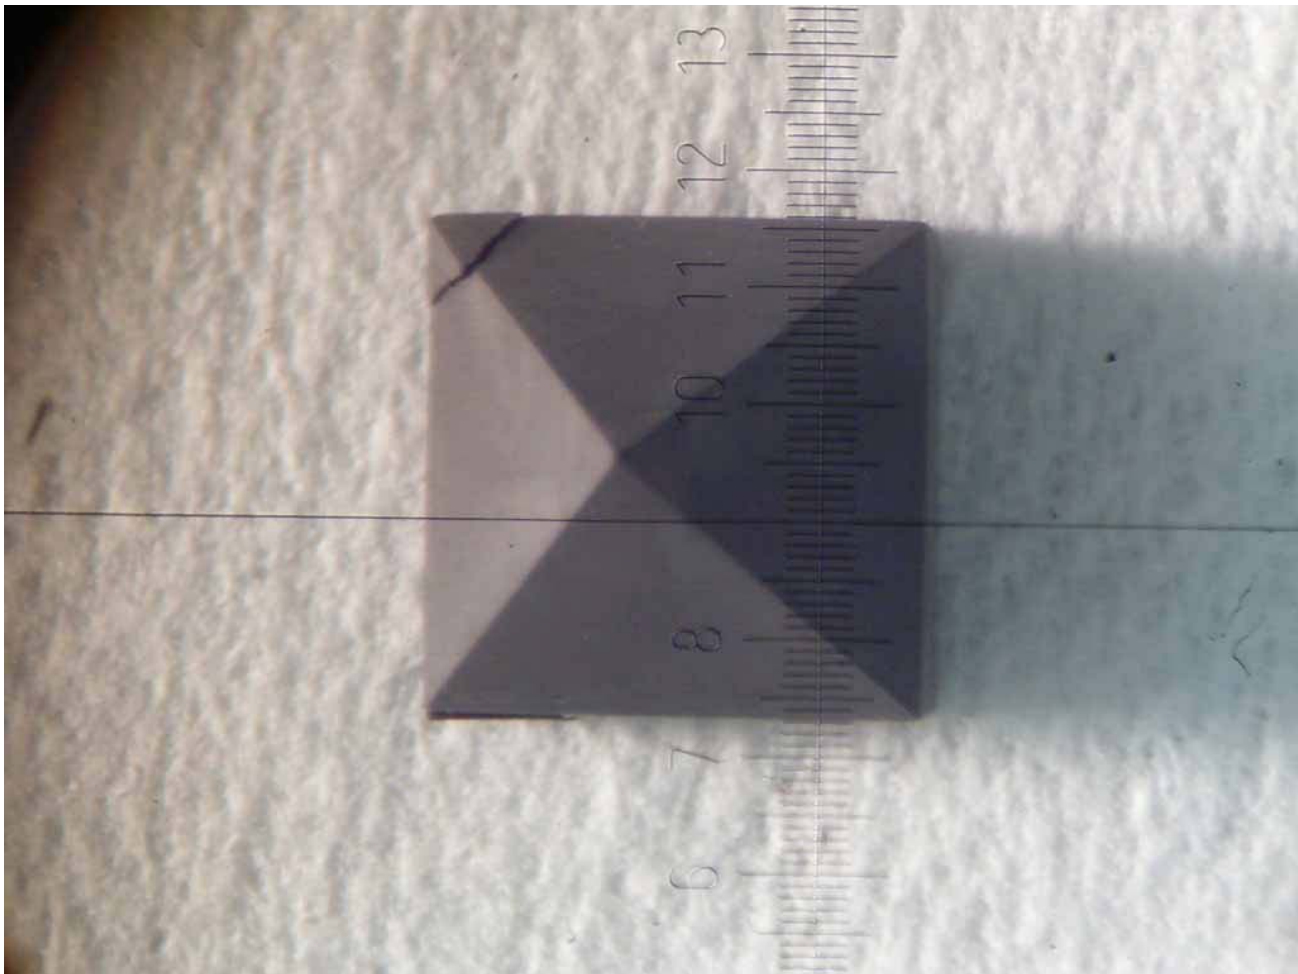
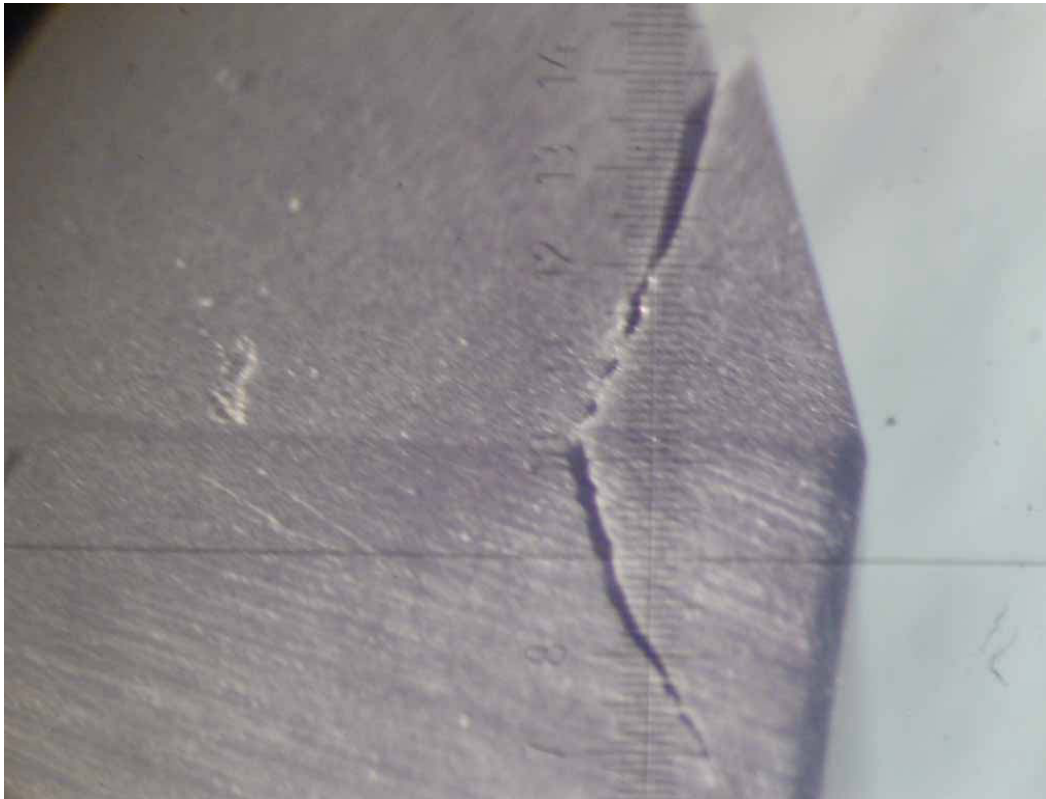
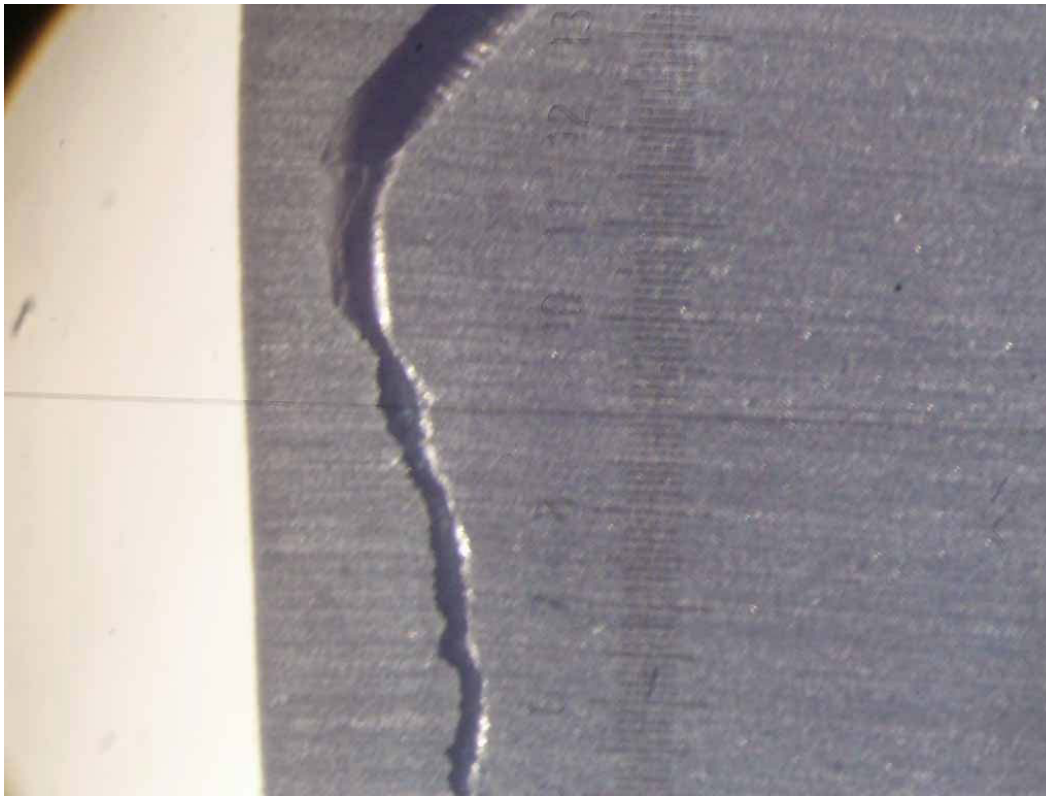
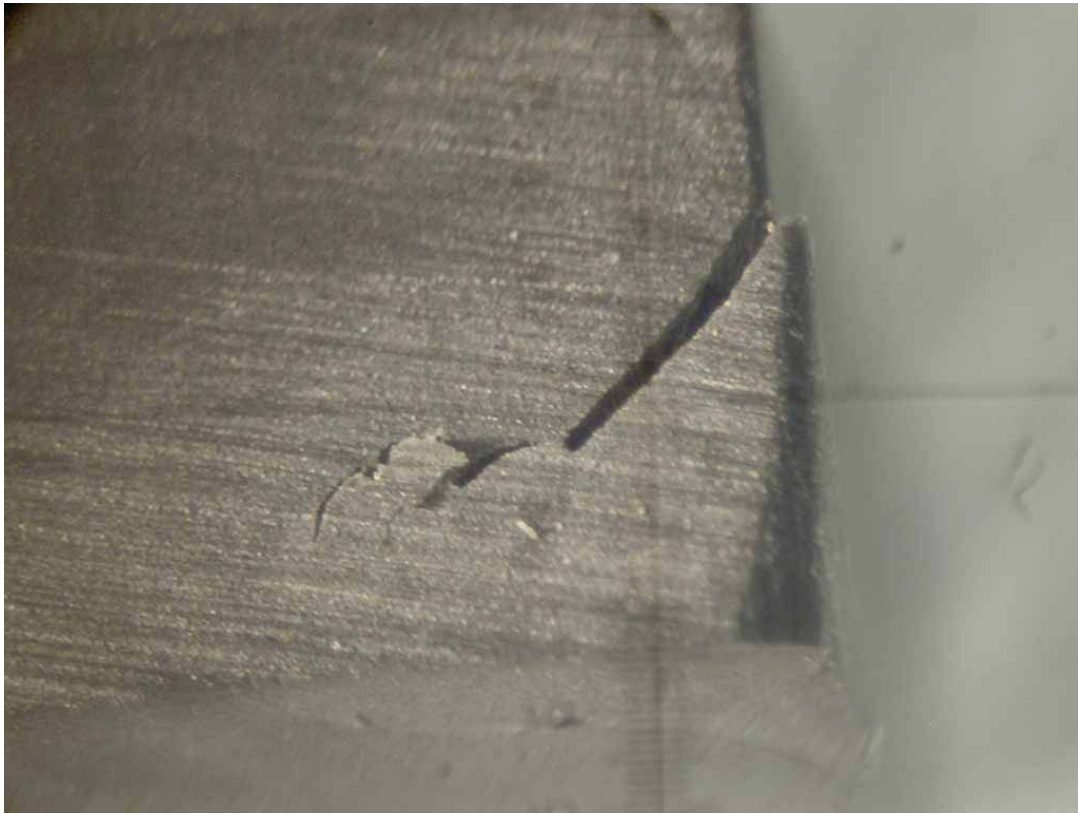
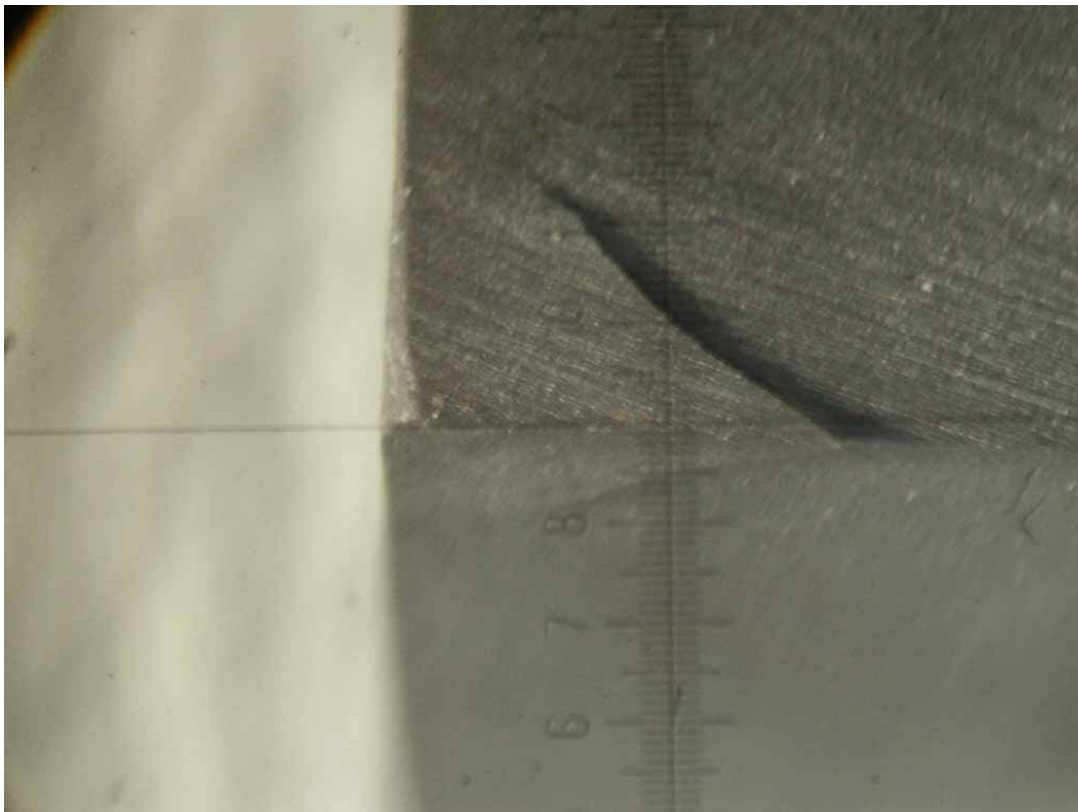
**10.2 Specimen 1b – Pyramids @44GHz acetone&ultrasound**

DATE	TIME	TEST CONDITION	NOTE
09/03/05	11.00	21.4°C40%HR	<b>Visual Inspection:</b> there aren't visible defects <b>Mass:</b> 0.5[g]
09/03/05	11.20		<b>Start a battery of 3 cycles of ultrasonic cleaning bath</b>
09/03/05	12.30		<b>End of cycles.</b> <b>Visual Inspection:</b> The specimen has several cracks on all edges. <b>Mass:</b> 0.5[g]

In the followings images is visible the specimen after all the test

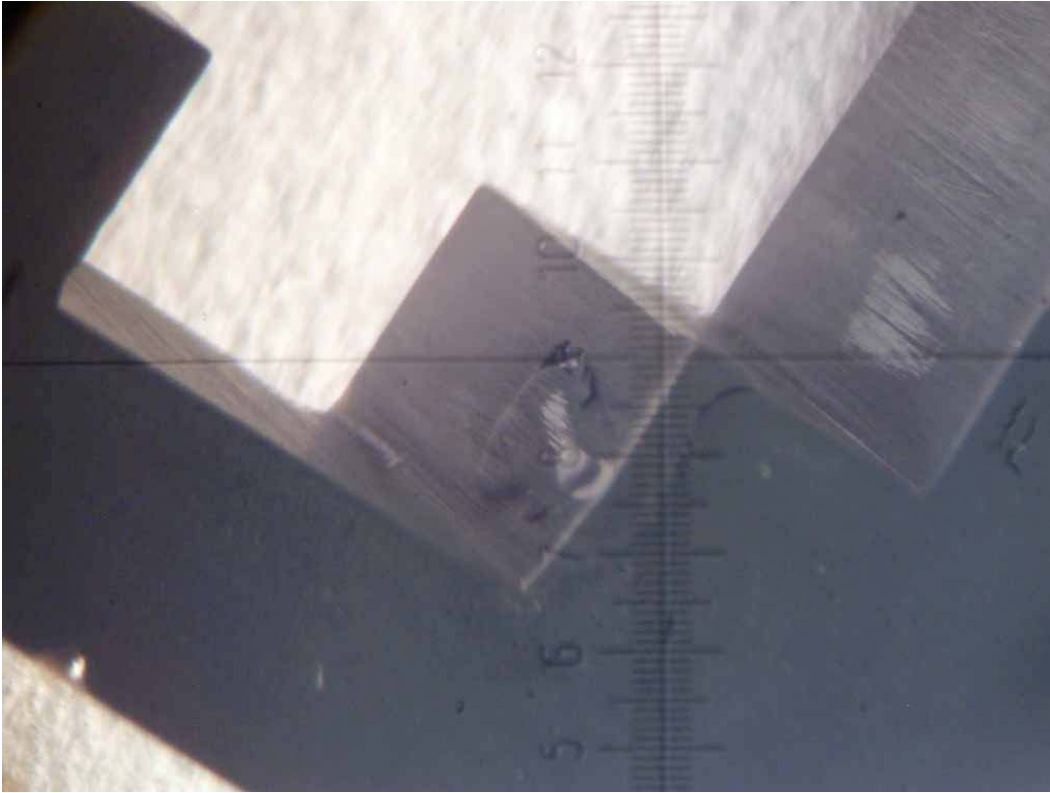
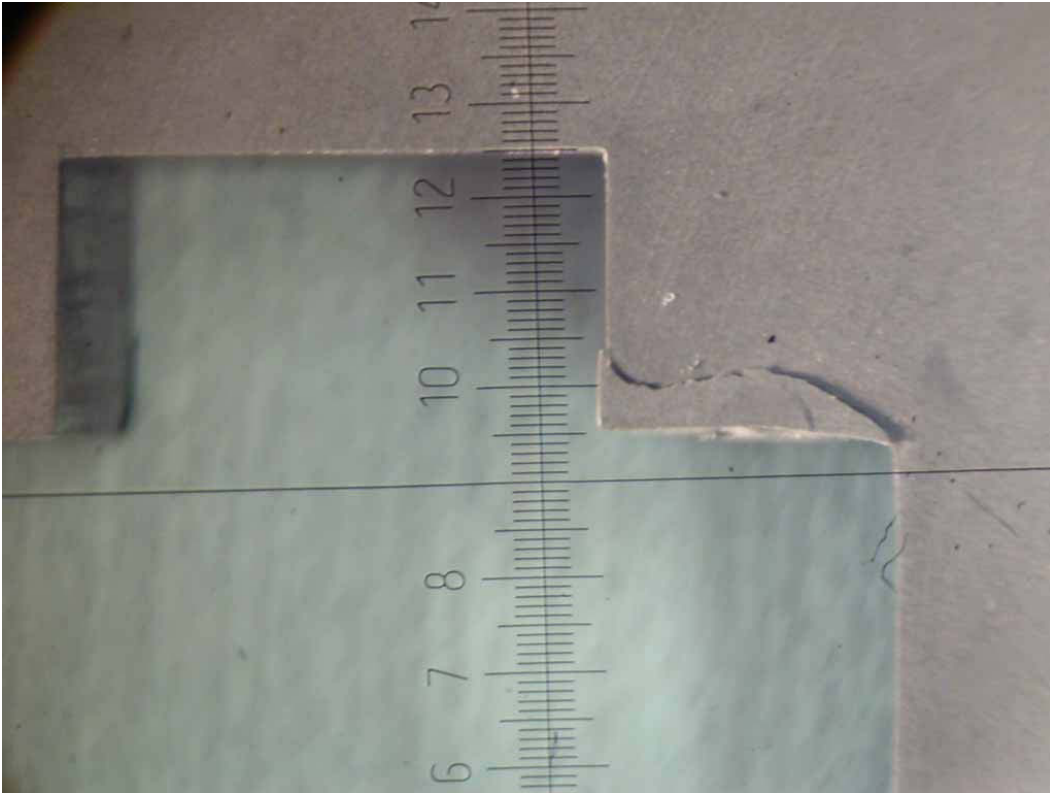
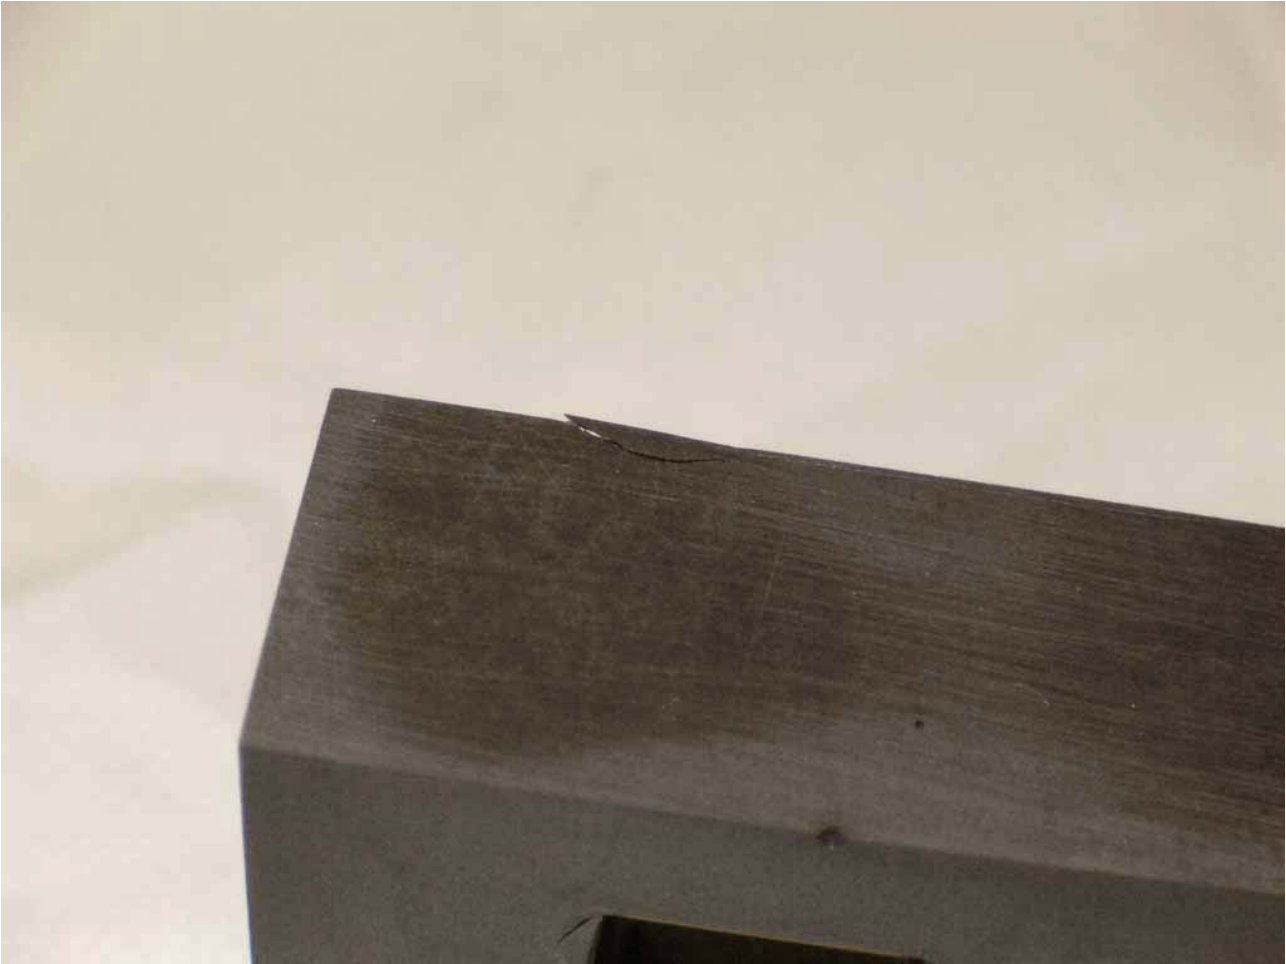
**10.3 Specimen 2 – Cross @30GHz acetone&ultrasound**

DATE	TIME	TEST CONDITION	NOTE
09/03/05	11.00	21.4°C40%HR	<b>Visual Inspection:</b> There are 2 blister on the external edge <b>Mass:</b> 16.5[g]
09/03/05	11.20		<b>Start a sequence of 3 cycles of ultrasonic cleaning bath</b>
09/03/05	12.30		<b>End of the battery of the cycles.</b> <b>Visual Inspection:</b> The specimen doesn't have any crack. <b>Mass:</b> 16.5[g]
09/03/05	16.30	21.6°C40%HR	<b>Start the IV cycle of ultrasonic cleaning bath</b>
09/03/05	17.00		<b>End of the cycle</b> <b>Visual Inspection:</b> There are visible cracks on all the edges

In the followings images is visible the specimen after the IV cycle

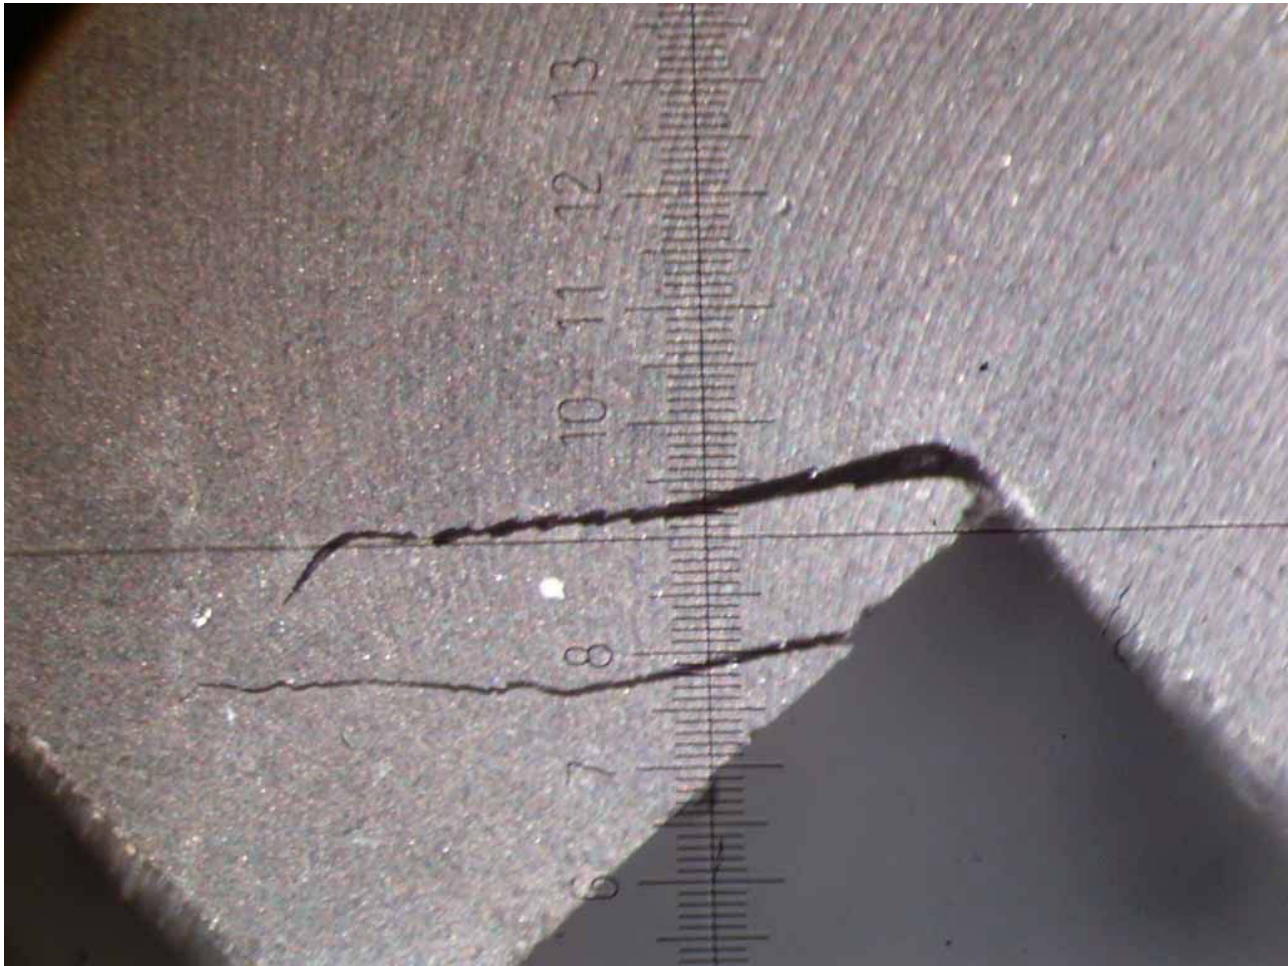
### 10.4 Specimen 3a – Cross@30GHz acetone

DATE	TIME	TEST CONDITION	NOTE
09/03/05	11.00	21.4°C40%HR	<b>Visual Inspection:</b> There is a defect on the external edge <b>Mass:</b> 17.9[g]
09/03/05	11.30		<b>The specimen is covered with acetone</b>
09/03/05	14.10		<b>Visual Inspection:</b> there aren't additional visible defects <b>Mass:</b> 17.9[g]
09/03/05	16.40		<b>Visual Inspection:</b> There are visible some white spots.
10/03/05	10.15	21.3°C47%HR	<b>Visual Inspection:</b> There are visible several cracks on all the specimen. It is needed to disrupt the backer to extract the specimen from the backer, since its volumes has increased.

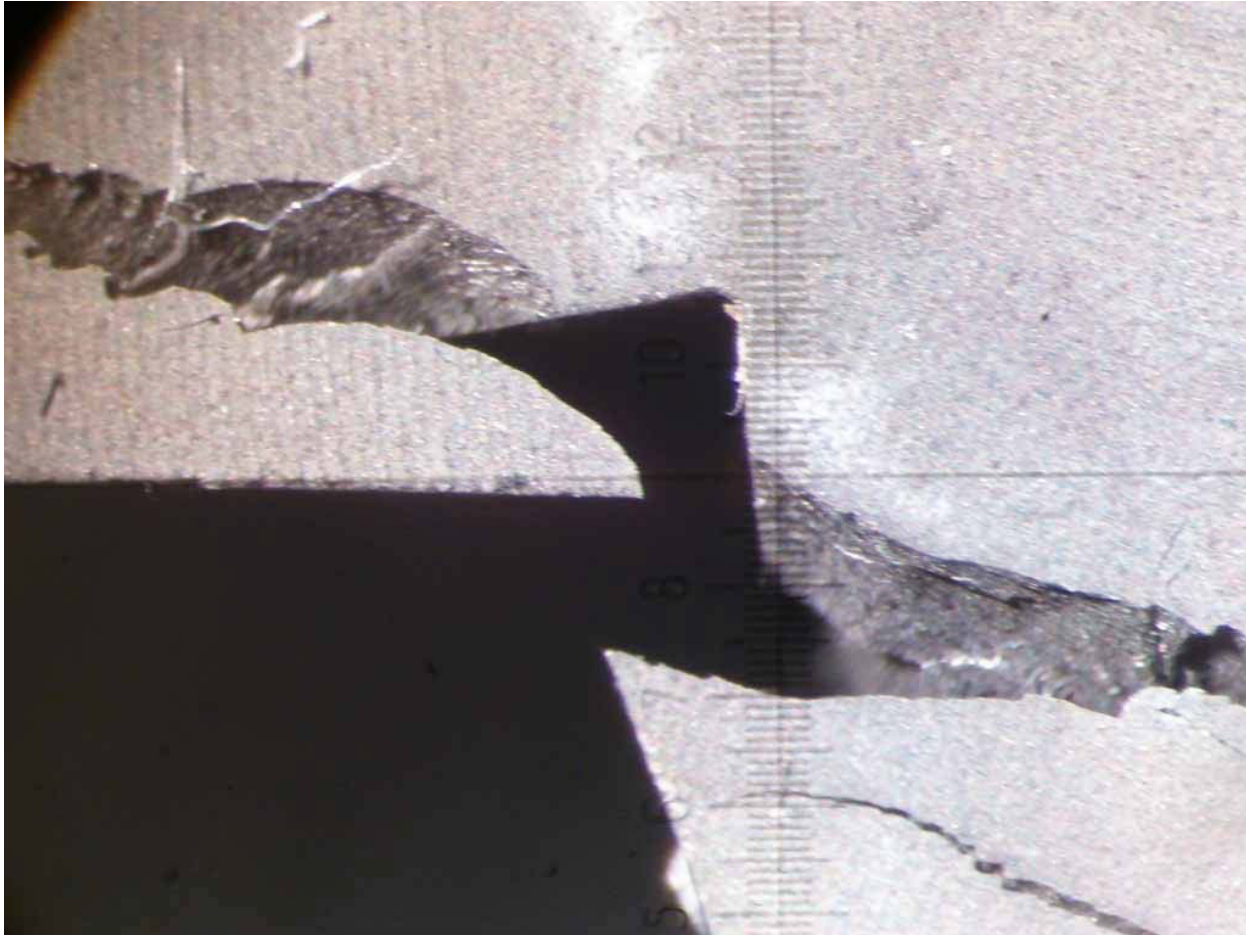
### 10.5 Specimen 3b – Cross@44GHz acetone

DATE	TIME	TEST CONDITION	NOTE
09/03/05	11.00	21.4°C40%HR	<b>Visual Inspection:</b> there aren't visible defects <b>Mass:</b> 5.6[g]
09/03/05	11.30		<b>The specimen is covered with acetone</b>
09/03/05	14.10		<b>Visual Inspection:</b> there aren't visible defects <b>Mass:</b> 5.6[g]
09/03/05	16.40		<b>Visual Inspection:</b> there aren't visible defects
10/03/05	10.15	21.3°C47%HR	<b>Visual Inspection:</b> There are visible several cracks on all the specimen. It is needed to disrupt the backer to extract the specimen from the backer.

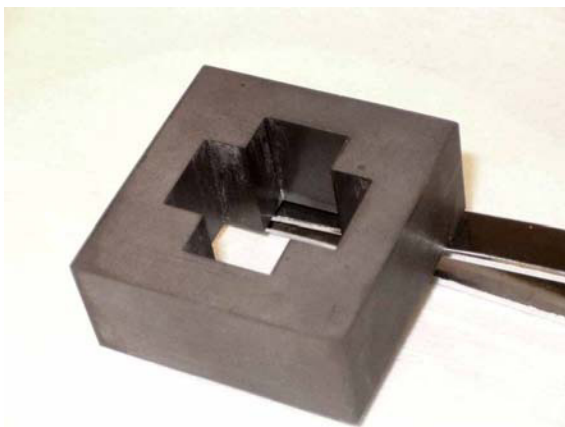
### 10.9 Specimen 6 – Cross@30GHz, water&ultrasound

DATE	TIME	TEST CONDITION	NOTE
10/03/05	15.00	21.3°C47%HR	<b>Visual Inspection:</b> There is a long crack on one of the internal edges. <b>Mass:</b> 18.28 [g]
10/03/05	16.00		<b>Start of the I cycle of ultrasonic cleaning bath</b>
10/03/05	16.25		<b>End of the cycle</b> <b>Visual Inspection:</b> there aren't additional visible defects.
10/03/05	16.30		<b>Start of the II cycle of ultrasonic cleaning bath</b>
10/03/05	16.55		<b>End of the II cycle</b> <b>Visual Inspection:</b> there aren't additional visible defects.
11/03/05	11.15	21.6°C40%HR	<b>Start of the III cycle of ultrasonic cleaning bath</b>
11/03/05	11.40		<b>End of the III cycle of ultrasonic cleaning bath</b> <b>Visual inspection:</b> there aren't additional visible defects.
11/03/05	12.05		<b>Start of the IV cycle of ultrasonic cleaning bath</b>
11/03/05	14.05		<b>End of the IV cycle of ultrasonic cleaning bath</b> <b>Visual inspection:</b> there aren't additional visible defects.

11/03/05	14.12		<b>Start of the V cycle of ultrasonic cleaning bath</b>
11/03/05	14.35		<b>End of the V cycle of ultrasonic cleaning bath</b> <b>Visual inspection:</b> there aren't additional visible defects.
11/03/05	14.35		<b>Start of the VI cycle of ultrasonic cleaning bath</b>
11/03/05	15.00		<b>End of the VI cycle of ultrasonic cleaning bath</b> <b>Visual inspection:</b> there aren't additional visible defects.
11/03/05	15.05		<b>Start of the VII cycle of ultrasonic cleaning bath</b>
11/03/05	15.25		<b>End of the VII cycle of ultrasonic cleaning bath</b> <b>Visual inspection:</b> there aren't additional visible defects.
11/03/05	15.30		<b>Start of the VIII cycle of ultrasonic cleaning bath</b>
11/03/05	15.55		<b>End of the VIII cycle of ultrasonic cleaning bath</b> <b>Visual inspection:</b> there aren't additional visible defects.

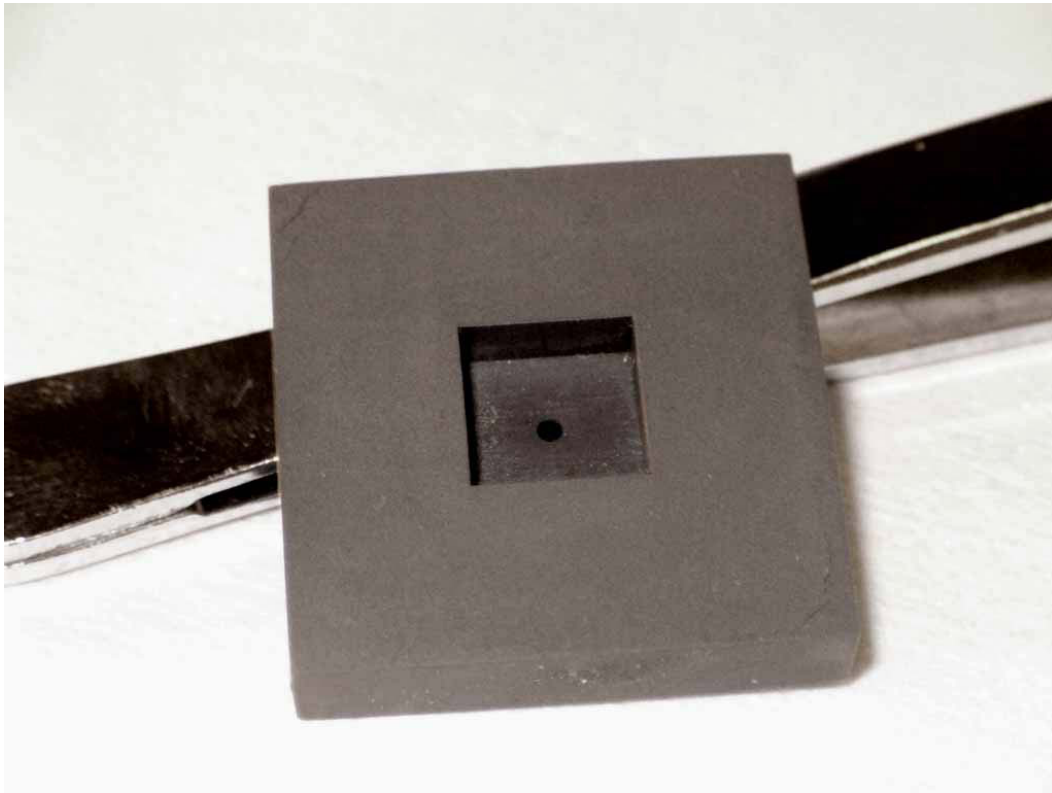
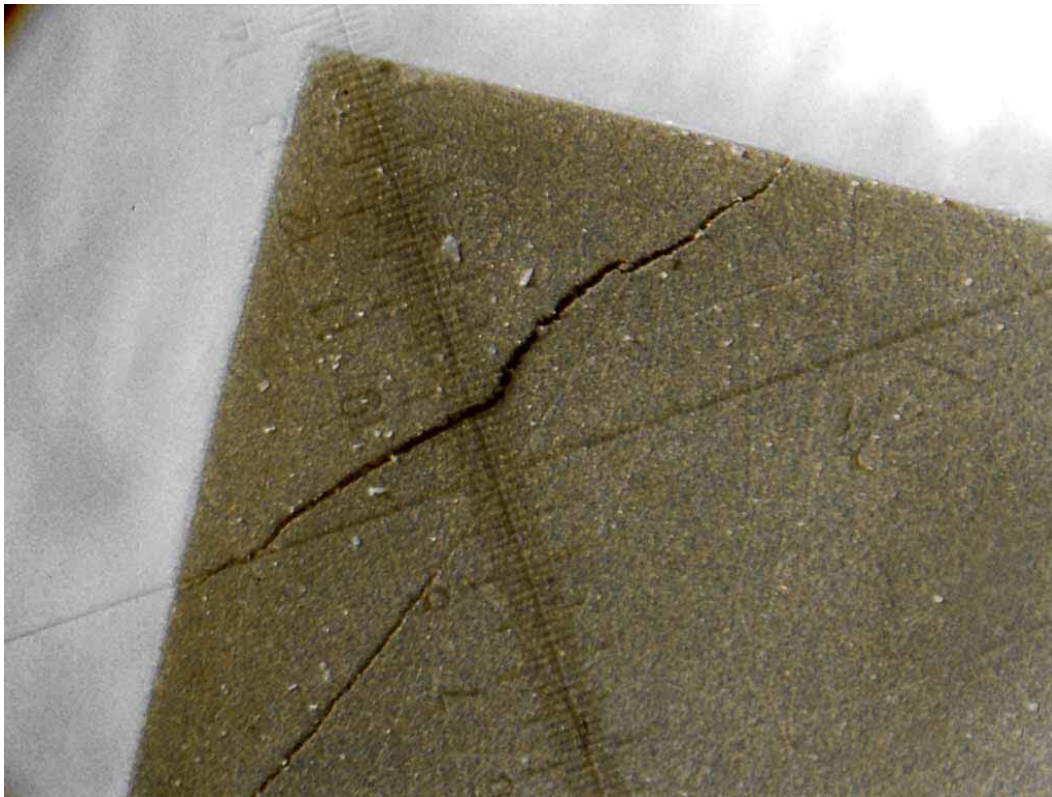
### 10.10 Specimen 7 – base@44GHz acetone

DATE	TIME	TEST CONDITION	NOTE
09/03/05	11.00	21.4°C40%HR	<b>Visual Inspection:</b> There aren't visible defects <b>Mass:</b> 9.3[g]
09/03/05	11.30		<b>The specimen is covered with acetone</b>
09/03/05	14.10		<b>Visual Inspection:</b> there aren't visible defects <b>Mass:</b> 9.3[g]
09/03/05	16.40		<b>Visual Inspection:</b> there aren't visible defects
10/03/05	10.15	21.3°C47%HR	<b>Visual Inspection:</b> There aren't visible defects. <b>Mass:</b> 9.7[g]
10/03/05	16.50		<b>Visual Inspection:</b> there aren't visible defects
11/03/05	11.00		<b>Visual Inspection:</b> there aren't visible defects <b>Mass:</b> 9.79 [g]
11/03/05	14.12		<b>Visual Inspection:</b> there aren't visible defects
11/03/05	16.00		<b>Visual Inspection:</b> there aren't visible defects
14/03/05	9.50		<b>Visual Inspection:</b> the acetone is evaporated and there is a viscous liquid on the surface and it is easy to scratch. <b>Mass:</b> 9.83 [g]

14/03/05	15.20		<b>Visual Inspection:</b> there aren't visible defects
15/03/05	10.00	21.5°C40.3%HR	<b>Visual Inspection:</b> there aren't visible defects, but it is possible to crack it with a light hand pressure. <b>Mass:</b> 9.92 [g]
15/03/05	15.30		<b>Mass:</b> 9.88 [g]
