**TITLE:** **ECCOSORB failure analysis**

**DOC. TYPE:** TECHNICAL NOTE

**PROJECT REF.:** PL-LFI-TES-TN-015

**DATE:** May 2005

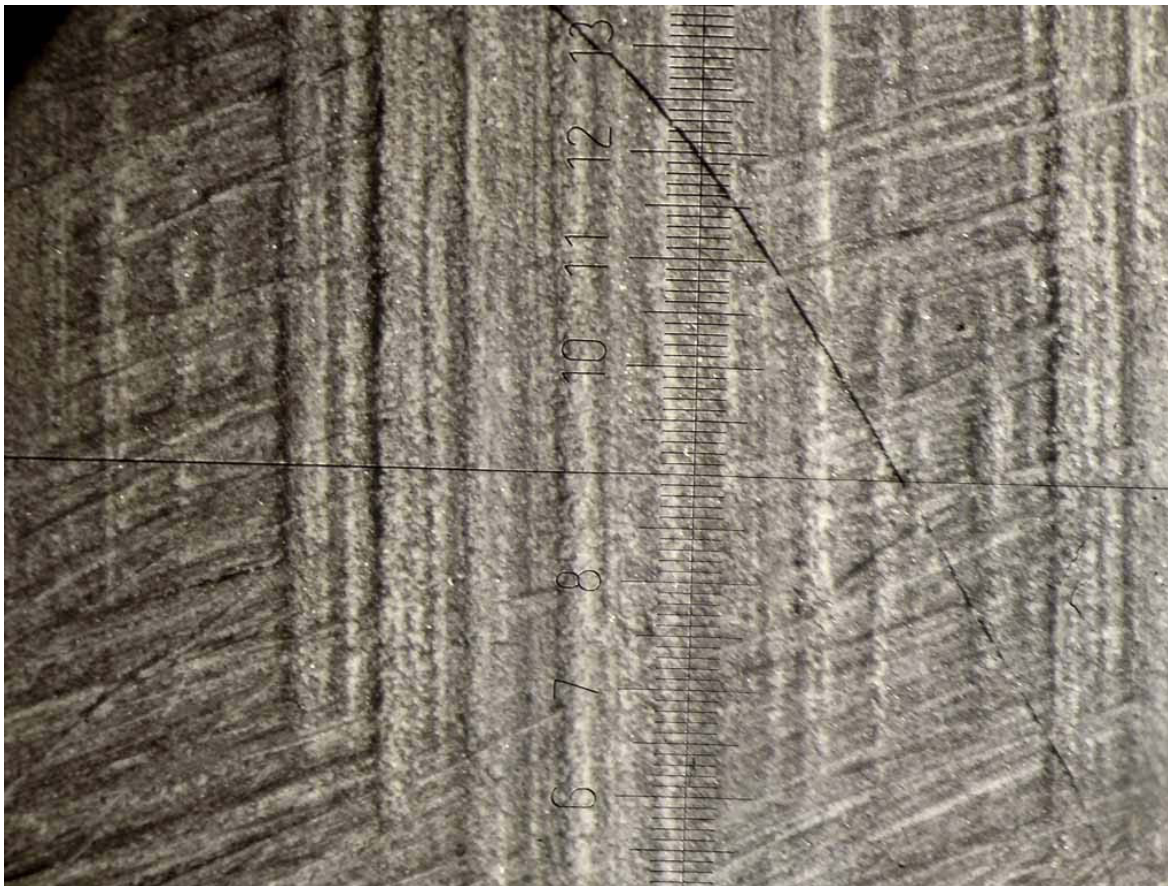
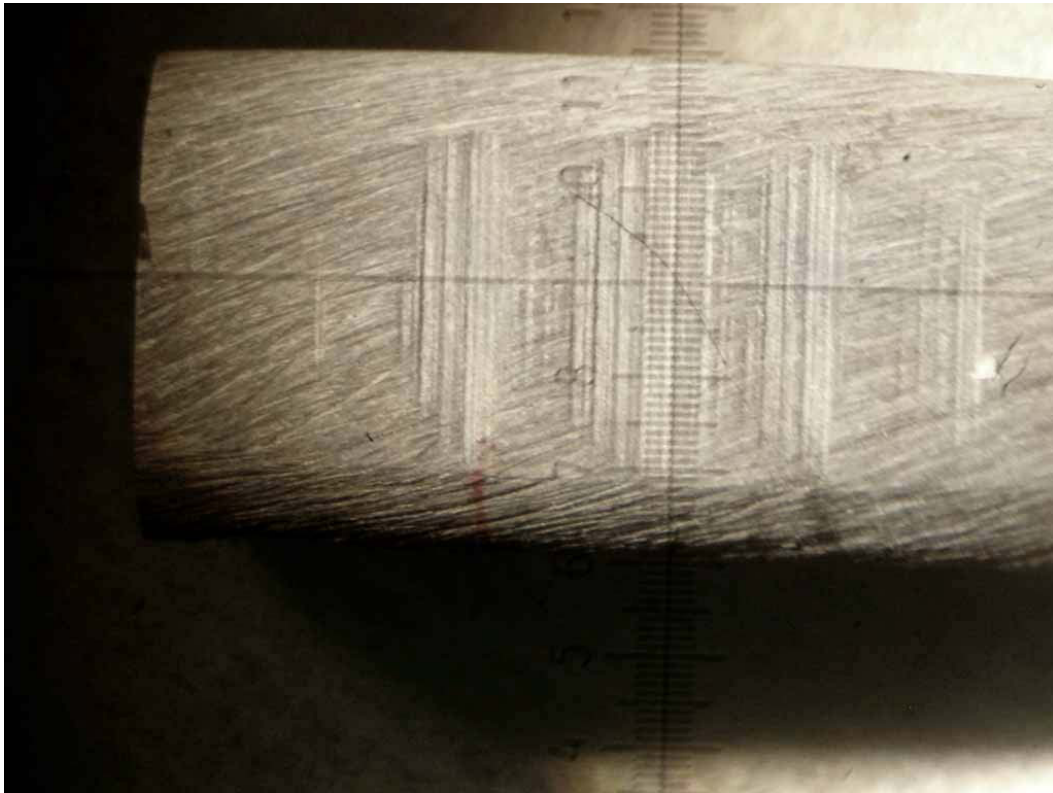
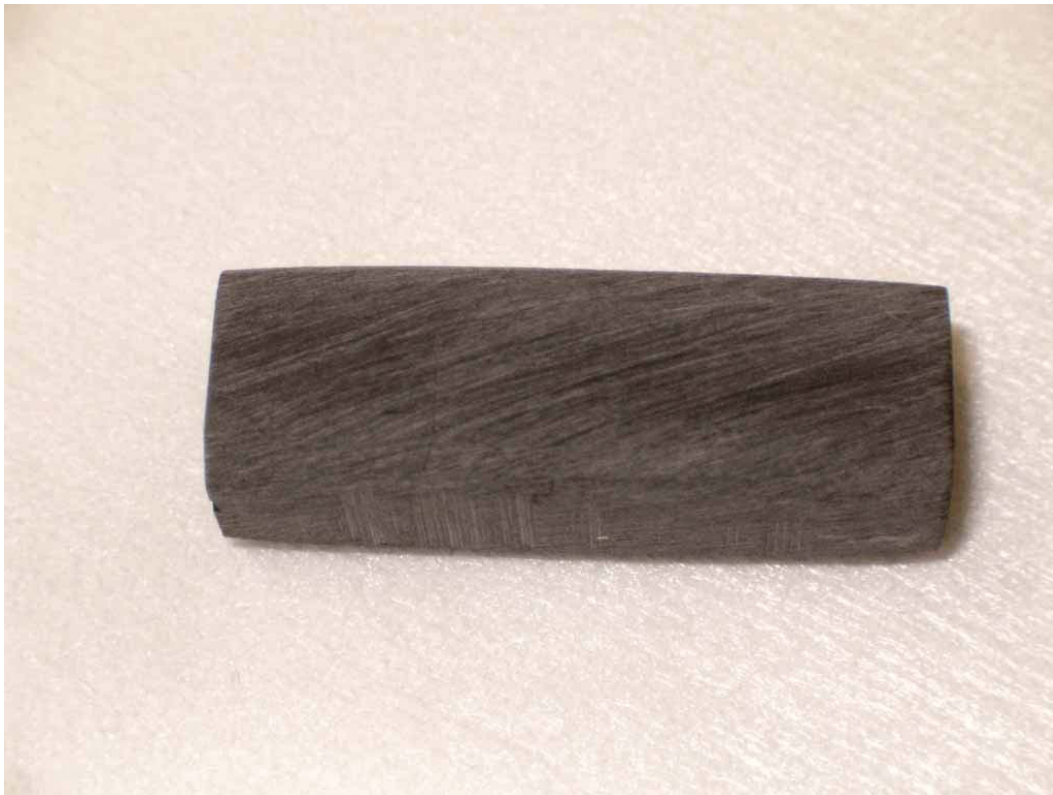
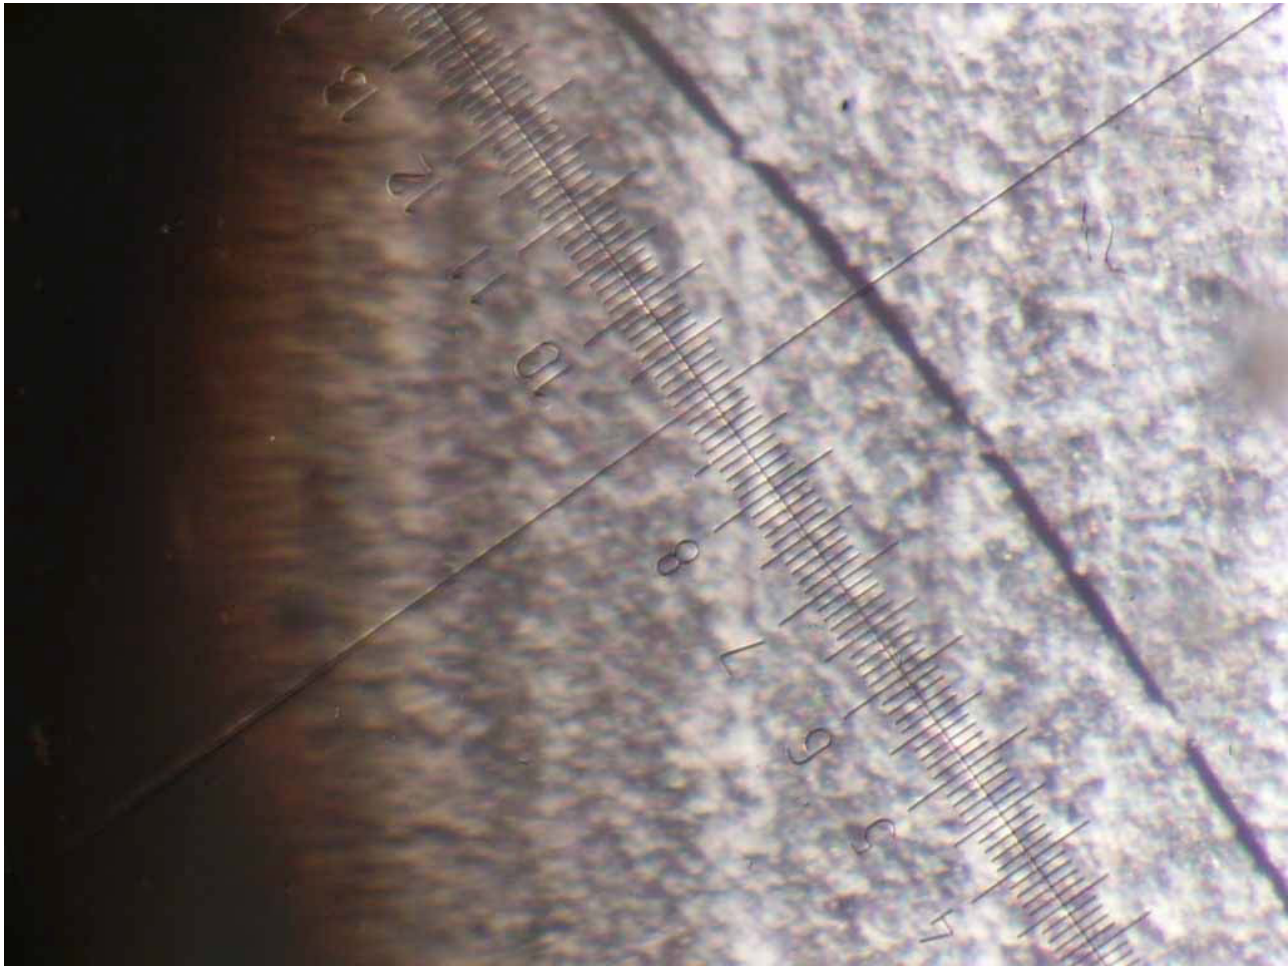
**10.12 Specimen 9 – bulk toluene**

DATE	TIME	TEST CONDITION	NOTE
15/03/05	15.30	22.9°C38.7HR	<b>Visual Inspection:</b> the specimen has the lateral surfaces lumpy <b>The specimen is partially covered with toluene</b>
16/03/05	9.55		<b>Visual Inspection:</b> there is a log crack.

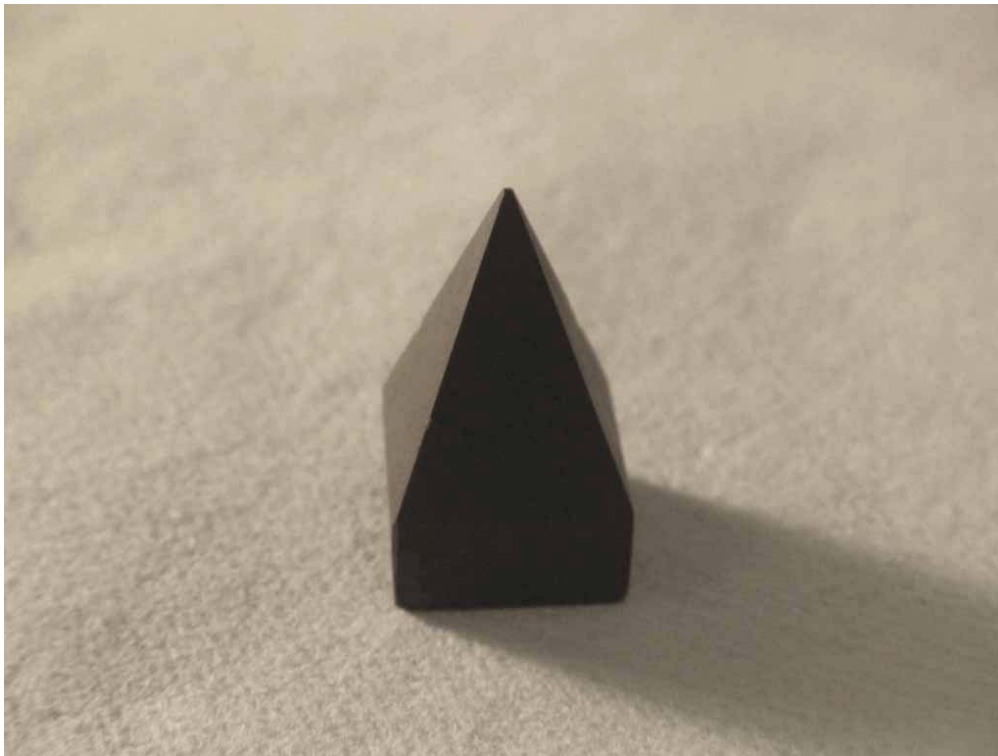
### 10.13 Specimen 10 – Pyramid acetone

DATE	TIME	TEST CONDITION	NOTE
09/03/05	11.00	21.4°C40%HR	<b>Visual Inspection:</b> There aren't visible defects <b>Mass:</b> 1.9[g]
09/03/05	11.30		<b>The specimen is covered with acetone</b>
09/03/05	14.10		<b>Visual Inspection:</b> there aren't visible defects <b>Mass:</b> 1.9[g]
09/03/05	16.40		<b>Visual Inspection:</b> there aren't visible defects
10/03/05	10.15	21.3°C47%HR	<b>Visual Inspection:</b> There aren't visible defects
10/03/05	16.50		<b>Visual Inspection:</b> there aren't visible defects
11/03/05	11.00		<b>Visual Inspection:</b> there aren't visible defects <b>Mass:</b> 1.94 [g]
11/03/05	14.12		<b>Visual Inspection:</b> there aren't visible defects
11/03/05	16.00		<b>Visual Inspection:</b> there aren't visible defects
14/03/05	9.50		<b>Visual Inspection:</b> there aren't visible defects. The acetone is evaporated. <b>Mass:</b> 1.94 [g]
14/03/05	15.20		<b>Visual Inspection:</b> there aren't visible defects

15/03/05	10.00	21.5°C40.3%HR	<b>Visual Inspection:</b> there aren't visible defects. <b>Mass:</b> 1.95 [g]
