**Si TITLE:**                    **Analysis of Signal Swap in output  
of Channel 2510 (Action#4 H-P-  
TASF-MN-9737)**

**DOC. TYPE:**                **TECHNICAL NOTE**

**PROJECT REF.:**        **PL-LFI-PST-TN-082**        **PAGE: I of IV, 1 of 15**

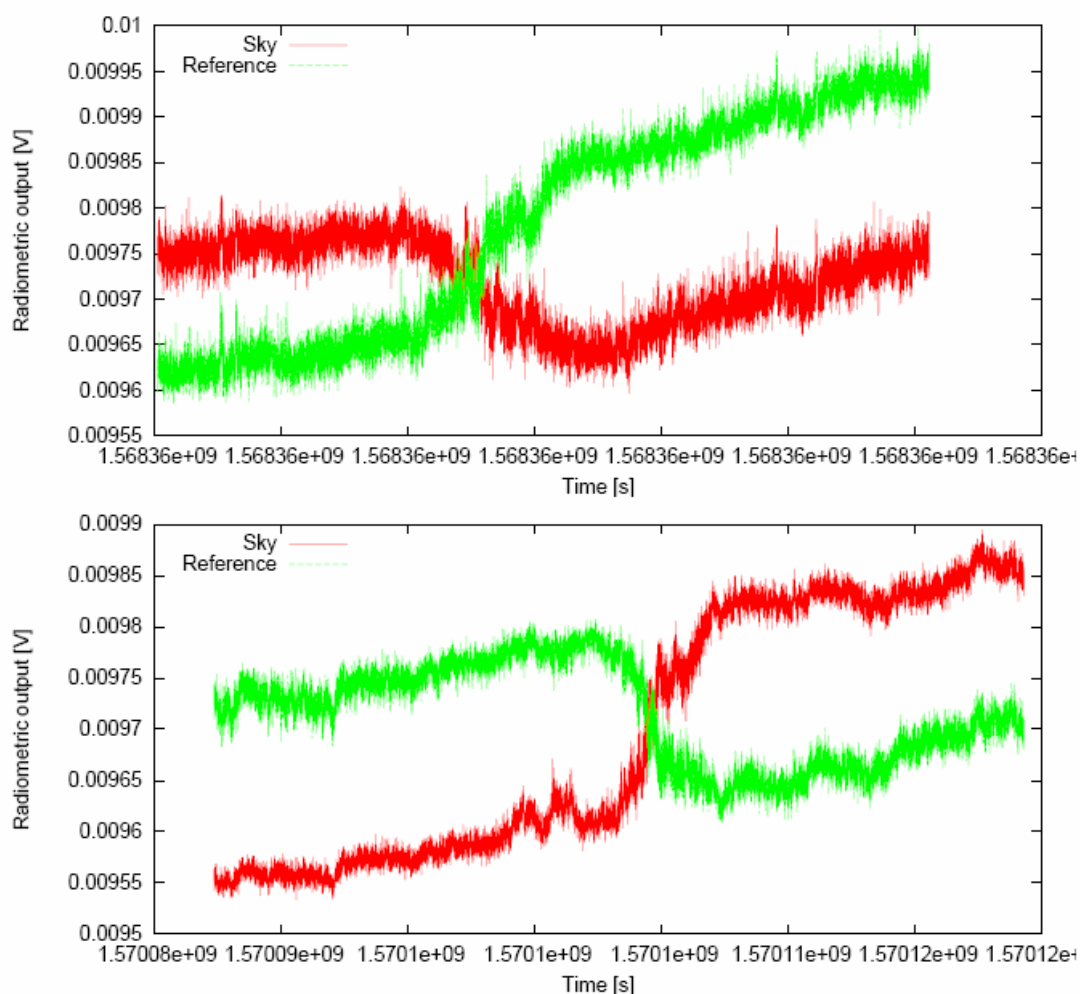
Figure 1 shows the output of detector #2510 during tests AMB\_0099 and AMB\_0108. The inversion between the sky and the reference was not immediate, but instead took some time to complete (five minutes for both inversions in AMB\_0099, a couple of hours in AMB\_0108).

The inversion problem as seen in tests AMB\_0099 (above) and AMB\_0108. The sky and reference output slowly crossed in some time, and then remained stable.

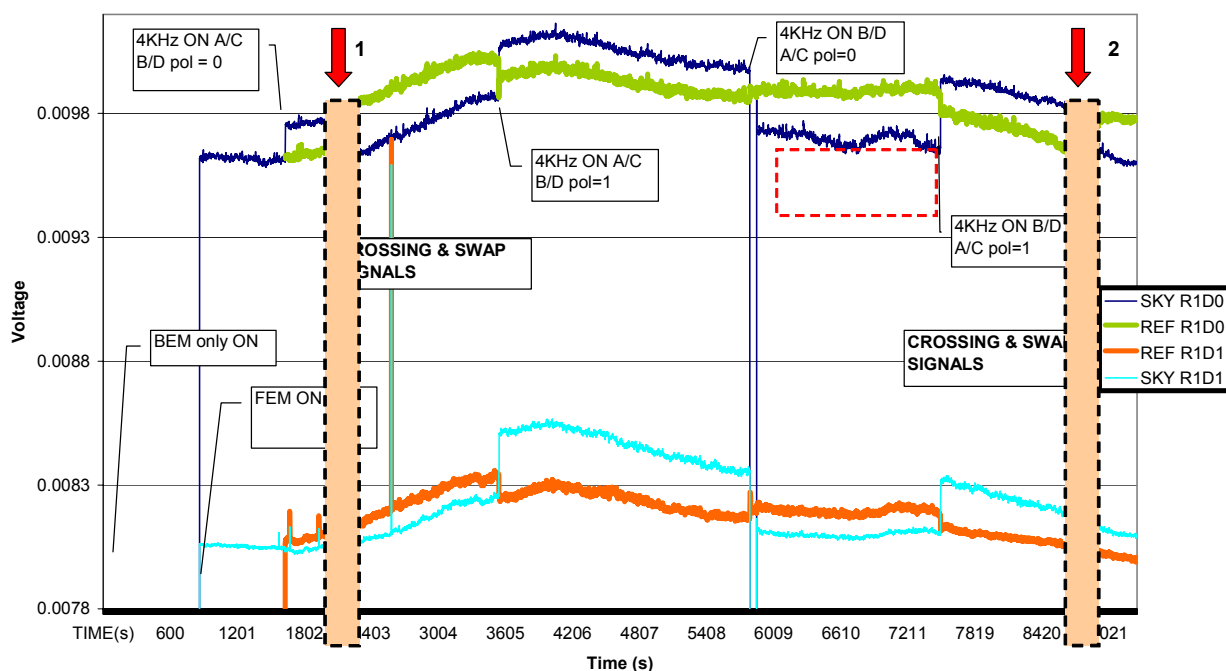
AMB0099: RCA25 - R1D0 & R1D1

During test AMB\_0099 the effect repeated twice following a very symmetric behaviour, as displayed in figure below. Inversions are indicated by the red arrows. Both channels (R1D0 and R1D1) are here displayed. The difference Sky-Ref is also displayed, for both the coupled channels, in Figure 2

Figure 1 Test AMB\_0099: inversions on sky and ref signals from RCA25R0D1 are highlighted by rectangles and arrows. Other changes, foreseen by the test, are commented by callouts. Signal from RCA25R1D1 seems to not be affected by the same effect.

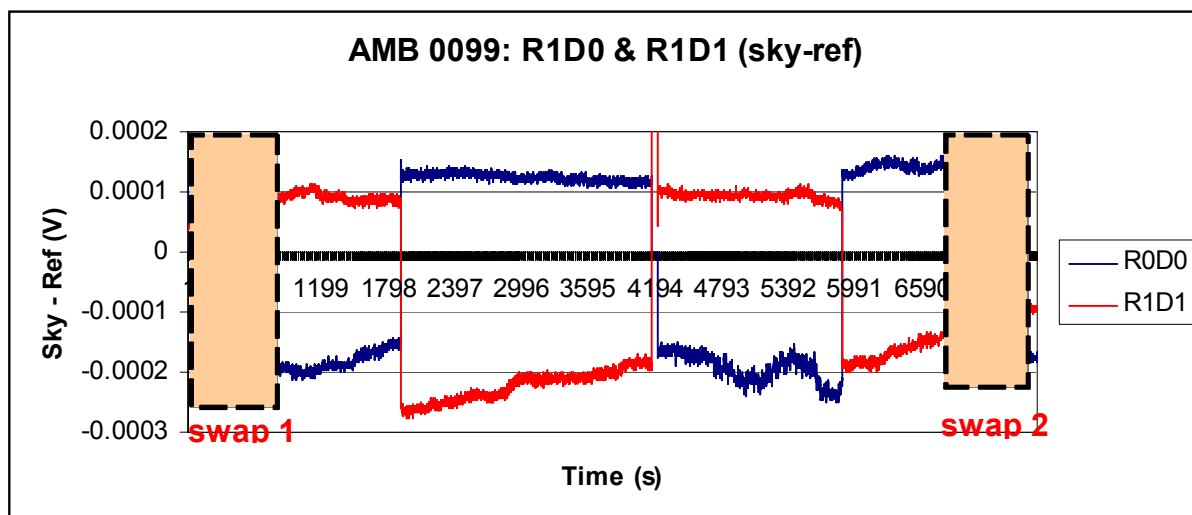
Figure 2 Test AMB\_0099 : Difference sky - ref is shown for R0D1 and R1D1.

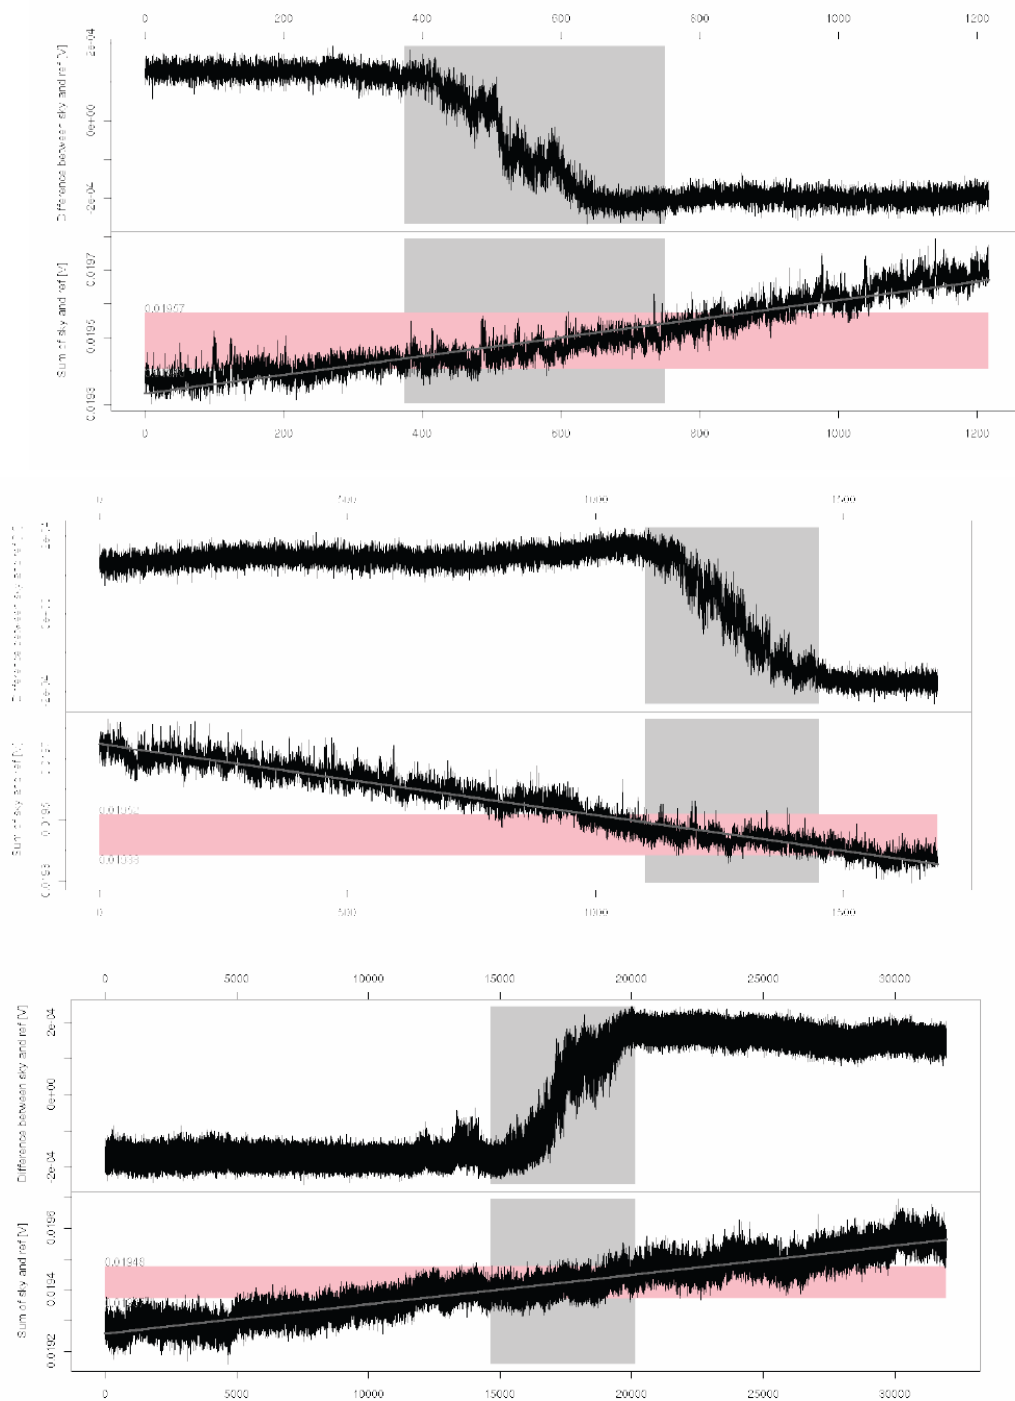
Figure 3 Difference and sum of the sky and reference signals for detector #2510 during tests AMB\_0099 (top, middle) and AMB\_0108 (bottom). The time window where the mixing happened is shown against a gray background. The pink rectangle indicates the voltage level of the sky+reference sum within the inversion time window. The thick gray line is a linear interpolation of the sum, and has been used to extract the boundaries of the pink rectangle.

Moreover, the inversion effect seems to appear always when the absolute level of the sky/reference signals crosses some boundary. This is evident from **figure 2**: the three inversions were observed when the sky/reference signals were around 10 mV.

In **figure 2** the upper and lower bounds of the pink rectangle are given by the crossing between the slope of the line (linear fit of the summed signal) and the grey rectangle (time window of the inversion). The bounds have been enlarged by the standard deviation of the summed signal minus its linear fit, in order to compensate for the linear fit approximation. These bounds are reported in the following table:

Inversion	Time [s]	Min [mV]	Max [mV]	Range [mV]
AMB_0099(a)	375	19.40	19.57	0.17
AMB_0099(b)	350	19.38	19.52	0.14
AMB_0108	5500	19.37	19.48	0.11

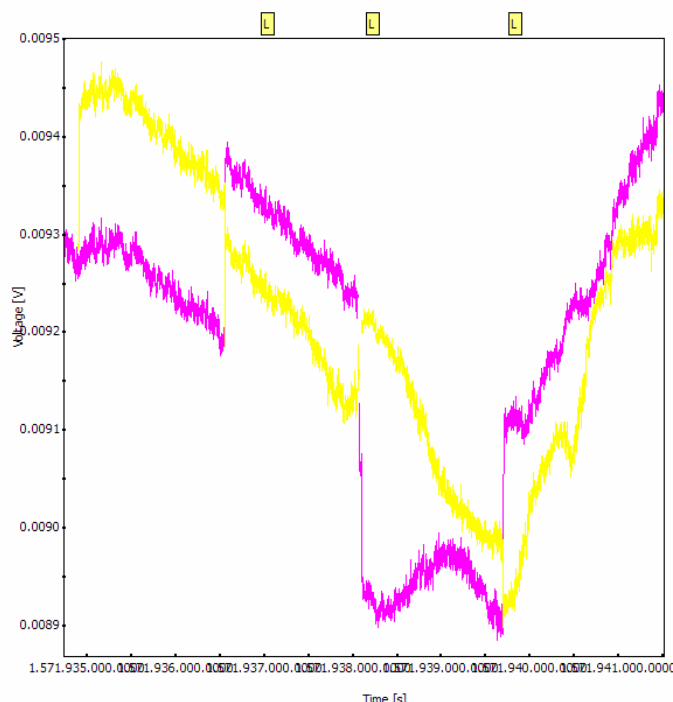
**Figure 4 AMB\_0114 (SIT) : RCA25 R1D0. Sky and ref signals seem to be going to invert but inversion is never reached. Here the Voltage is lower than the critical value found in the previous tests and producing the signal swap.**

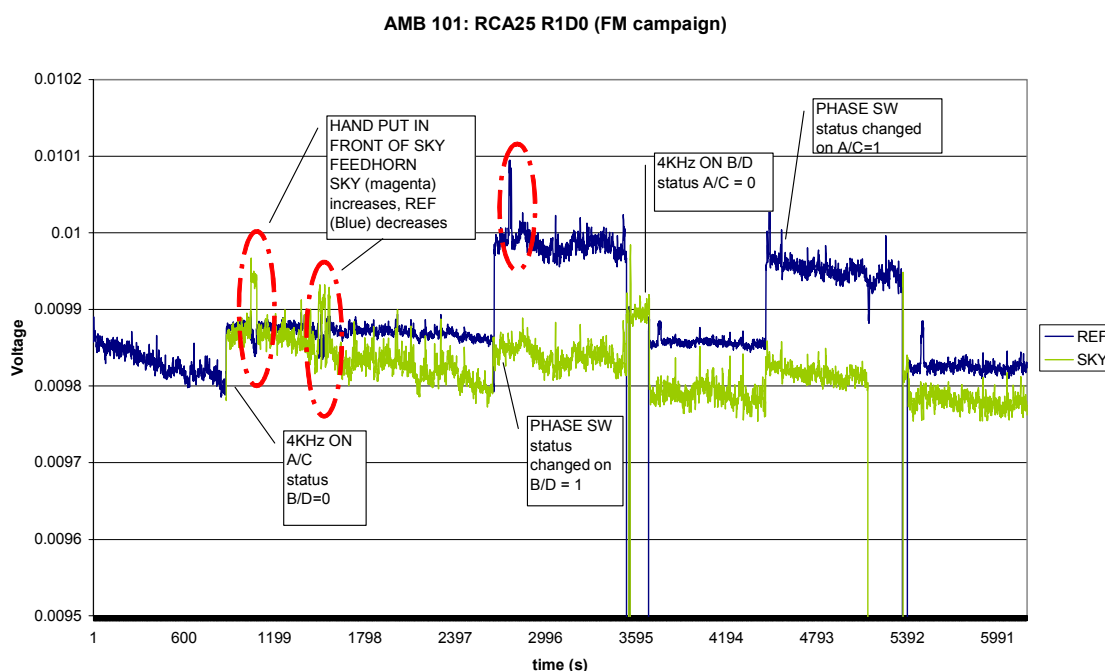
for some unwanted noise observed. In principle, if everything is fine, just the sky signal should increase: however, this is not what observed. Looking at Figure 5, Figure 6 and Figure 7 it is clear that, when the hand is put in front of the sky feed horn, an opposite effect is also observed in the Ref signal: however, the effect is also opposite with respect to what expected, since ref increases and ref decreases!

At the end of the same test we find the inverted situation: sky to increases and ref decreases, as suggesting that, also during this FM test, the two signals somehow swapped during the test. Moreover, it is to be noted that during this test, whichever be the state of phase switches, the blue line keeps always higher than the green line.

**Figure 5 FM AMB\_0101 : effect of a thermal load put in front of the FPU. The effect is opposite on sky and ref and the very strange thing is that it is mainly visible on ref (R1D0) instead of sky (R1D0), as was instead expected. At the end of the test (last step) the effect is correctly visible on sky. To be noted that the PH/SW change is never able to swap the two signals, as instead appears in the other channel R1D1 (Figure 7)**

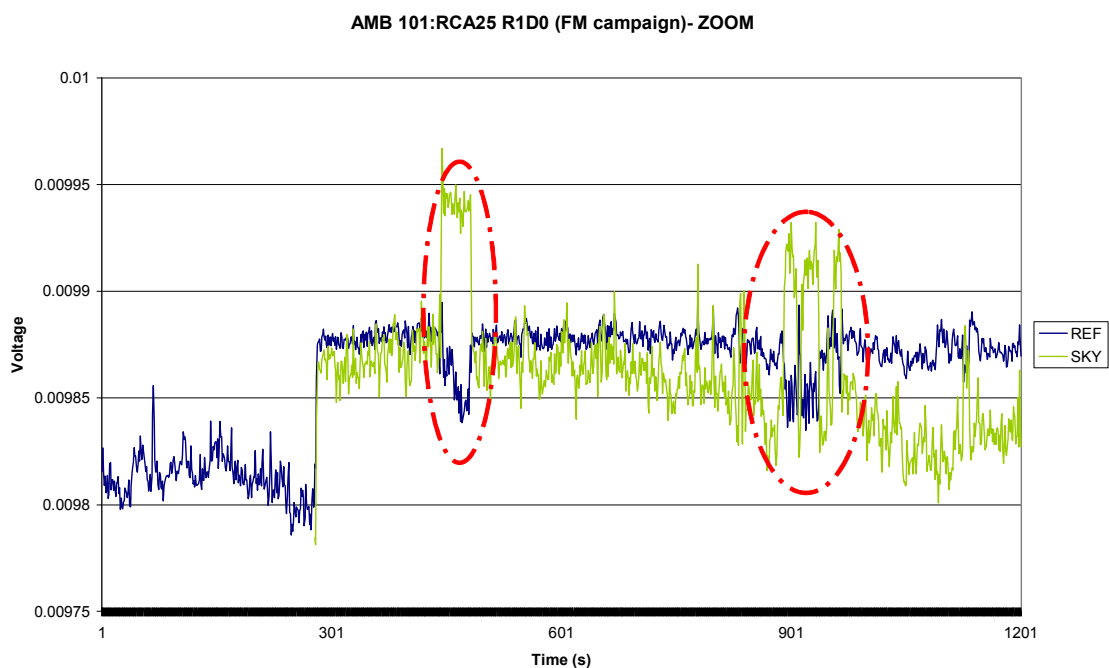
Figure 6 ZOOM on first part of above figure. The green line is sky

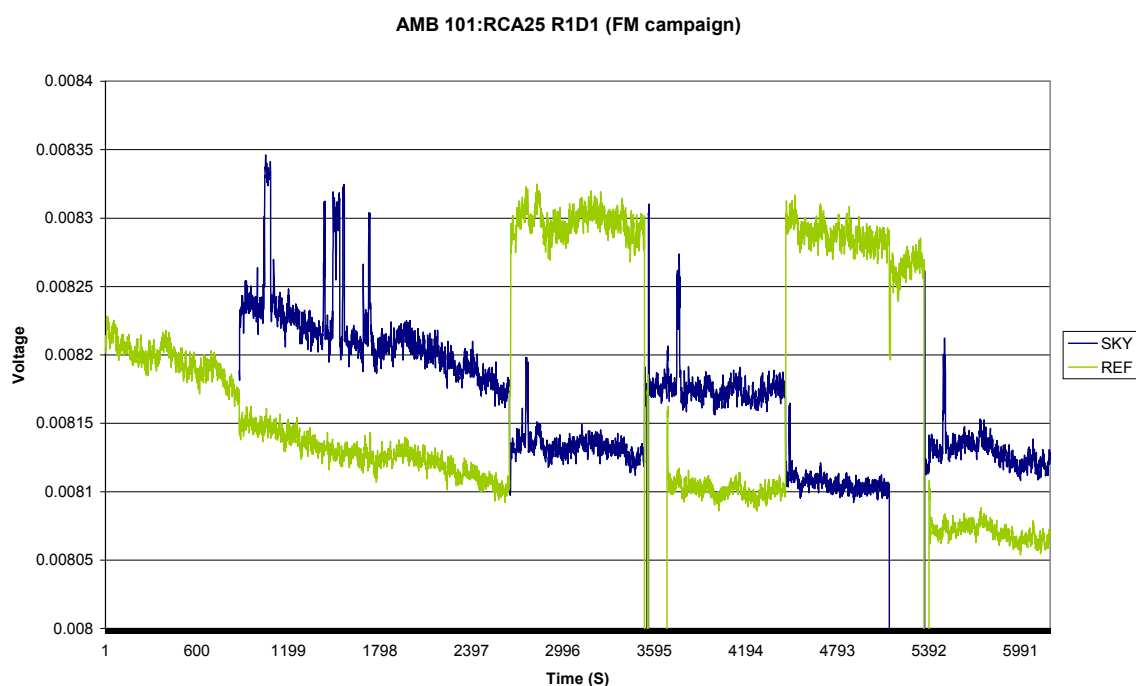
The same effect is not observed in the coupled diode, although the two diodes share the same Hybrids and amplifiers. So, in the case it was just an effect due to non-isolation, it should be seen simultaneously seen on both channels R0D1 and R1D0.

Figure 7 AMB 0101 Channel R1D1: none isolation effect is observed on Ref when a thermal load is put in front of the feedhorn (sky, blue line); the thermal load appears always on sky .

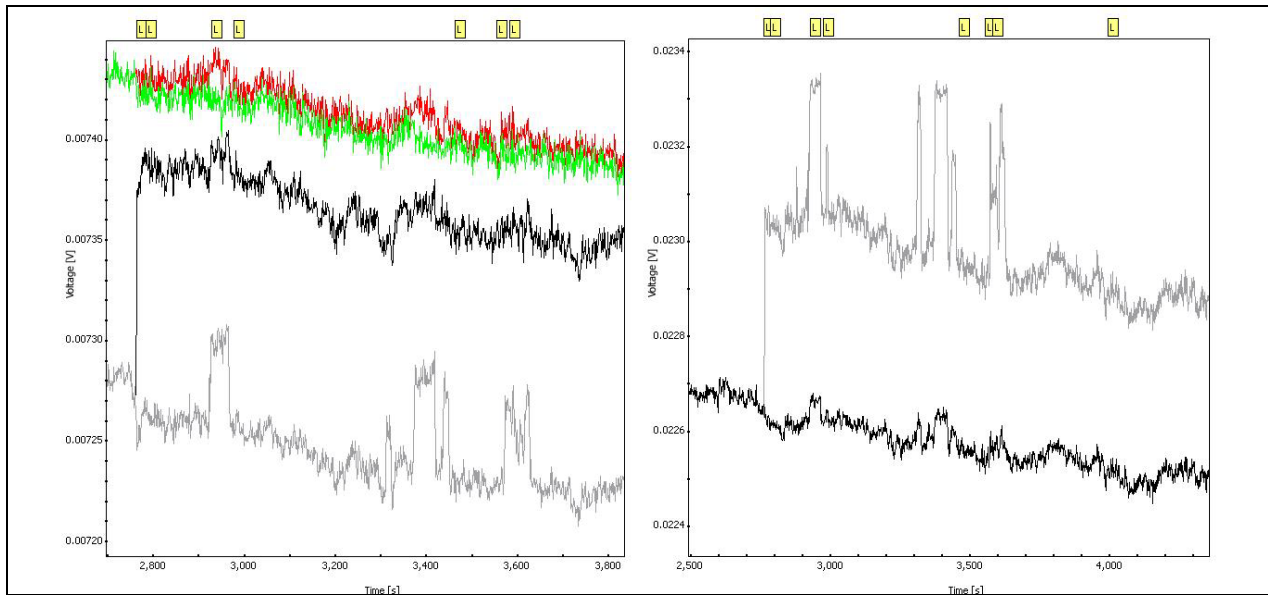
Moreover, in all other radiometers, the non isolation effect, if visible, exhibits always with the same sign on sky and ref, as displayed in Figure 7 Figure 8.

**Figure 8 TEST FM AMB\_0101: RCA24 (left panel) and RCA 26 (right panel) signal when a thermal load is put in front of the feedhorns. The non isolation, when present, is simultaneously visible on both channels. The effect has the same sign on sky and ref an is always positive, corresponding to an increasing of both observed signals.**
