TITLE: **ECCOSORB failure analysis**

DOC. TYPE: TECHNICAL NOTE

PROJECT REF.: PL-LFI-TES-TN-015

A failure on some of the 4KRL QM parts was observed after the cryo cycles. A detailed activity was started to study the failure, to identify its causes, to find a solution before the assembly of the FM unit.

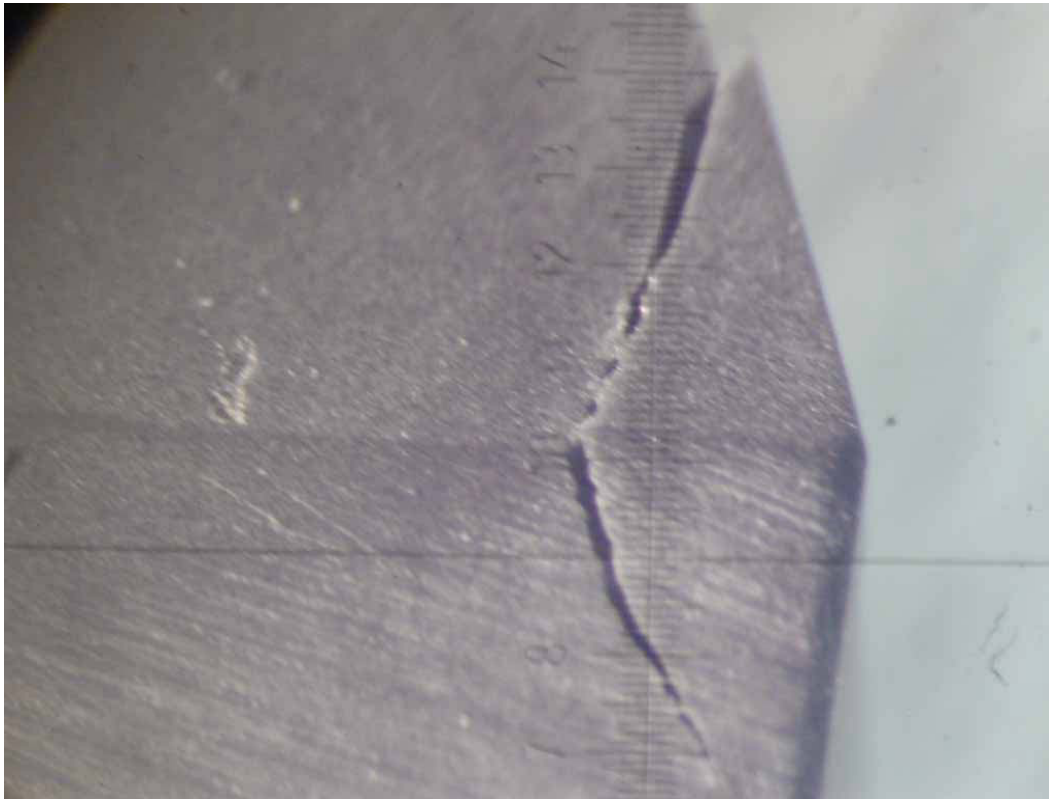
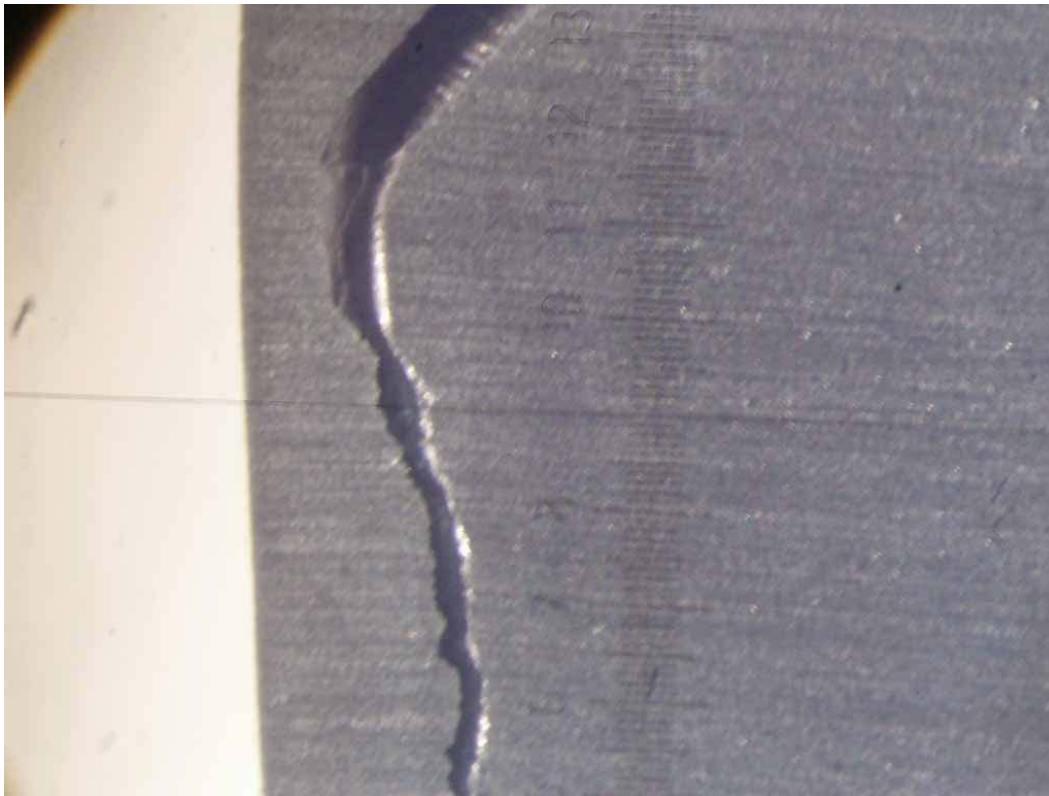
10.2 Specimen 1b – Pyramids @44GHz acetone&ultrasound

DATE	TIME	TEST CONDITION	NOTE
09/03/05	11.00	21.4°C40%HR	Visual Inspection: there aren't visible defects Mass: 0.5[g]
09/03/05	11.20		Start a battery of 3 cycles of ultrasonic cleaning bath
09/03/05	12.30		End of cycles. Visual Inspection: The specimen has several cracks on all edges. Mass: 0.5[g]

In the followings images is visible the specimen after all the test

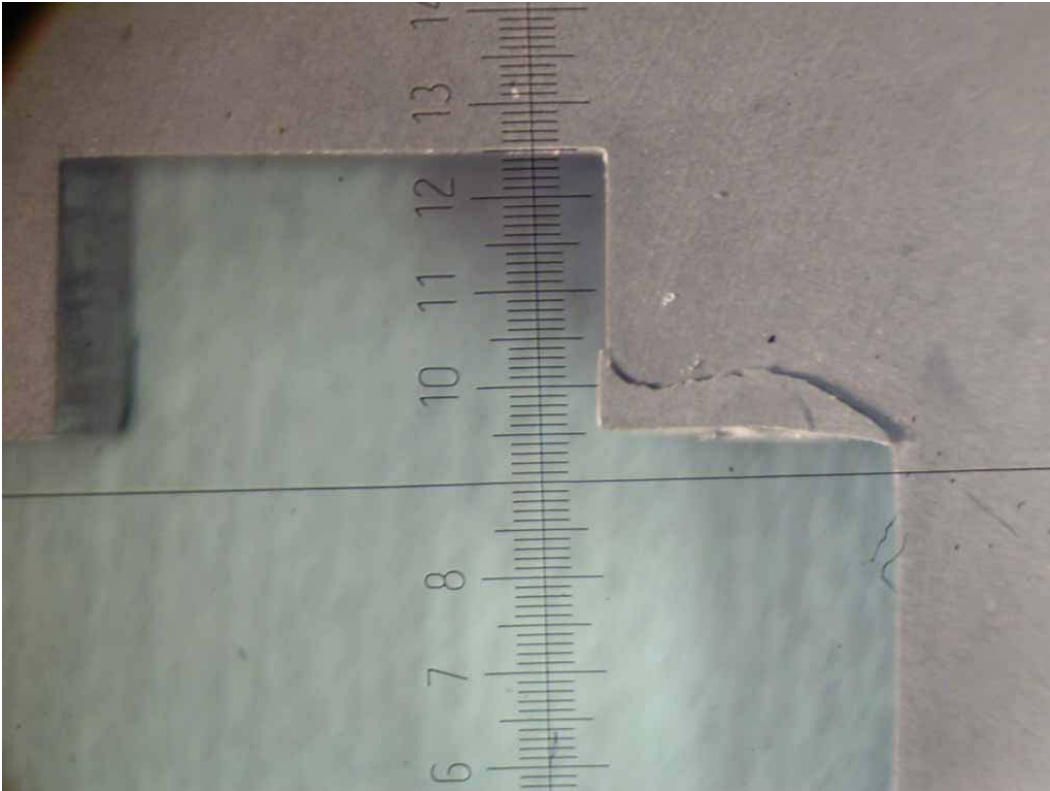
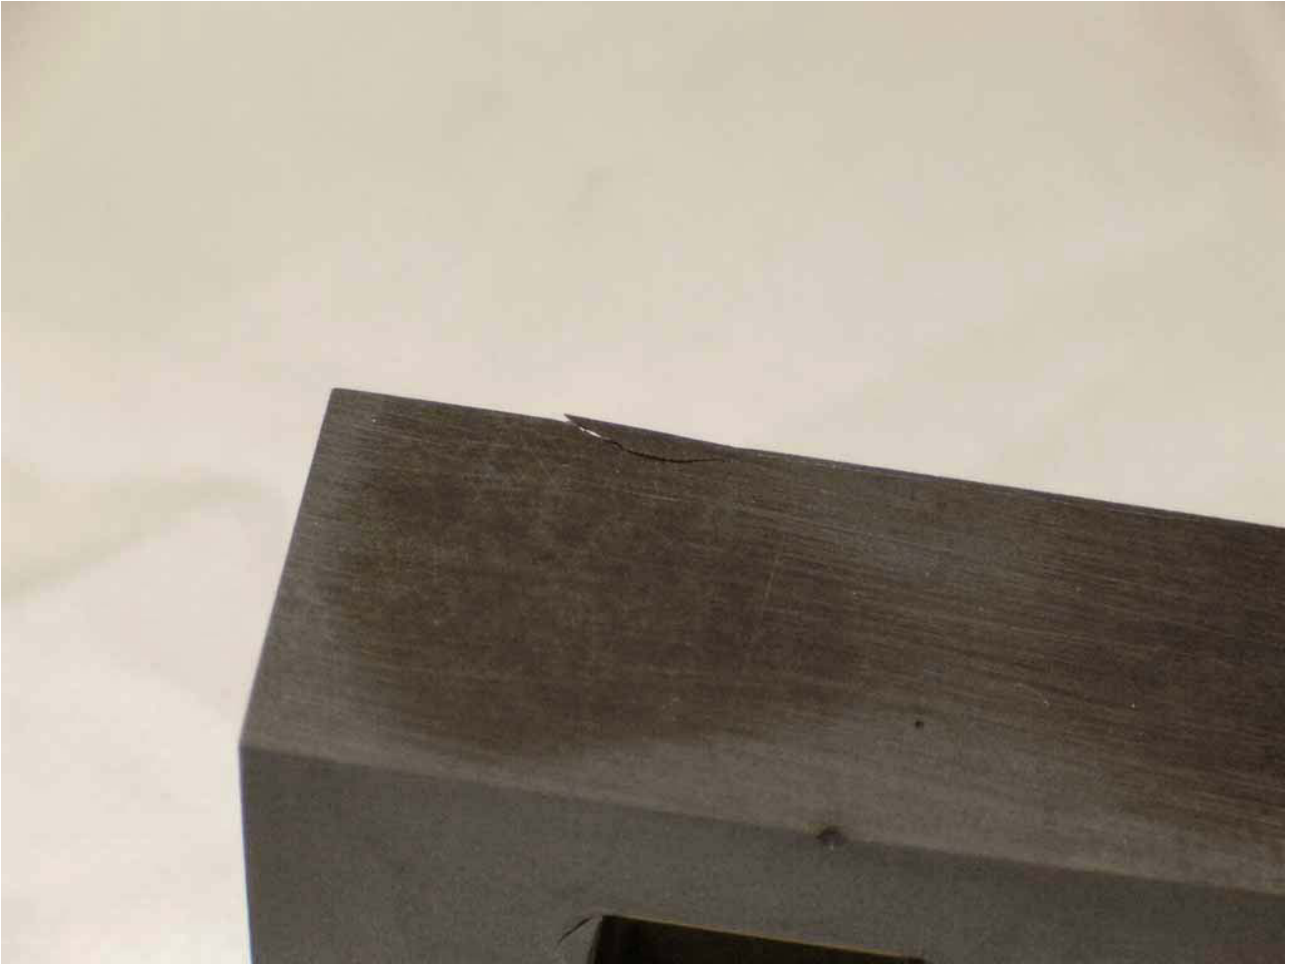
10.3 Specimen 2 – Cross @30GHz acetone&ultrasound

DATE	TIME	TEST CONDITION	NOTE
09/03/05	11.00	21.4°C40%HR	Visual Inspection: There are 2 blister on the external edge Mass: 16.5[g]
09/03/05	11.20		Start a sequence of 3 cycles of ultrasonic cleaning bath
09/03/05	12.30		End of the battery of the cycles. Visual Inspection: The specimen doesn't have any crack. Mass: 16.5[g]
09/03/05	16.30	21.6°C40%HR	Start the IV cycle of ultrasonic cleaning bath
09/03/05	17.00		End of the cycle Visual Inspection: There are visible cracks on all the edges

In the followings images is visible the specimen after the IV cycle

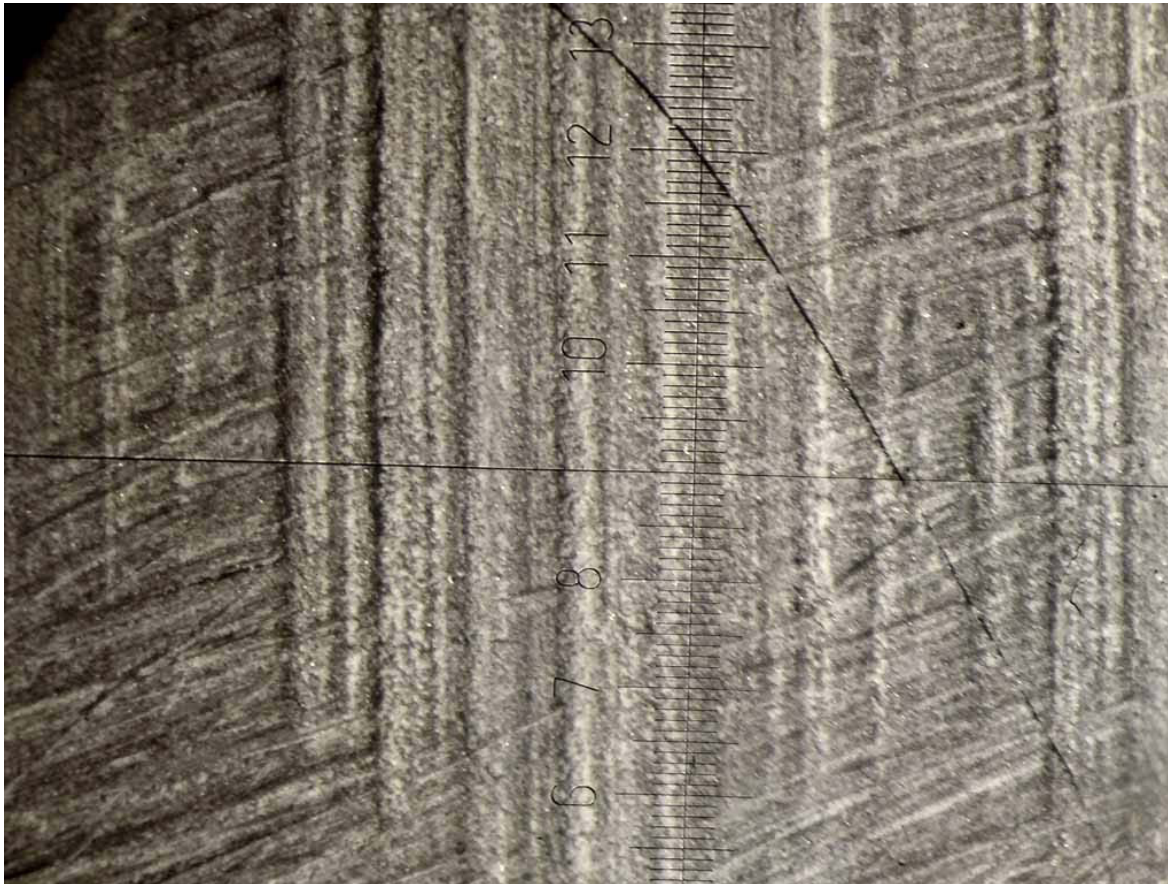
10.12 Specimen 9 – bulk toluene

DATE	TIME	TEST CONDITION	NOTE
15/03/05	15.30	22.9°C38.7HR	Visual Inspection: the specimen has the lateral surfaces lumpy The specimen is partially covered with toluene
16/03/05	9.55		Visual Inspection: there is a log crack.
