DPU-ASW Management of the  
DCU ERROR REG content with possible  
off-line recovery actions

Ref : EUCL-IBO-TN-7-035  
Issue : 1.1  
Date: 20/10/2021  
Page: 1/45

<b>TITLE:</b>	DPU-ASW Management of the DCU ERROR REG content with possible off-line recovery actions		
<b>Date:</b>	20/10/2021	<b>Issue:</b>	1.1
<b>Reference:</b>	EUCL-IBO-TN-7-035		
<b>Custodian:</b>	Eduardo Medinaceli

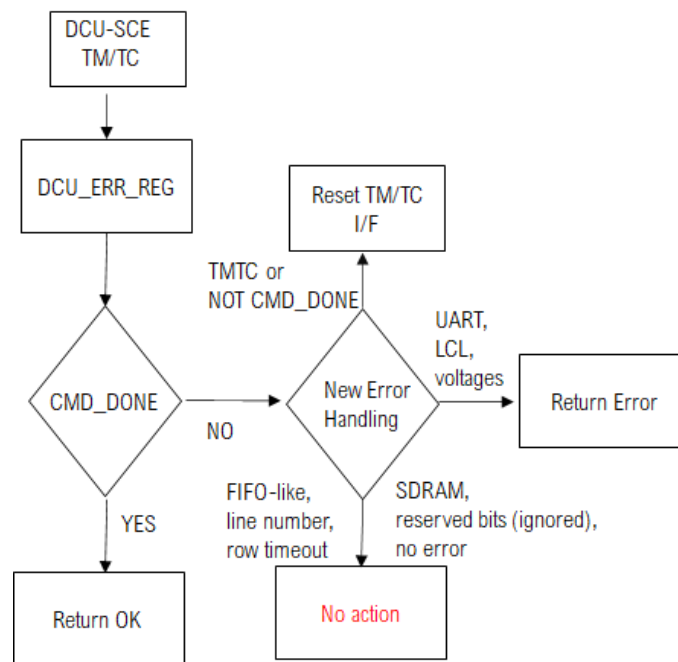
Figure 1, DPU-ASW new DCU\_ERROR\_REG handling strategy

Figure 1 shows the implementation philosophy in the DPU-ASW of the new handling of the DCU\_ERROR\_REG.

- The clear of the DCU\_ERROR\_REG will be done automatically only when the TM/TC I/F is reset internally (TBD)
- In all the other cases when an error is returned, the clear of the register is associated to the recovery action.

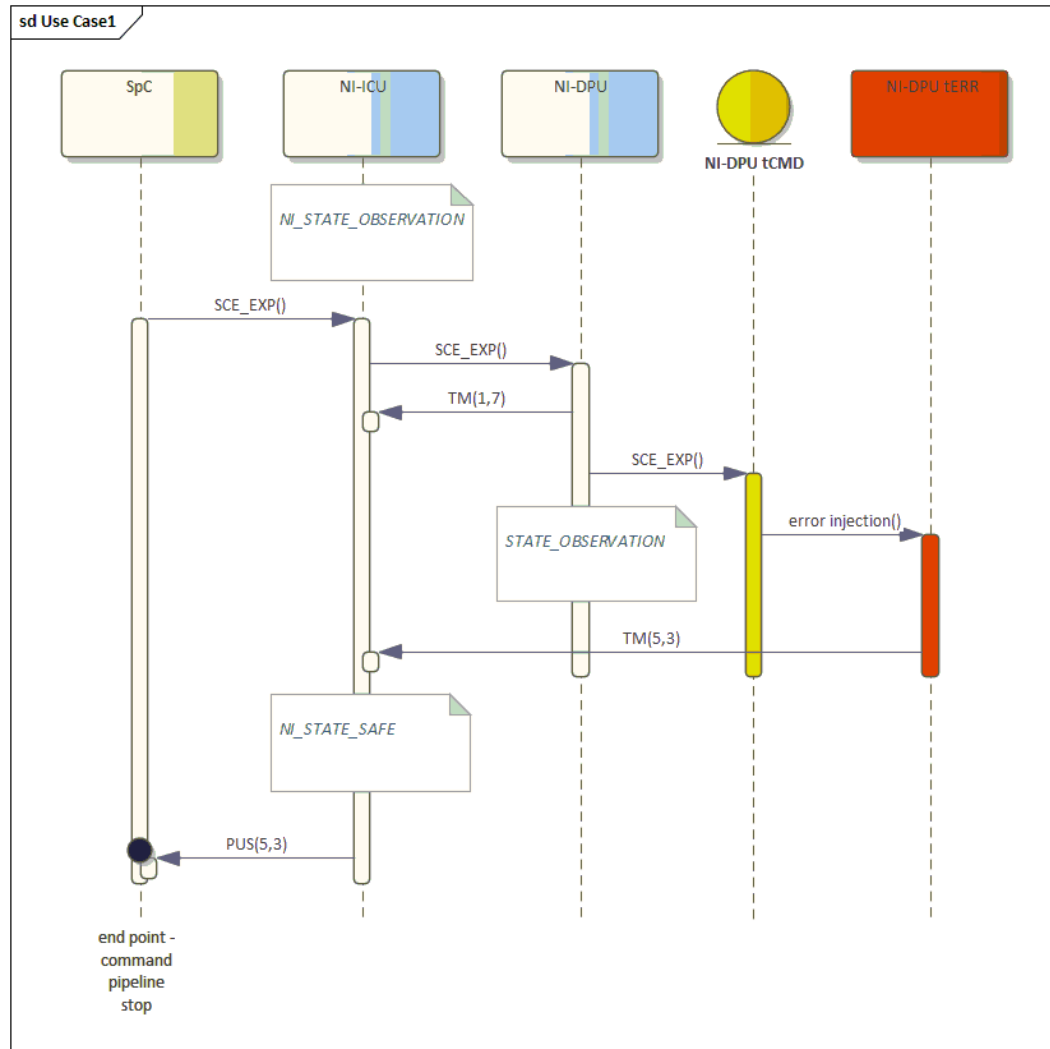
The UML timeline diagram of Figure 2 shows the new error injection mechanism associated to errors during execution of commands SCE\_EXP, SCE\_KTCEXP, and SCE\_IPCEXP denoted in the figure as SCE\_EXP().

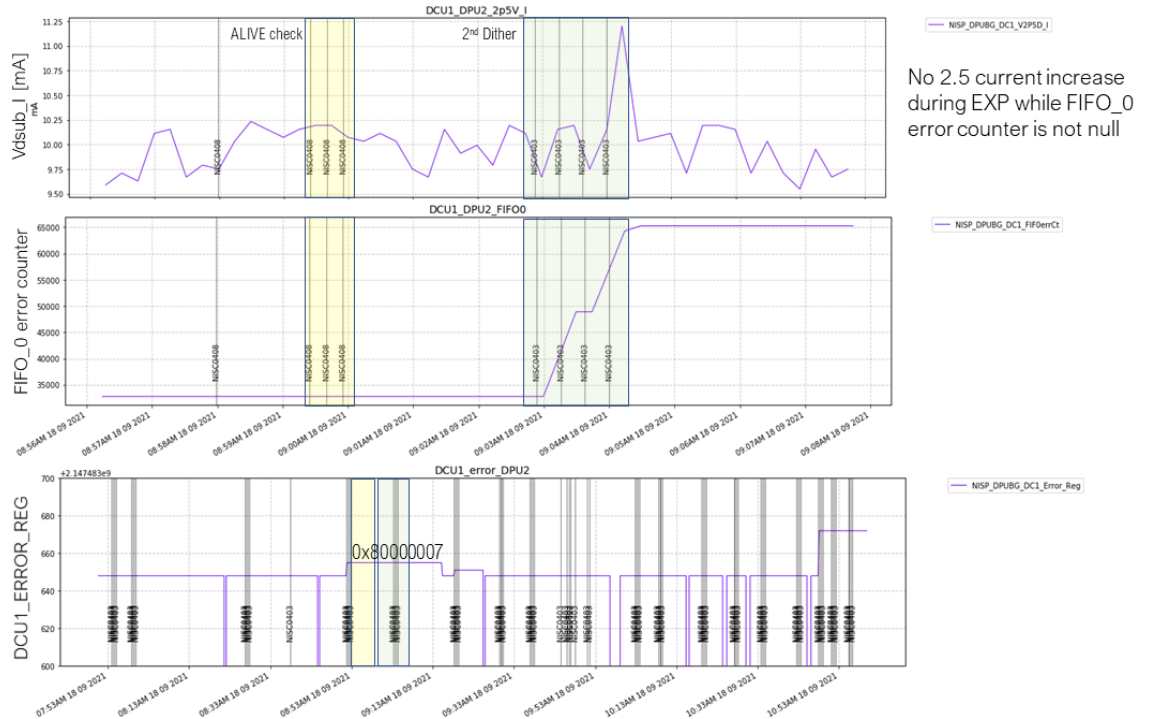
Test case (3)

No 2.5 current increase during EXP while FIFO\_0 error counter is not null

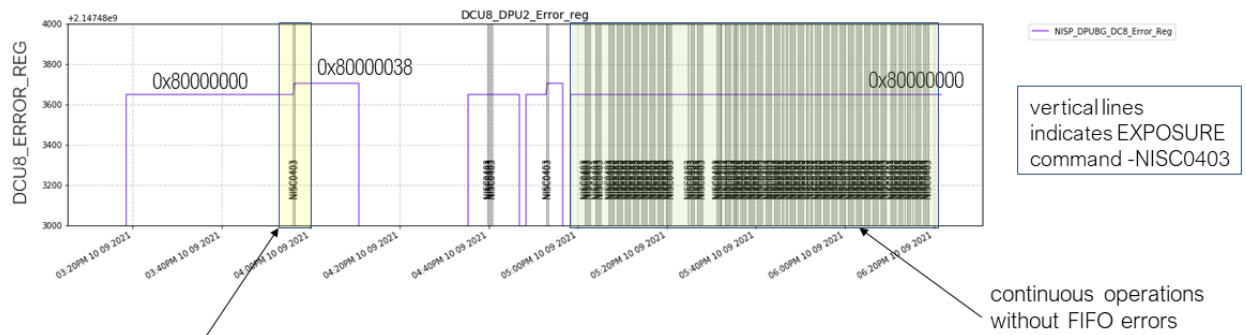
## Repetition of the error condition with DPU-ASWv1.3.7 (used at CSL) during LAM setup verification

### ERROR CONDITION

Date	status_reg	FIFO_0_err_counter	FIFO_1_err_counter	error_reg
2021-09-10 15:56:41.544000	0x31	0	0	0x80000000
2021-09-10 15:56:56.544000	0xB5	0	7477	0x80000038

} same CSL error condition
