**TITLE: PLANCK OPTICAL SHIELD 2:
CRYO TESTS ON
REPRESENTATIVE PANELS**

DOC. TYPE: Test Report

PROJECT REF.: PL-LFI-PST-RP-026 PAGE: I of III, 26

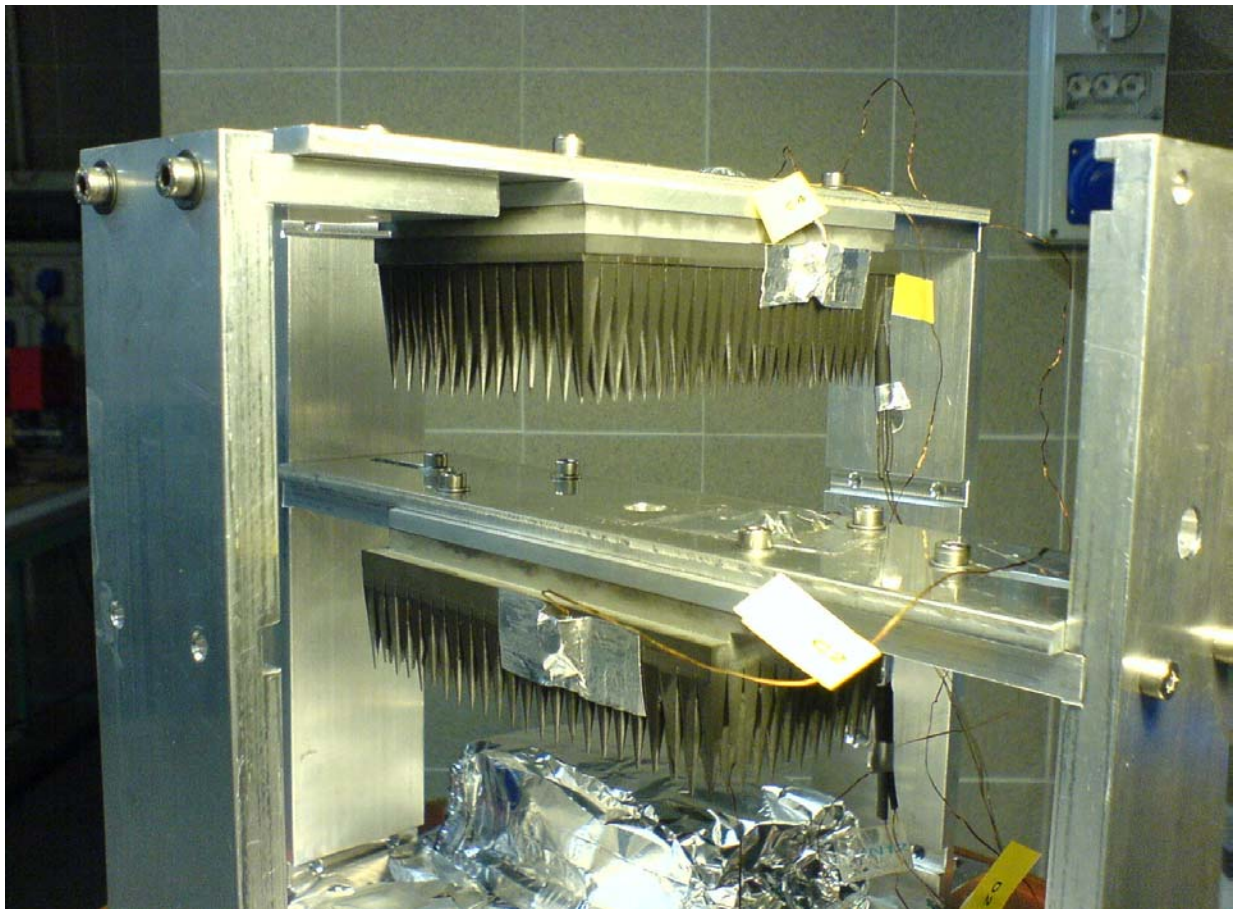
Both inspections gave no evidence of possible problems or defects ascribable to the cycle.

Figure 3 detail of the mounting after warmup

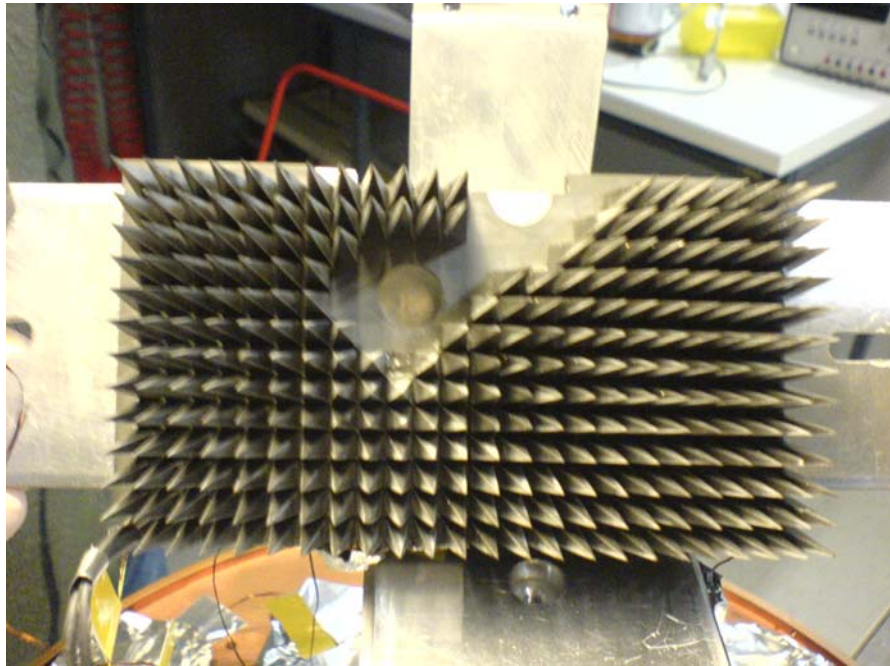
Figure 4 special panel after removal for inspection

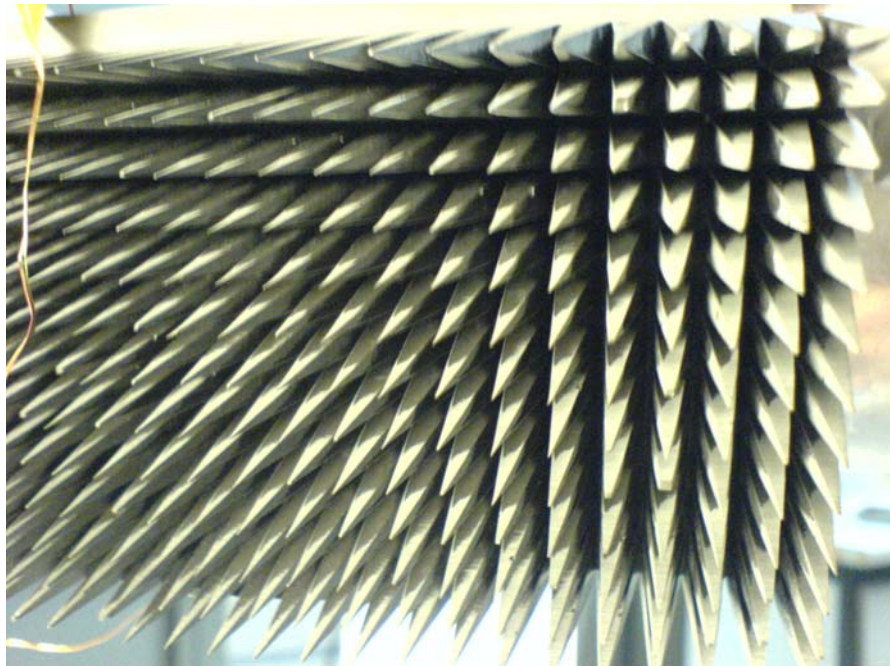
Figure 5 standard panel after removal for inspection

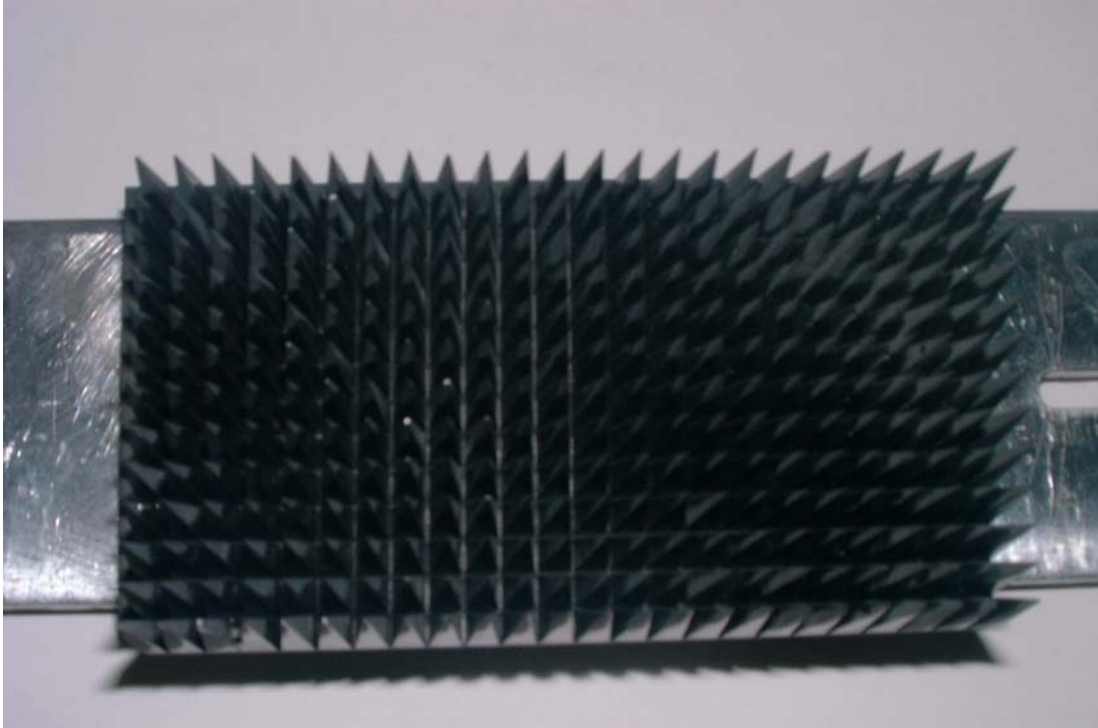
Comparison of photograph before the 1st cooldown and after the 5th warmup seems to show that nothing changed due to cycling.

Figure 15 standard panel after dismantling from facility supports

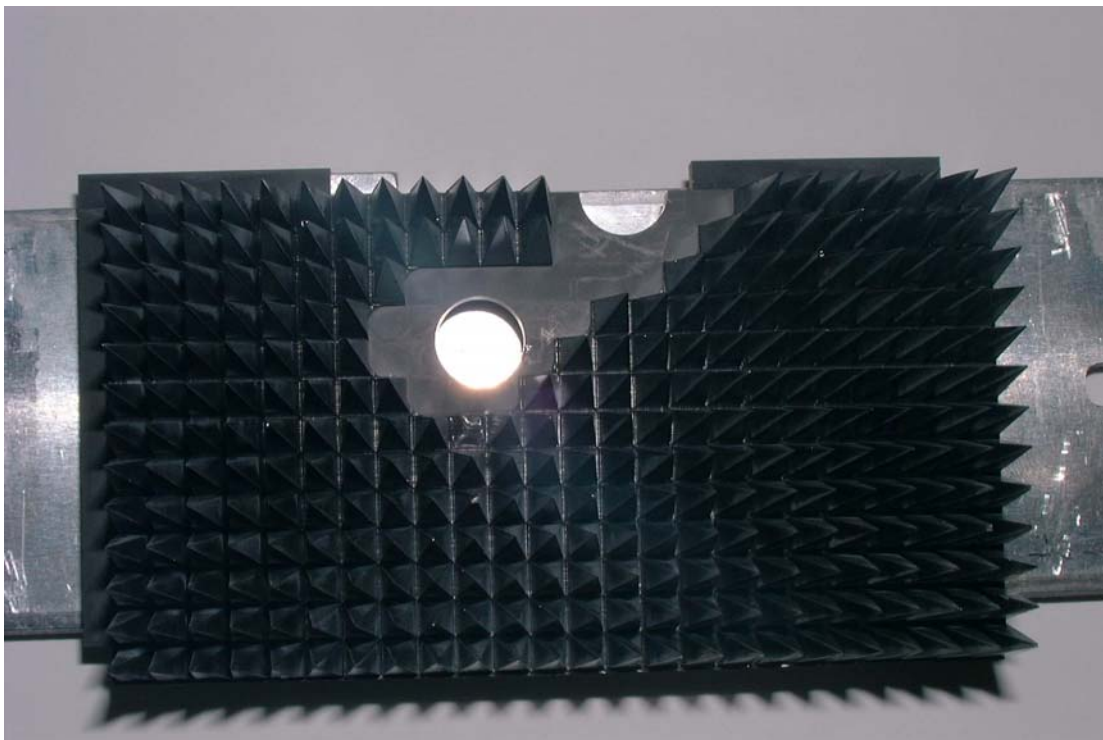
Figure 16 special panel after dismantling from facility supports

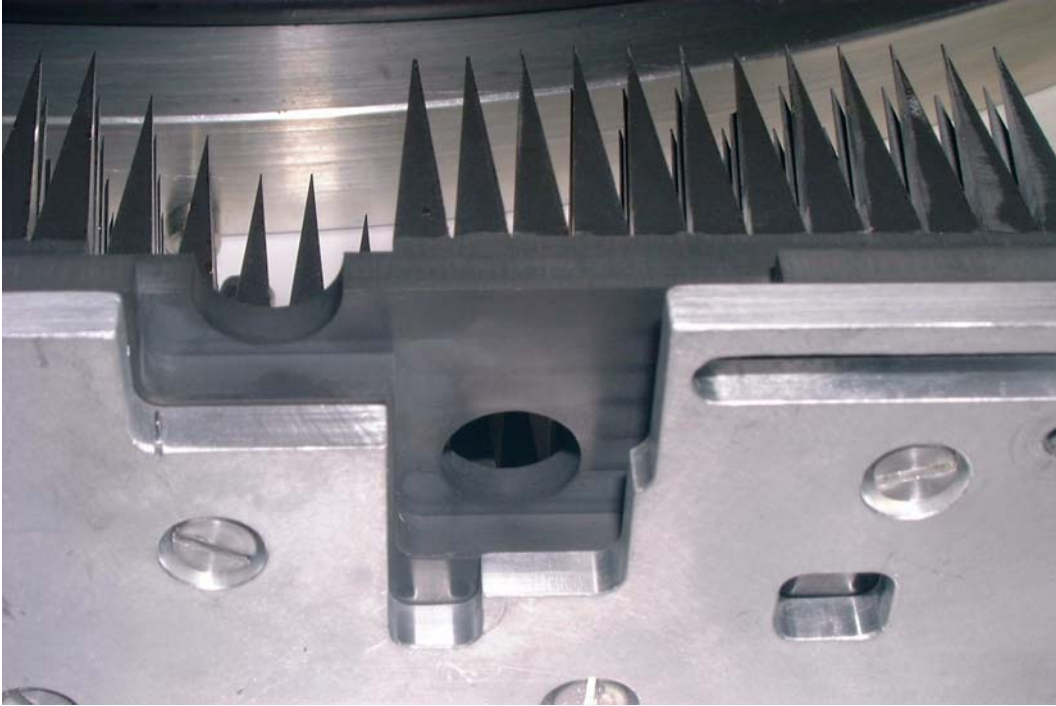
Figure 17 special panel from the back after dismounting from aluminium interface with cryo facility supports.

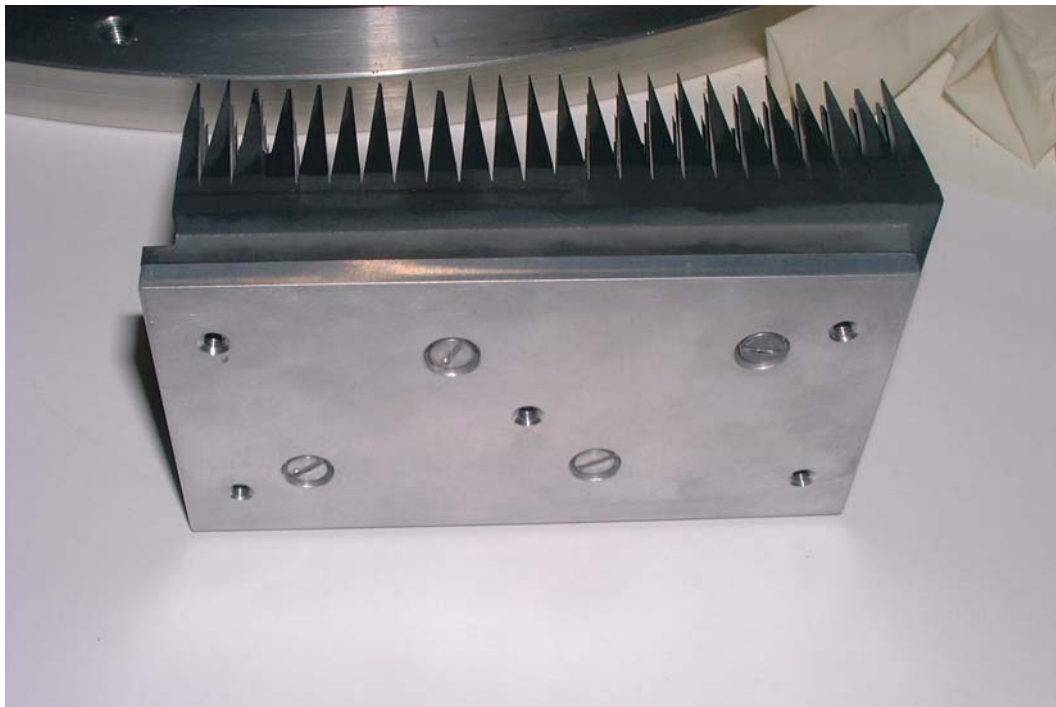
Figure 18 standard panel from the back after dismounting from aluminium interface with cryo facility supports.

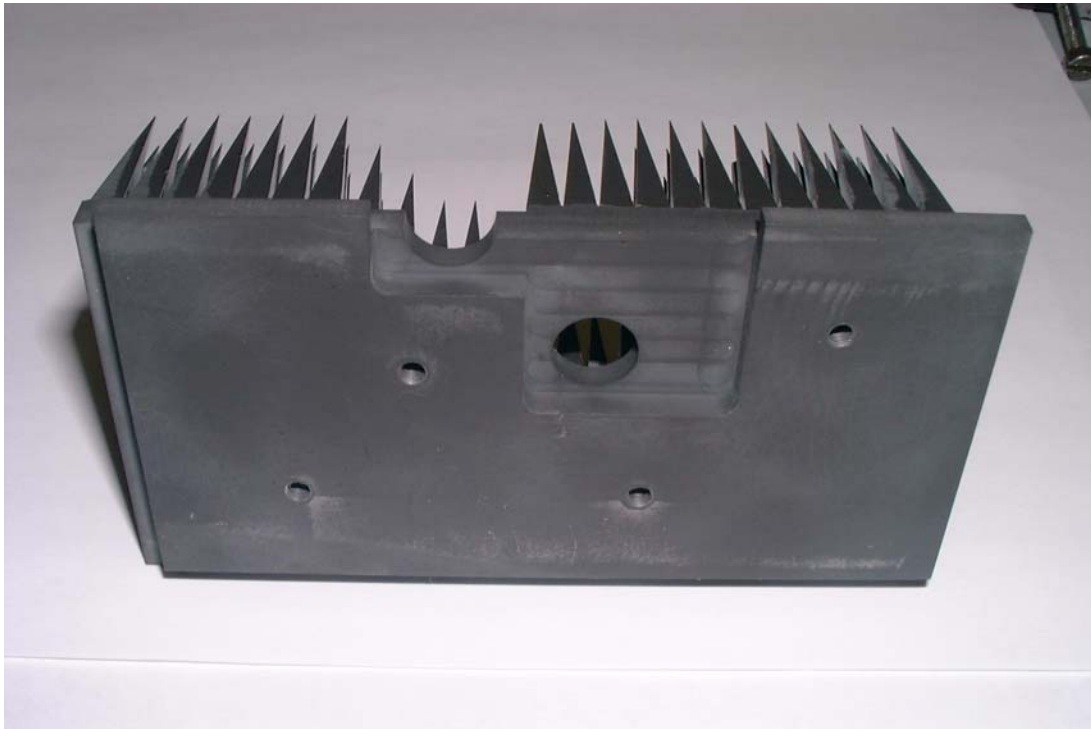
Metal backs have been removed: It allowed to observe the back of ECCOSORB panels for the first time since tests started: everything looked nice, as before cryo tests.

Figure 30 special panel (back)

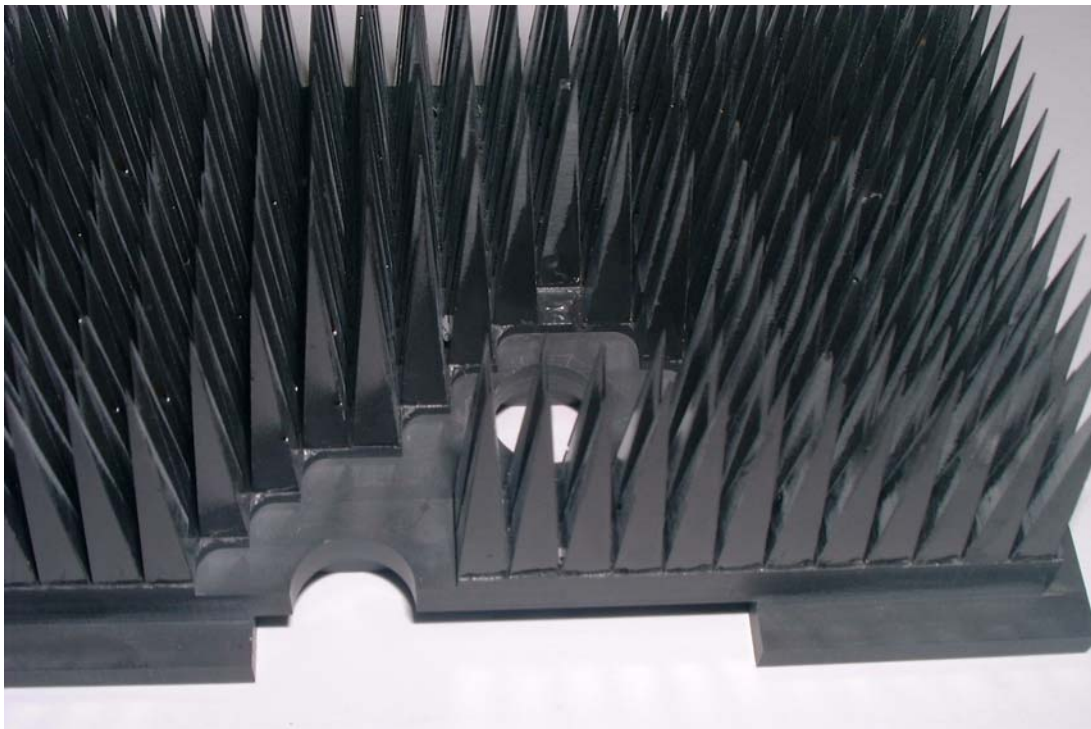
Figure 31 special panel: zoom on the region lodging sources
