DPU-ASW Management of the
DCU ERROR REG content with possible
off-line recovery actions

Ref : EUCL-IBO-TN-7-035
Issue : 1.1
Date: 20/10/2021
Page: 1/45

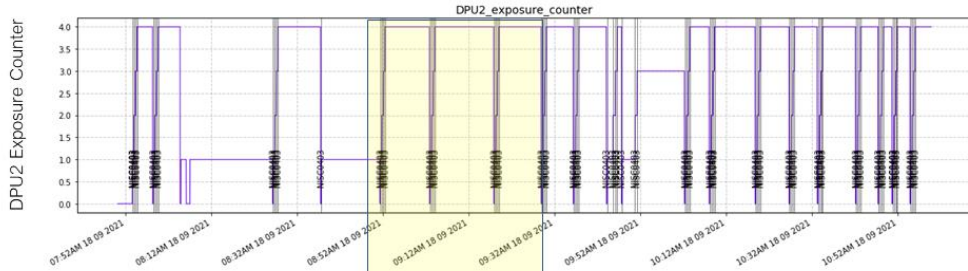
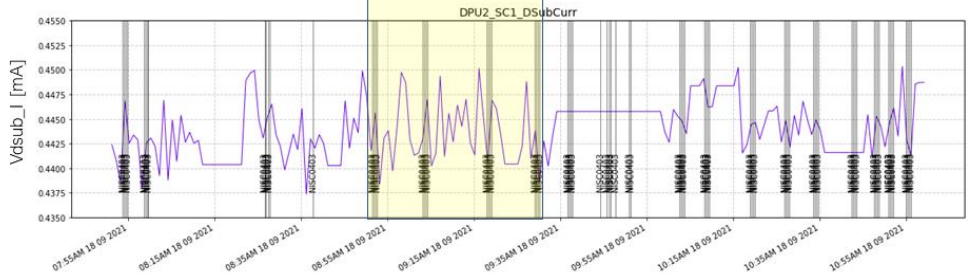
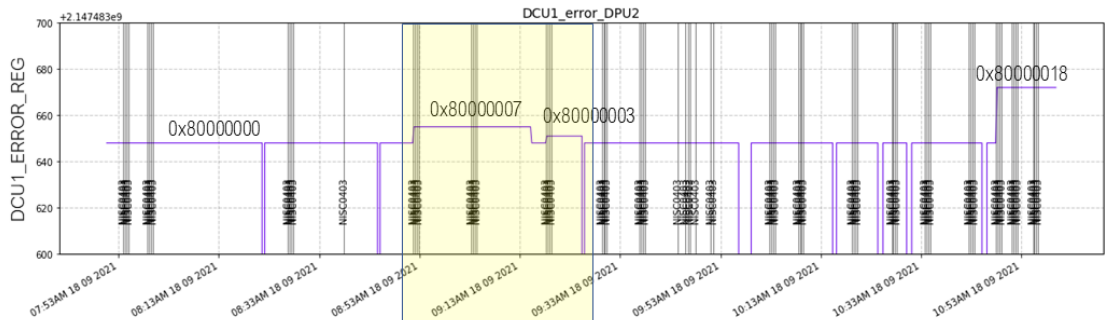
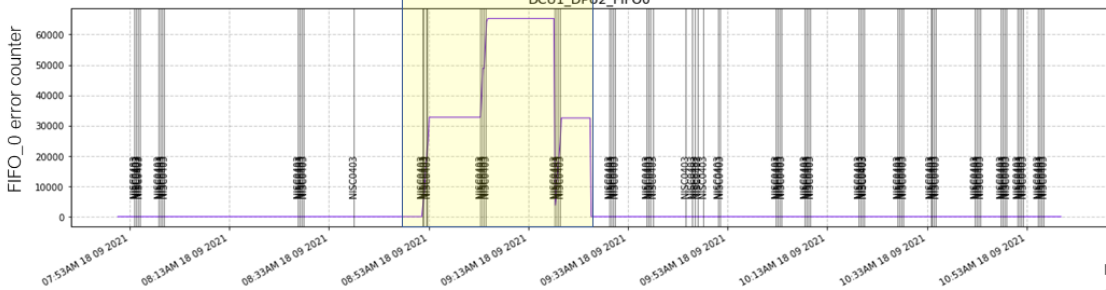
Tests using DPU ASW version 1.3.7.1 injecting FIFO_0 errors @LAM 18/9/2021 using 3xDither of 4xMACC(2,2,2) = 12 broadcast exposures

no exposure errors
 no SCE HSK stop
 no TM(5,2)

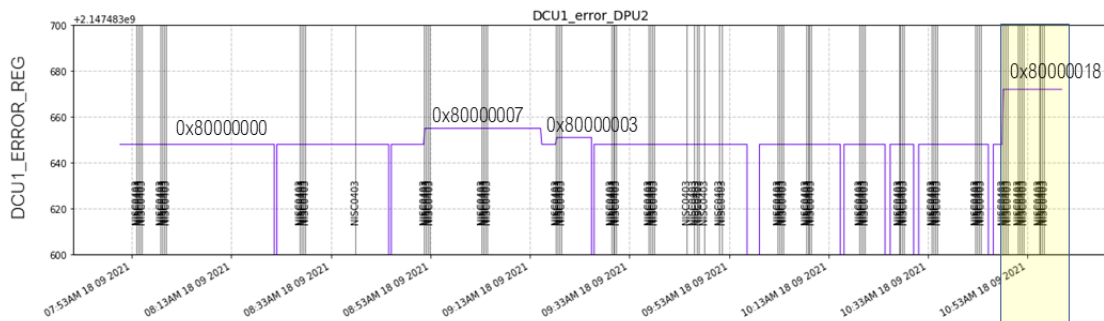
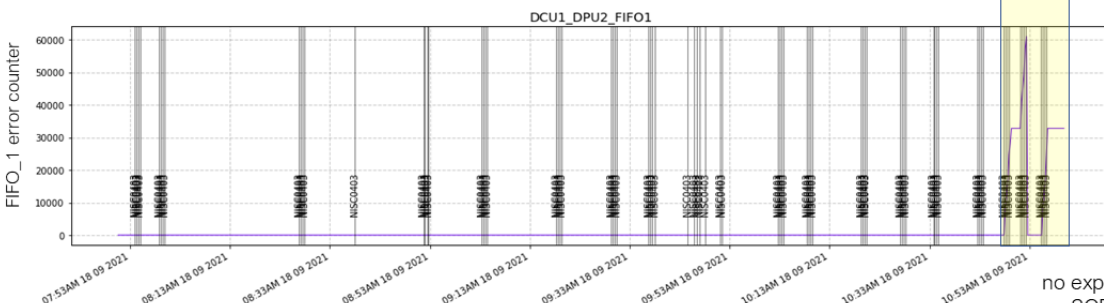
Tests using DPU ASW version 1.3.7.1 injecting FIFO_1 errors @LAM 18/9/2021 using 3xDither of 4xMACC(2,2,2) = 12 broadcast exposures

no exposure errors
 no SCE HSK stop
 no TM(5,2)

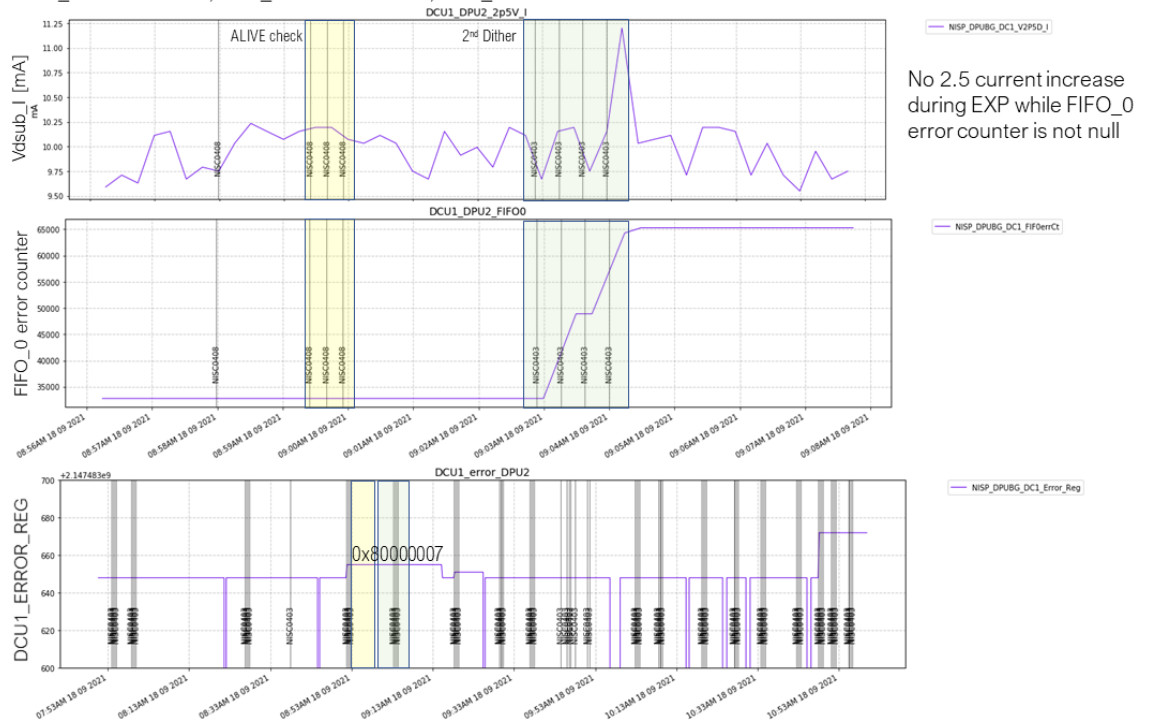
Test case (3)

No 2.5 current increase during EXP while FIFO_0 error counter is not null
