TITLE: **Current Drop Noise in RCA 23
FEM**

DOC. TYPE: **TECHNICAL NOTE**

PROJECT REF.: **PL-LFI-PST-TN-079** **PAGE: I of IV, 7**

Scope of this document is to give a description of a feature observed during PLM SIT test on RCA 23, this description could be used to open a dedicated NCR in order to monitor the problem through the System Test Campaign. The data shown here after have been collected during the PLM SIT performed on the 24th of October 2007 in Cannes.

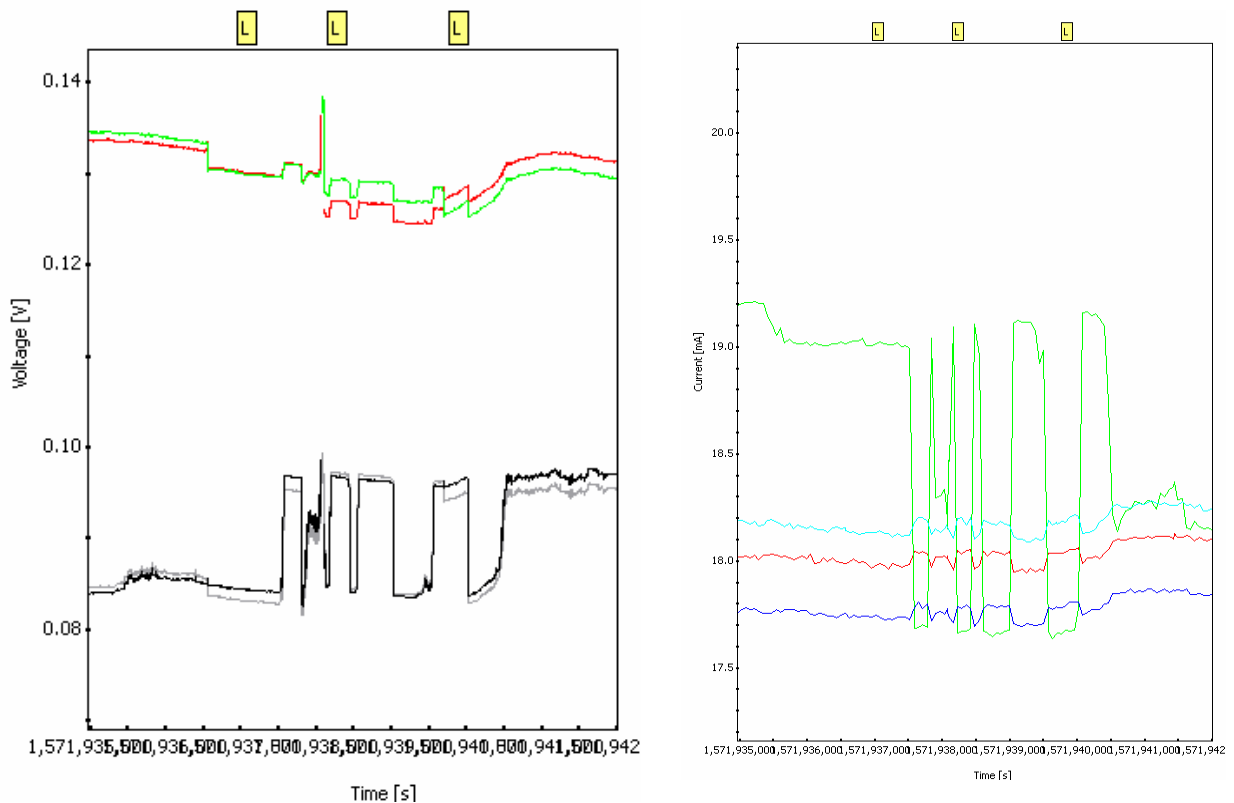
Fig. 1. RCA23 Burst Noise AMB_0114

a) Scientific Output (Volt)

b) I drain (mA) DAE HK

In the above figure the output from the detector R1D1 (in gray) and the output from the detector R0D0 (In red and green) are shown. A quite high “Burst Noise like” is visible in both outputs where no changes in LFI configuration were expected.

Looking at I drain current values (fig 1 b) from the House Keeping it is quite evident that the current of the LNA associated to S1 is changing within three different values (*high low* and *middle* values). The change in the S1 is somehow reflected in the currents of the others LNA and this is also visible in voltage output. The order of magnitude of the current changes is about 1.5mA (peak to peak).

The feature is visible for 1 hour and the I drain of S1 stabilize at a *middle* value. In this configuration the change in percentage of the current respect to WFT test that is our reference point is more than 5%, while at the beginning of the test when the current was in his *higher* state the difference respect to WFT was lower than 0.8%. The current remains in this *middle* values all along the test until the end.

The first time the feature appears in AMB_0113 at the 14:09:06 just when the LUT of the SCS were uploaded via TC, anyway there is no direct connection between the two event because the LUT were uploaded also at 9:44:52 and no feature was visible at that time.

From literature, the nature of the *Burst Noise like* in output voltage is that it has a strong dependence with applied voltages to amplifier, this means that the higher the voltages the higher the noise could be. [RD02] From FM test campaign the Burst noise was no observed during the whole cryogenic test where lower biases to S1 ACA were applied respect to the one applied during the Warm Tests. If nothing is changed somewhere from the FM cryogenic tests we would expect that also in CSL and in Flight the feature will disappear, but indeed this Noise appeared only during the PLM SIT tests and it was not visible during WFT, SFT and EMC tests.

LFI would monitor the feature so a dedicated NCR should be opened.

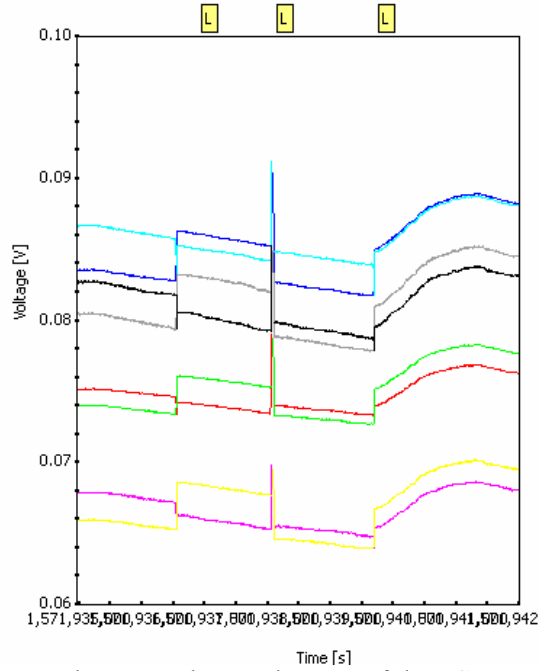
In the figure below is show the same output when the right current is applied and no noise is seen.

The changes in output in the figure above are due to changes of the PS status via TC sending.

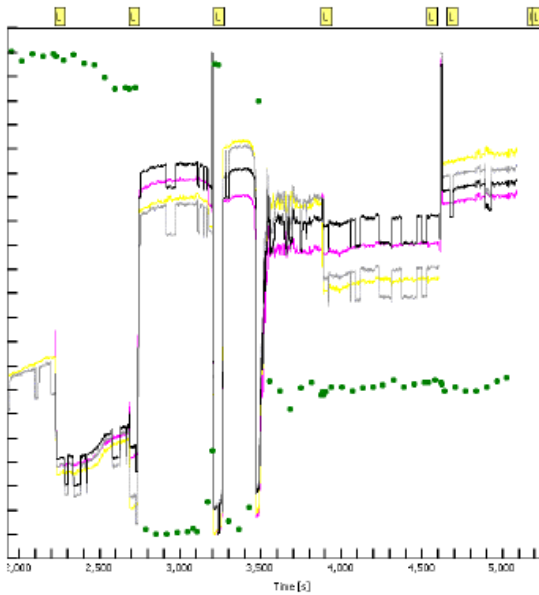
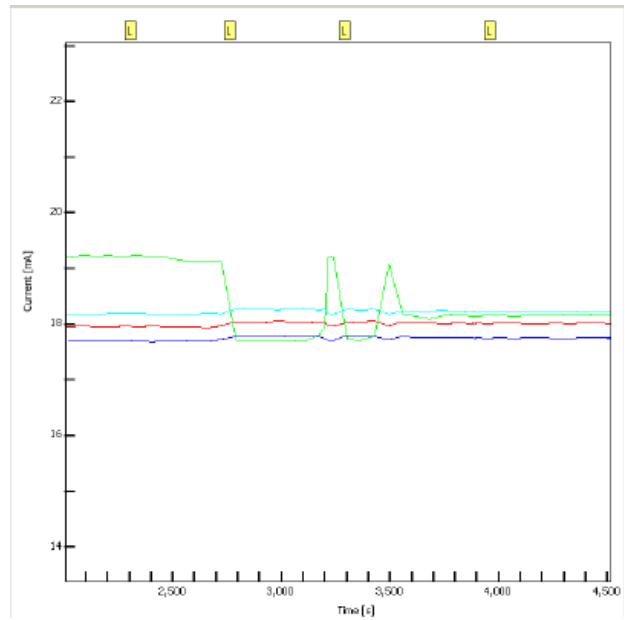
a) Scientific Output (Volt)

b) I drain (mA) DAE HK

The above picture refers to data collected during FM test AMB_0090 [RD01]. It is visible the current noise of the same order of magnitude of the one found in system level, $\sim 1.5\text{mA}$. The Burst noise was found before and after the FM calibration in cryogenic condition and a NCR was open at that time to keep trace of the unexpected behaviour.

A similar feature was found during the FM test campaign (Summer 2006) at instrument level.
