**BepiColombo**  
**SIMBIO-SYS**

# **BC-SIM-IAPSUPA-TR-001**

## **HRIC NECP report**

The present document has been issued with the aim of describing the NECP (Near Earth Commissioning Phase) Tests of HRIC.

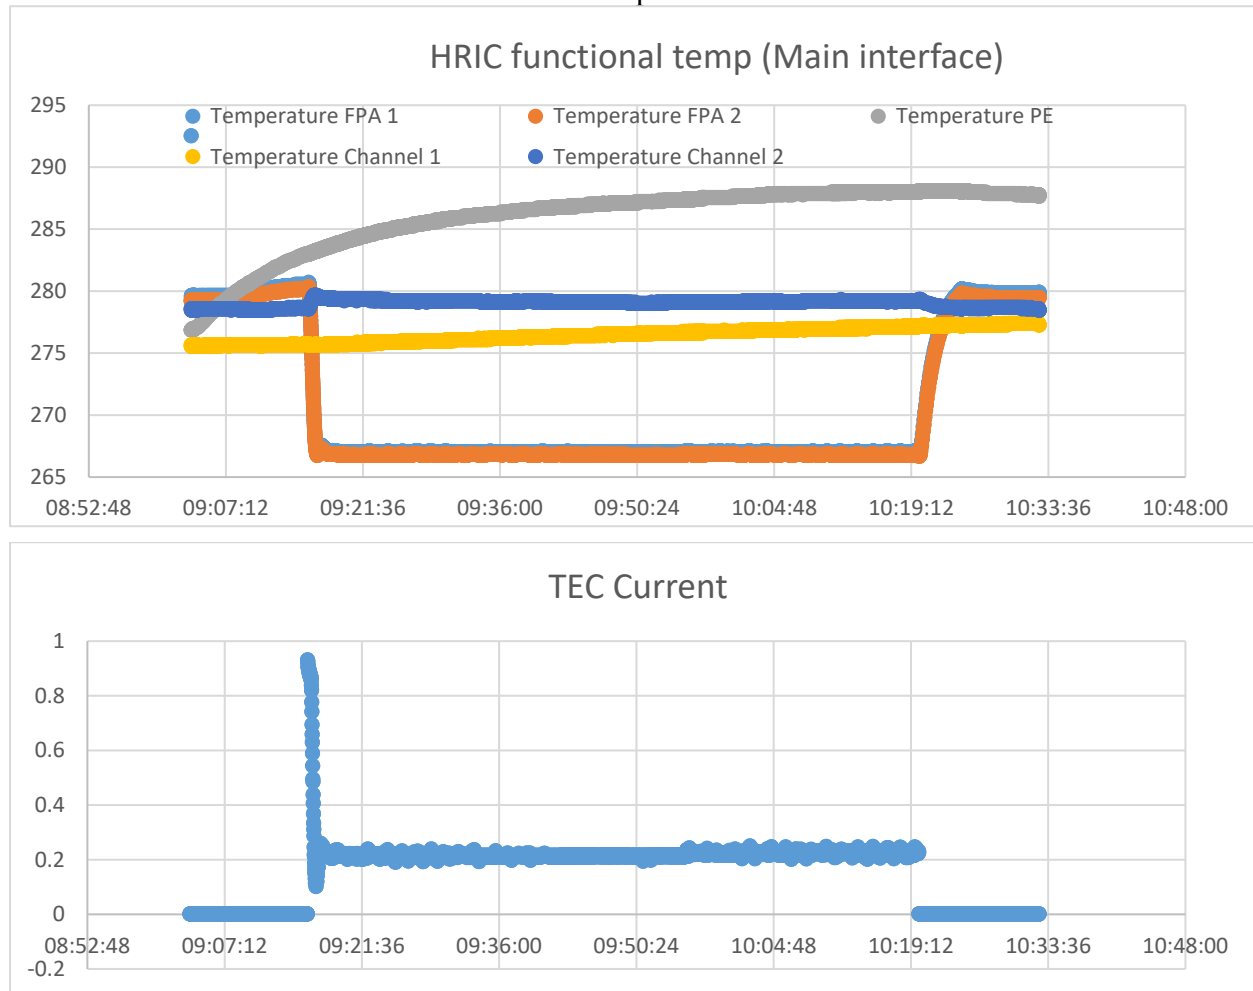
**Figure 2** Temperatures and Tec Current sensors for the first day of the functional test main of NECP.

The diagram of Figure 2, shows the trends of the HK related to the temperatures (upper panel) and TEC current (lower panel) during the functional test of HRIC. The temperatures trends show expected behaviour: since the PE power on, PE temperature start to grow up reaching at the end of the test a maximum value of about 287 K. The temperature sensors linked to the detector show a trend connected to the operations: the temperatures after the switch on of the TEC drops down to the setting point. The Temperature Channel 2 that is connected to the external case of the FPA show a trend linked to the TEC and FPA activation with a small temperature increase. The Temperature channel 1 shows a small increasing trend from the beginning of the test: the increase of the temperature during the test is less than 1 °C.

The current of the TEC (lower panel) shows a peak at the switch on: this is due to the small temperature difference between the commanded set point and the actual temperature of the FPA at the switch on and

due to wrong parameters values for the TEC used. In Fact, the bad parameters for the soft start of the TEC were not able to limit the current to the device. This error was checked by the team in the following test.

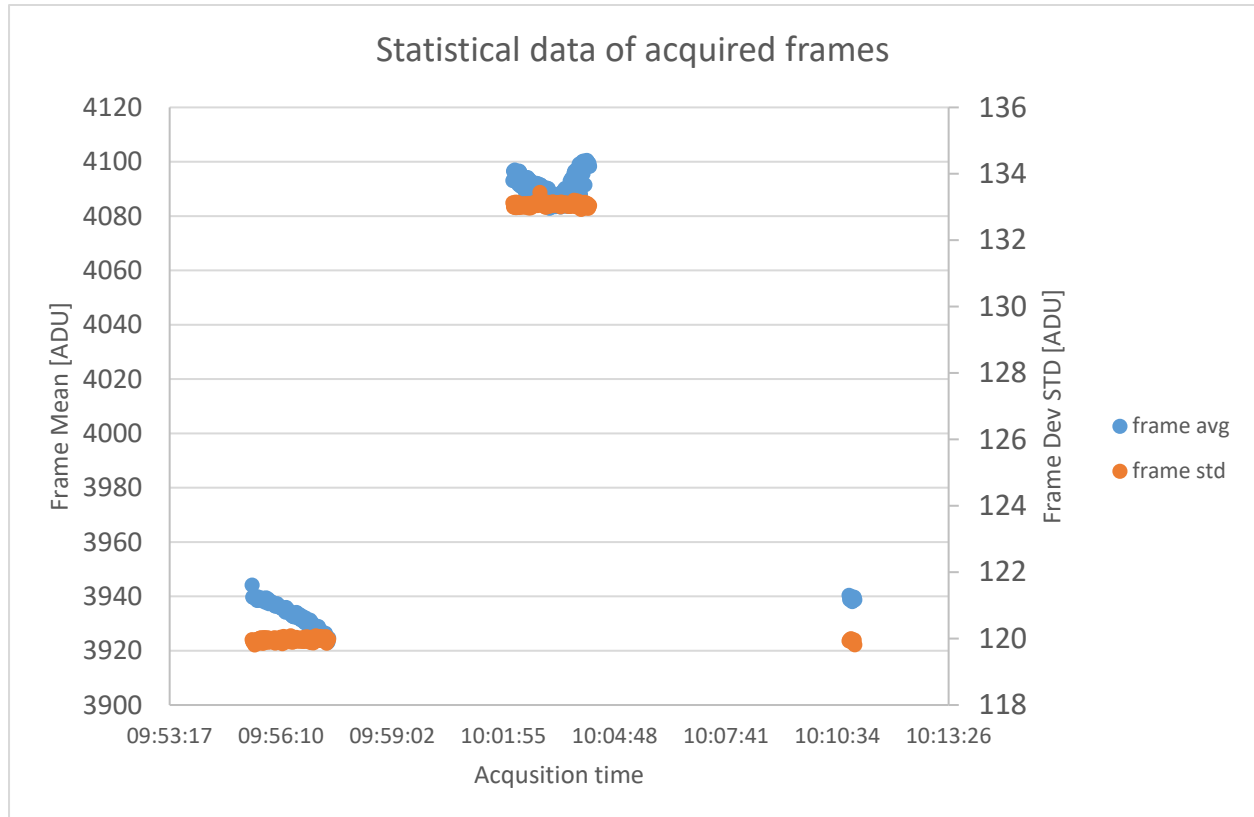
**Figure 3** In the plot are reported the average and the standard deviation over the whole frame for the pixel readings. The frames have been acquired in three steps changing the integration time: a) short integration time .000038 s; b) long integration time 0.3148 s; c) short integration time 0.000038 s.

The analysis of the frames acquired during the functional test show that the signals read from the detector are compatible with the values characterized during the on-ground calibrations. Average Signal Level and Standard deviation measured on the frames are compatibles with the same parameters acquired in similar conditions during the calibration campaign.

For both the measurements at short integration times and long integrations times the average values show small (in amplitude) trends. These do not show any simple correlation with the housekeeping parameters. Further investigation are ongoing to explain the observed trends.

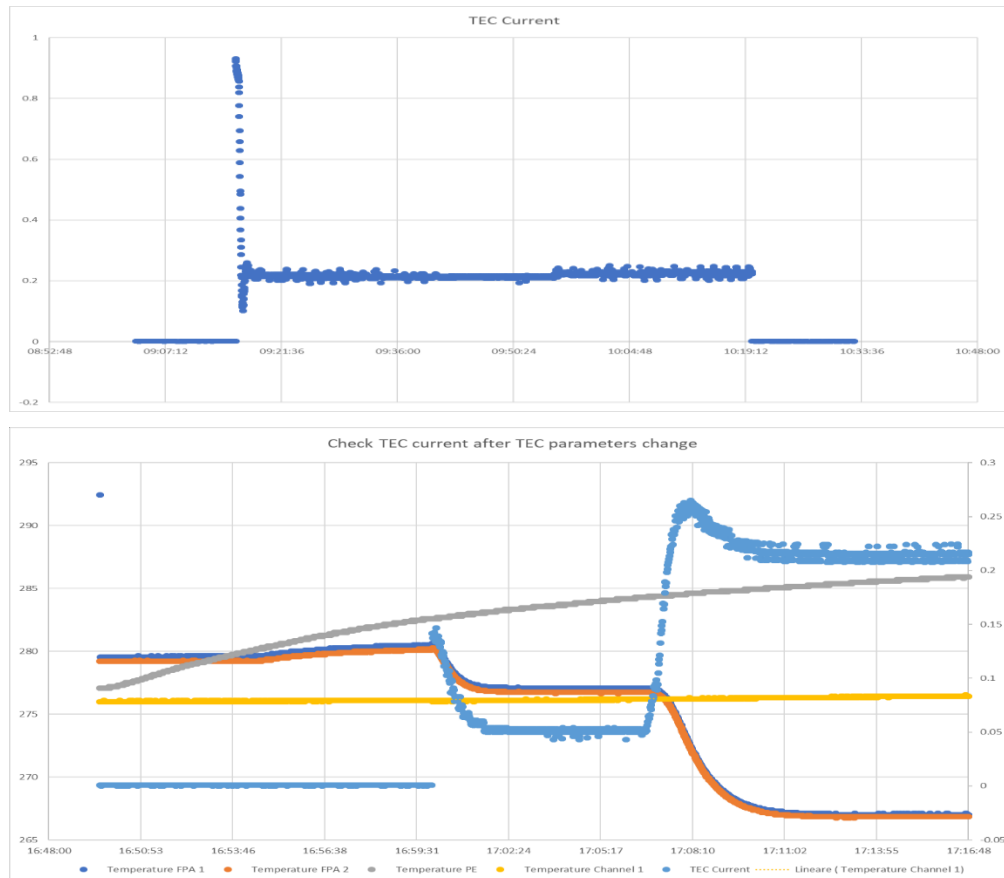
**Figure 4** TEC current and Temperatures trends obtained before (upper panel) and after (lower panel) the correction of the TEC parameters. With the correct values for the parameters the TEC current trend (blue dots on the lower panel) show the soft start as expected. In the plot the current trend show two different steps: this is because the TEC set point was changed during the test, as evident by the Temperature trends.

In **Figure 4** are reported the current Trends for the TEC and the FPA temperatures. In the Upper panel the behavior observed during the functional test with the high current peak at the switch-on of the TEC. In the lower panel the TEC behavior after setting the right parameters for the TEC: at the first switch-on of the TEC the current raise at about 0.1A (much lower than the safe limit for the device). When the FPA Temperature was set to the nominal values the TEC current raise slowly within several second, after a small overshoot the current reach a safe value of about 0.2 A when the FPA temperature reached the set point.

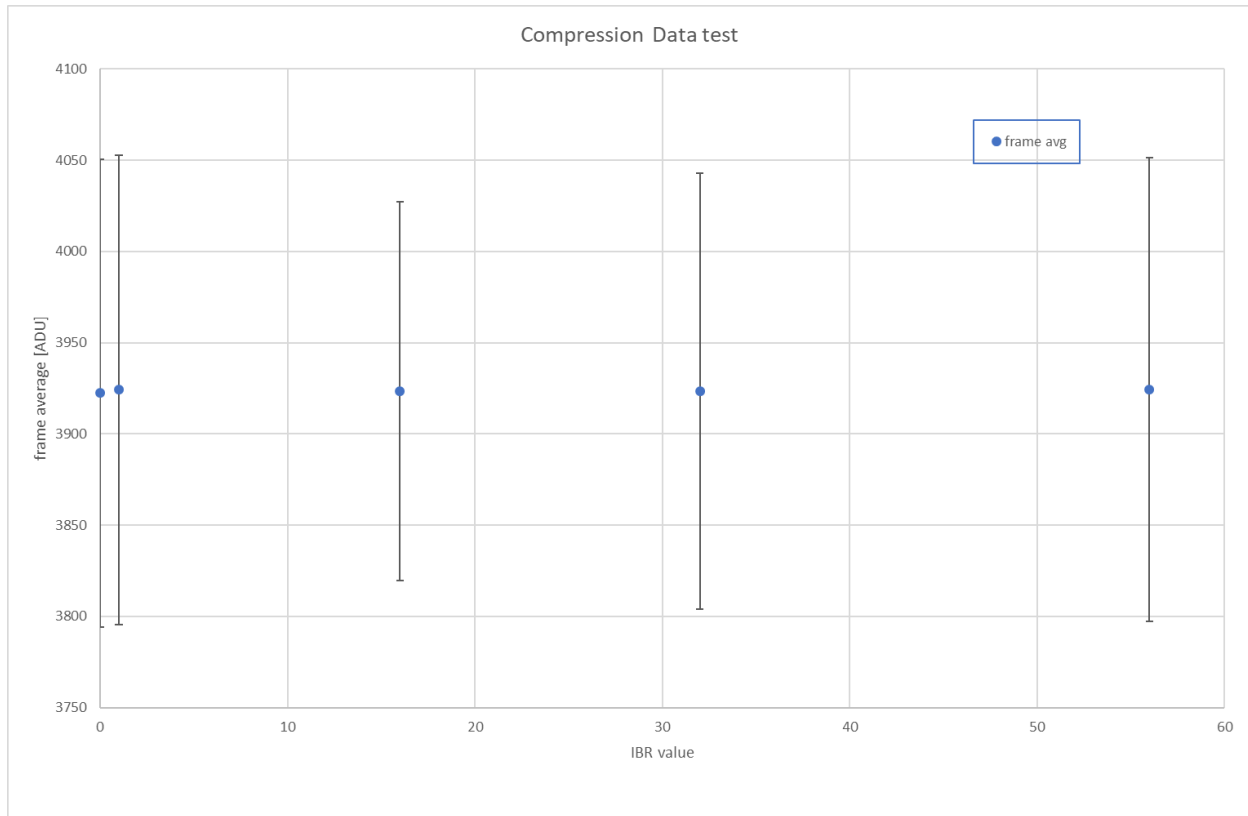
**Figure 5** Frame Average and standard deviation (reported as error bars) for acquisitions with same integration times.

During this test the same detector was acquired using the same integration time (96ms) and 5 different values of the compression (ibr=0,1,16,32,56 corresponding to compression levels: bit packing, lossless, 14, 7, 3.5). The differences between the acquisition considering the average and the standard deviation on the pixel values are negligible for the acquired scene (almost uniform dark image).

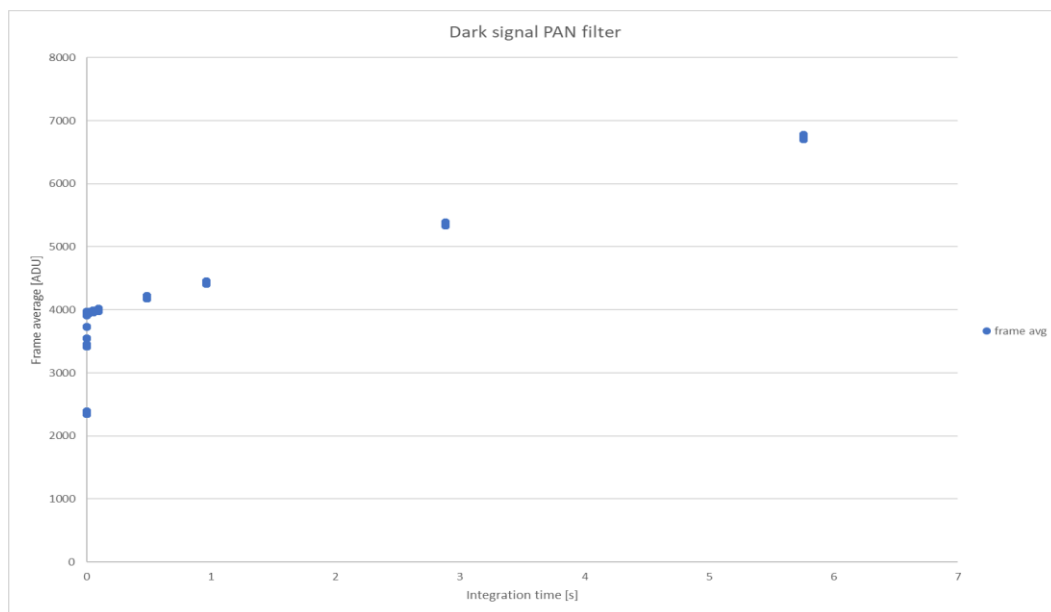
**Figure 7** Average of the pixel values over the frames acquired during the DARK test. In the plot are reported the values of the average of the frame for the Panchromatic filter.

During Dark test/measurement the areas of the detector corresponding to the Panchromatic, and to the three Broad Band filters have been acquired with different integration times starting from the minimal (400 nano-seconds in the configuration used for the ROIC) up to about 6 seconds. The values of the average of the acquired frames are reported in **Figure 7** and **Figure 8**. The trend shown in the plot is compatibles with the trends measured during the calibration campaign on ground and reported in RD7.

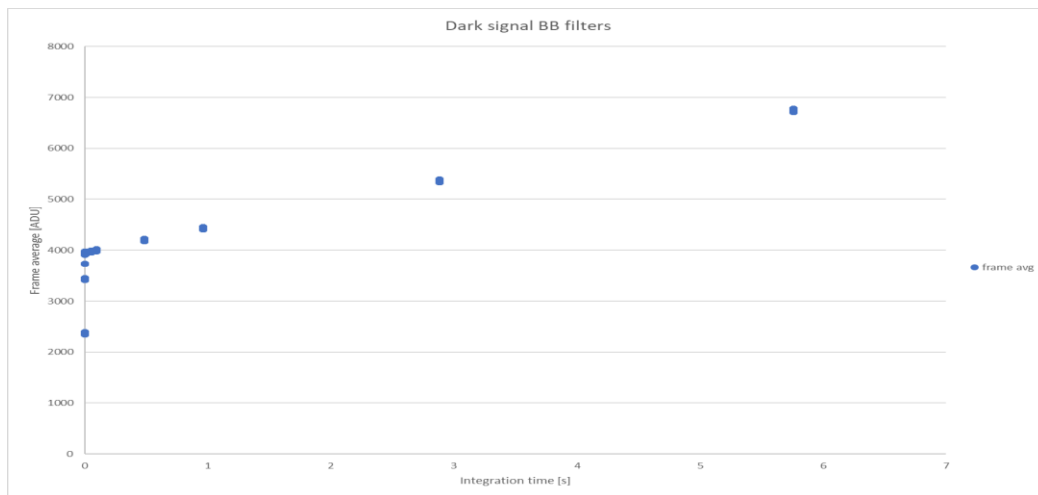
**Figure 8** Average of the pixel values over the frames acquired during the DARK test. In the plot are reported the values of the average of the frame for the BroadBand filters.

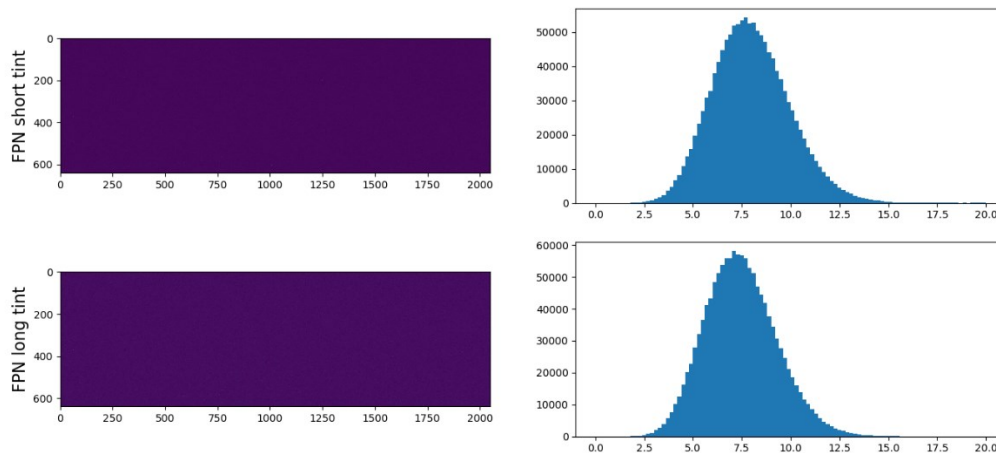
**Figure 10** RON frame at short time (average of 10 acquisition at minimum integration time (upper panel) and 48 microseconds (lower panel)).

Using the data collected during the DARK measurements also the FPN and the RON of the detector have been checked w.r.t the values obtained during the calibration campaign. The values obtained for both FPN and RON are in good agreement with the values obtained in RD7 (**Figure 9** and **Figure 10**).

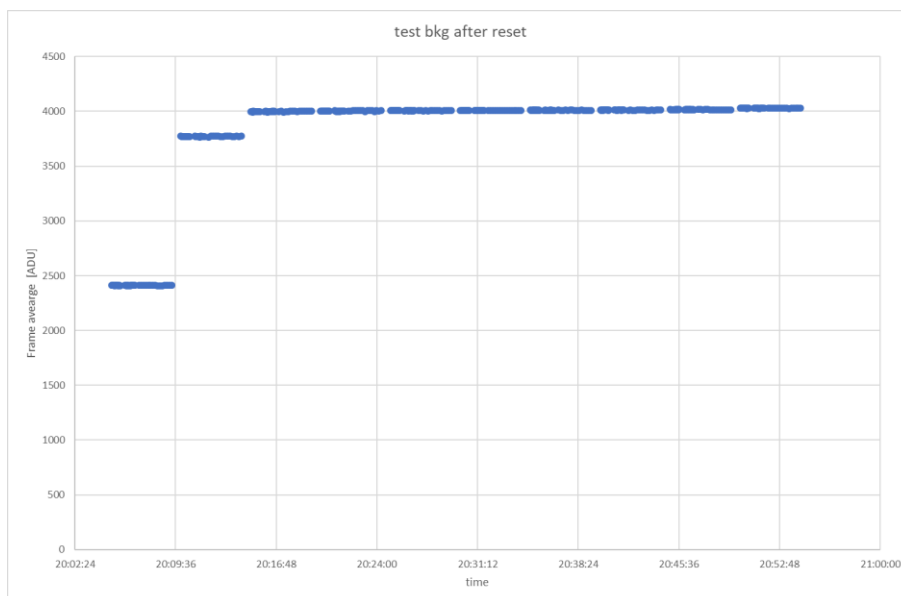
In order to check if is present an issue of charge accumulation on the pixels between 2 resets without image acquisition, several frames have been acquired with different integration times and delays between the frames. The average of the frames pixels values is plotted in **Figure 11** w.r.t. the acquisition time. The values during the sequence of acquisition are quite stable the only difference between the series is due to the DARK behaviour. As checked before the launch no reset issue is present on the HRIC detector (within the RON of the detector).

**Figure 11** Value of the average of the pixel values obtained in the frame acquired to check the behaviour of the detector pixels reset after acquisition.

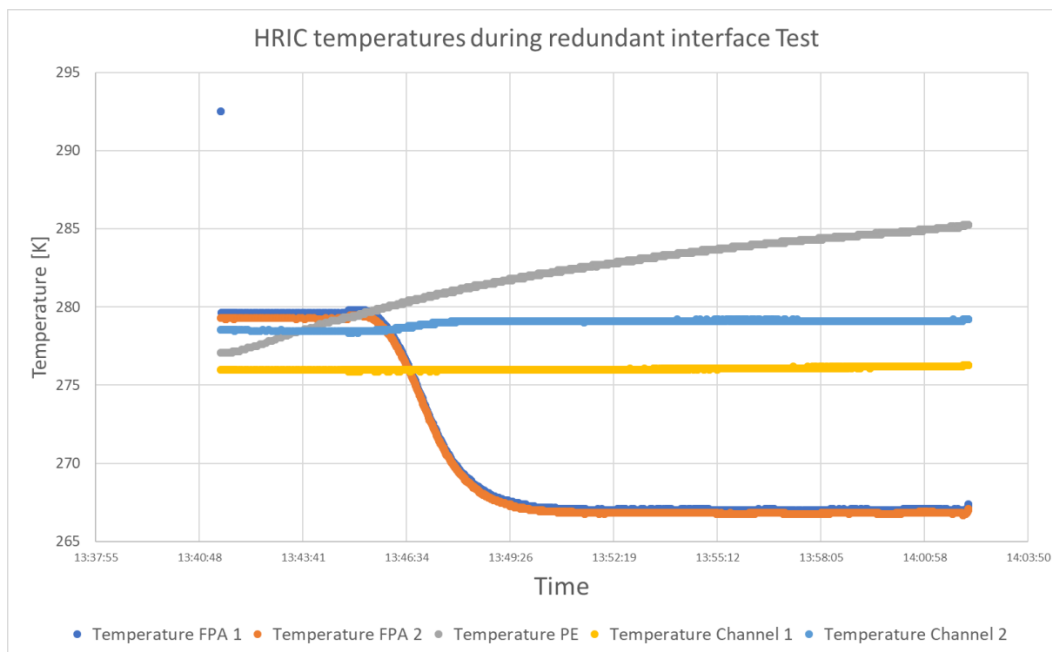
**Figure 12** HRIC Temperature trends during the functional tests on the redundant interface.

The functional tests on the redundant interface were a subset of the tests performed on the main interface: only a reduced number of images have been acquired. In **Figure 12** are reported the temperature trends during the test. All the trends are nominal, in this case the thermometer on the TIRD did not show any trend coupled with the PE temperature, probably because of the short duration of the test, in any case this behaviour will be checked in the next check-out of the instrument. The TEC current behaviour is nominal (**Figure 13**). The statistical analysis of the acquired frame didn't show any trend and the behaviour is nominal (**Figure 14**).

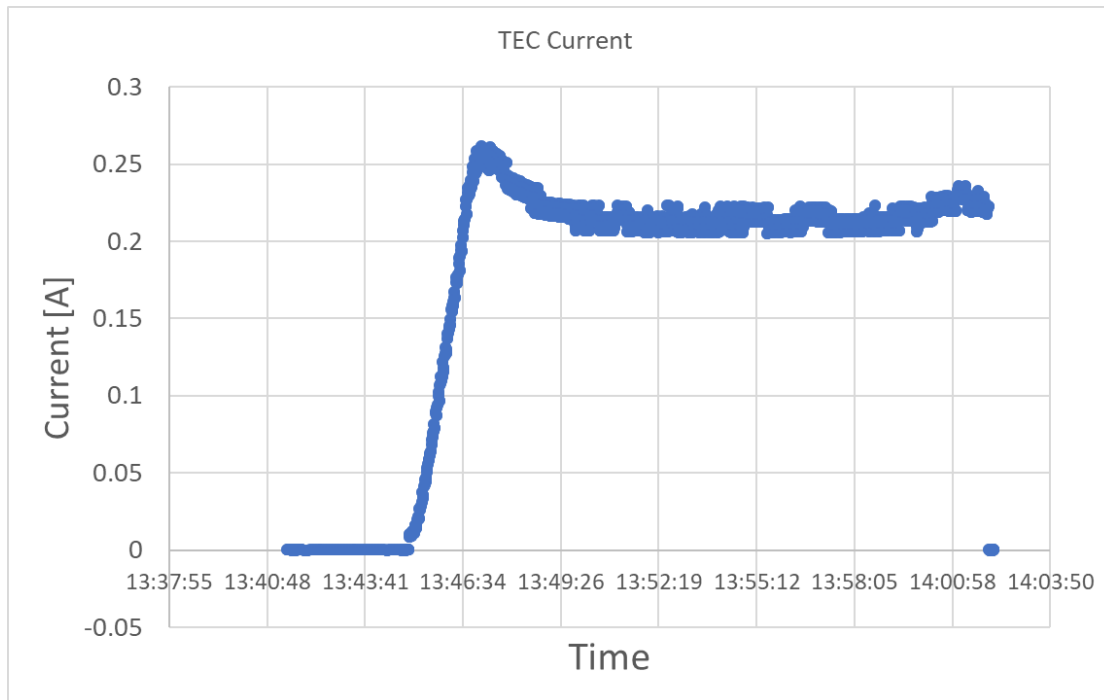
**Figure 13** TEC current trend during the Redundant interface switch on of HRIC.

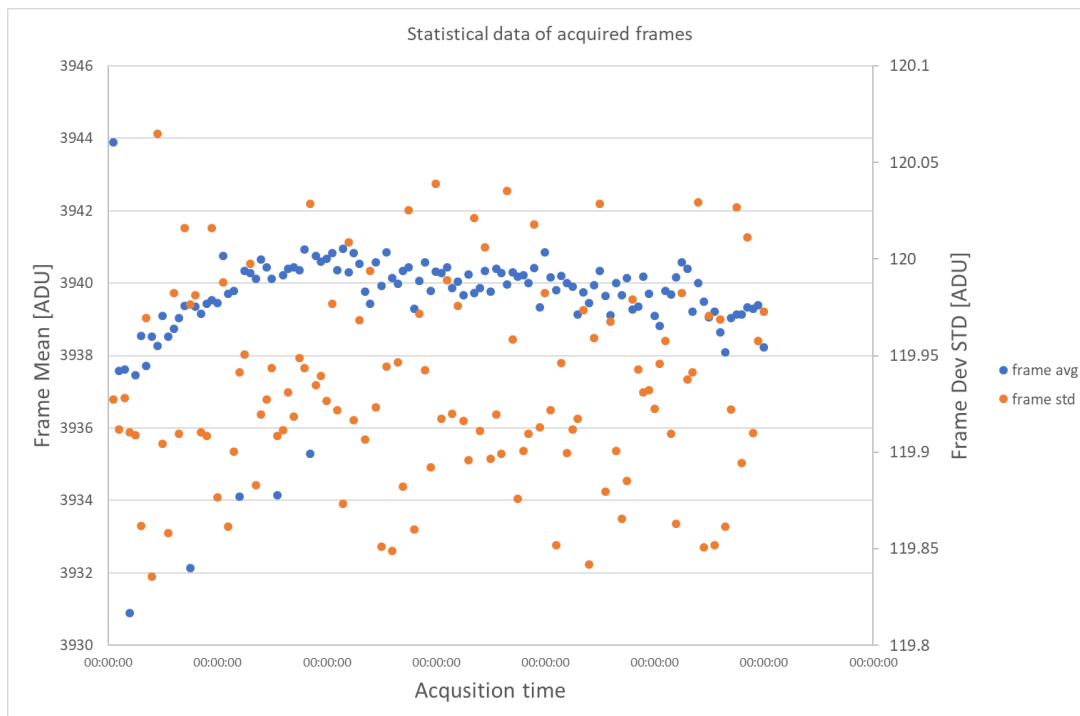
**Figure 14** Averages and standard deviations of the frames acquired by HRIC during the functional test on the redundant interface.
