| Title | Analysis of Voltage Jumps In LFI18 R0D0-R0D1 and LFI26 R1D0-R1D1 and debug procedure on LFI 26 during OD204 |

TITLE: **Analysis of Voltage Jumps In
LFI18 R0D0-R0D1 and LFI26
R1D0-R1D1 and debug procedure
on LFI 26 during OD204**

DOC. TYPE: Test Report

PROJECT REF.: PL-LFI-PST-RP-089

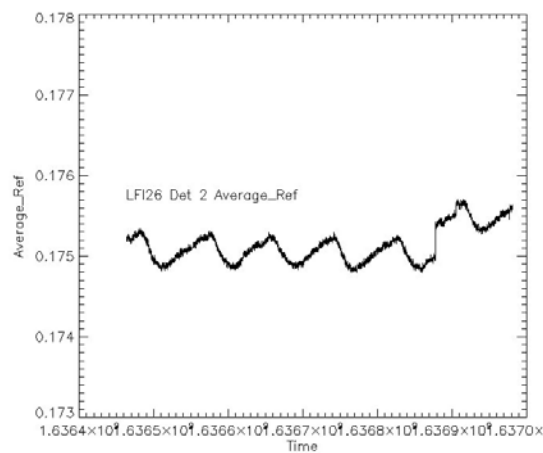
Figure 1 Vout change on LFI 26

In the case of channel LFI 26 the signal increased suddenly on both sky and ref without decreasing again. In the case of LFI 18 the signal decreased again.

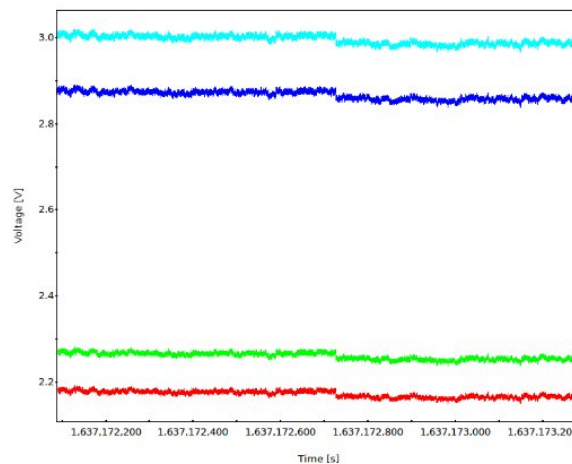
Figure 2 Vout changes on LFI 18

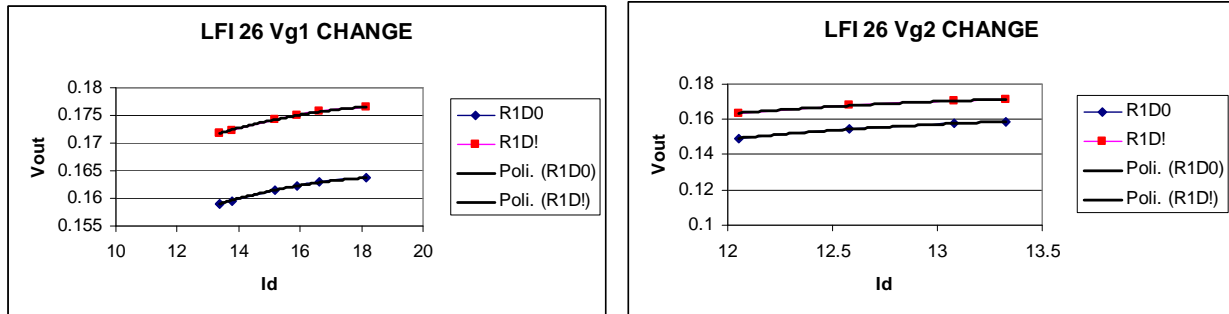
Figure 3 I-V curves for LFI 26 in the I_d range considered: left panel , V_{g1} is changed keeping v_{g2} still; right panel, V_{g2} is changed keeping V_{g1} still.

Actually, from I-V curves (below) fits using, as usual, a power law, it comes out that in the case the I_d variation was due to a V_g changes on S2, the expected V_{out} change should be hundred times smaller :

V_{g1} (I_d) change \rightarrow DELTA R1D0_sky (I_d) = $2.36 E-6$
Instead of the measured
DELTA_meas $>3 E-4$

V_{g2} (I_d) change \rightarrow DELTA R1D0_sky (I_d) = $1.16 E-6$
Instead of the measured
DELTA_meas $>3 E-4$

Hence, the difference between expected and measured data is by a factor 50 about.
This possibility does not fully explain the numbers we are measuring.

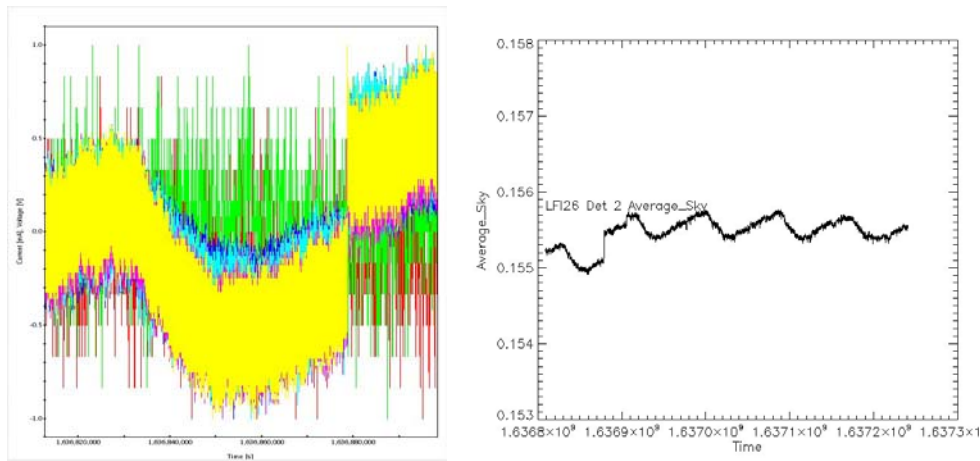
Figure 4 LFI 26 : V_{out} change (yellow, cyan, traces) vs. I_d . the two behaviours seem uncorrelated. The Voltage value keeps constant since the variation occurred on OD 184 (Right panel)

However, A bias change should be related to a drain current change in the LNAs. In LFI 26 no relevant I_d changes are observed. Despite the I_d changes are different on the two coupled ACAs (relative variation on S2 is ten times the variation on S1) , however the numbers involved seem to be too low to justify the V change.

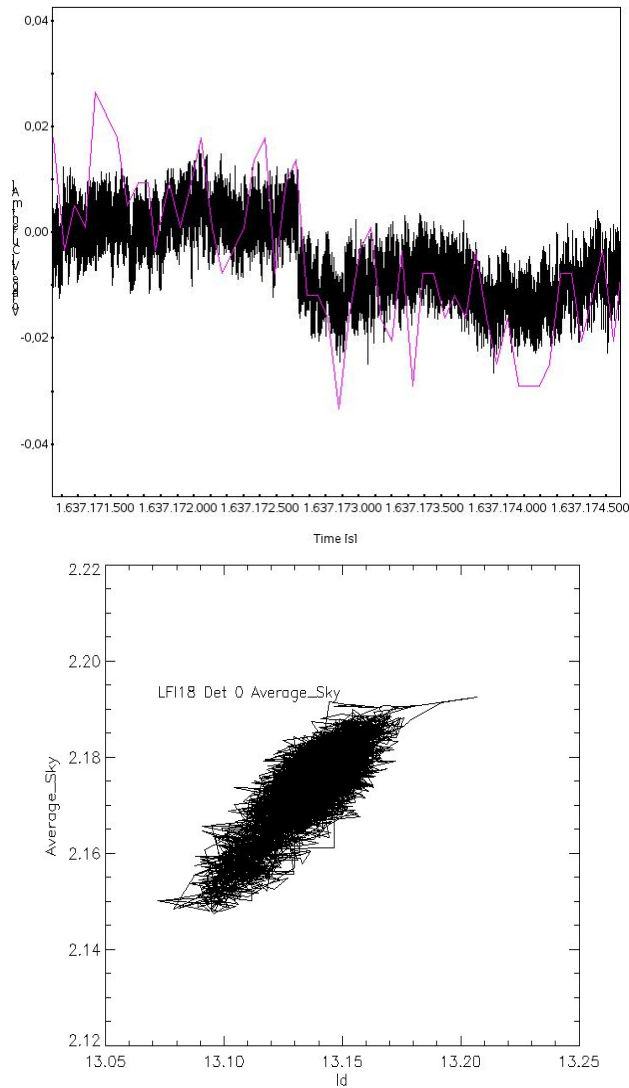
Figure 5 LFI 18: Id (M1, magenta) vs V (R0D0, black) correlation ; right panel: Id(M1) on x axis Vs Vout_R0D0 along three days

- a) b) c) The same as said before for LFI 26
- d) It seems to be a good explanation: actually , as reported in Figure 8, the signal changes are proportional on sky and ref. Moreover, if we consider the Id change and correlate it with the signal change, a good agreement comes out:

If we follow the same approach as for LFI 26, the amplitude of the expected V change due to Id change is :

- Vg1_M1 (Id) change → DELTA R0D0_sky (Id) = 6 E-3
- Vg2_M1 (Id) change → DELTA R0D0_sky (Id) = 5 E-3
- Vg1_M2 (Id) change → DELTA R0D0_sky (Id) = 8 E-4
- Vg2_M2 (Id) change → DELTA R0D0_sky (Id) = 6 E-4

Instead of the measured
DELTA_meas 1.2 E-2

Hence, the difference between expected and measured data is by a factor 2 about.

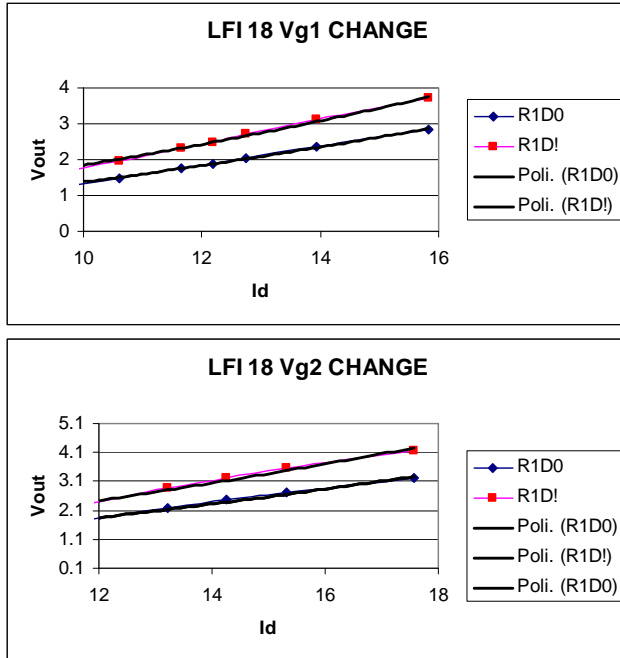
Figure 6 I-V curves for LFI 18 in the Id range considered: left panel , Vg1 is changed keeping vg2 still; right panel, Vg2 is changed keeping Vg1 still.

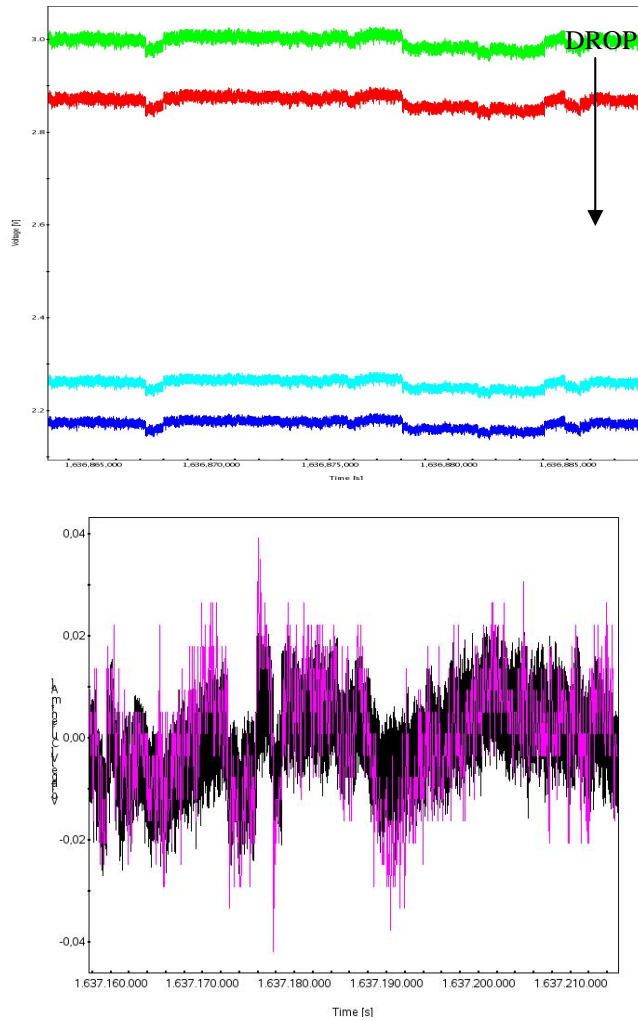
Figure 7 Left panel: Typical behaviour of LFI 18 M (OD 178) ; Right panel: OD 188 : correlation between V_{out} and I_d along 18 hours .

In add, we see that this behaviour is typical of this channel and that the previous signal level is restored after a certain time:

The above explanation seems to be satisfactory, not requiring to investigate also frames e) and f).

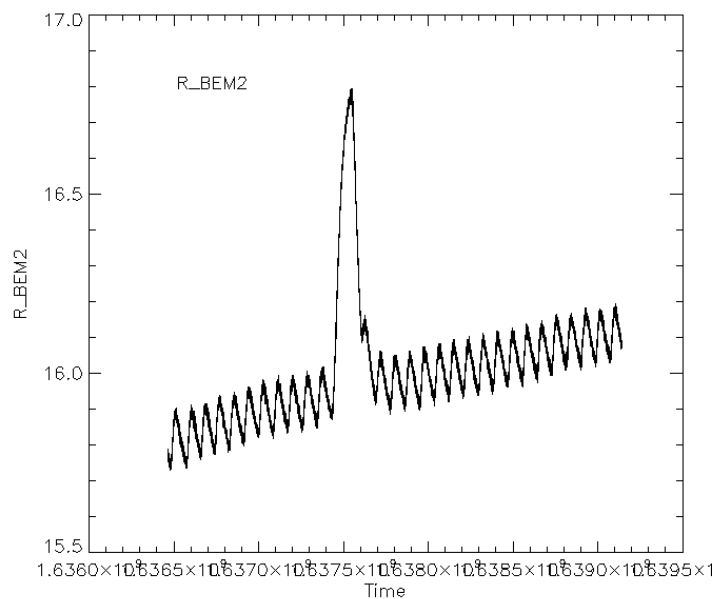
Figure 9 BEU temperature from OD 180 to OD 210: the abrupt increase is due to the transponder heating effect.

It is worth mentioning the problem occurred with the transponder during OD 192, exhibiting as an abrupt change in the scientific output of the most radiometers caused by the heating up and down of the Back End Unit containing the LFI warm amplifiers, for a period longer than the usual daily three hours.

Actually, as shown by Figure 9, for the time being the BEU temperature is higher than during OD 184. Hence, due to the typical thermal response of the LFI 26 (voltage output anti-correlated with the BEU temperature) we would expect today a V_{out} lower than that measured after the event of OD 184.

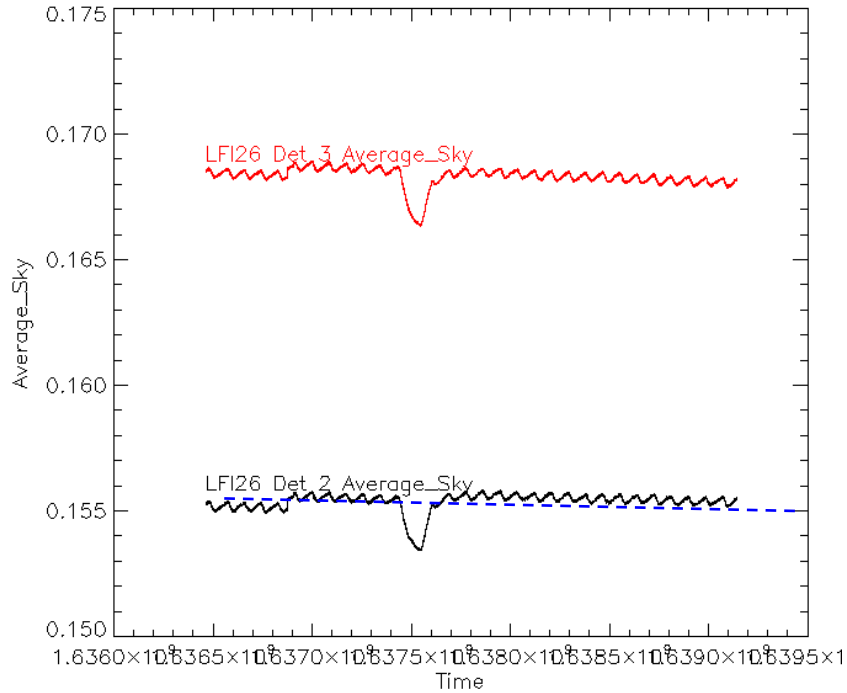
Figure 10 RCA26 R1D0 sky signal (black, bottom) and R1D1 ref signal (red, top) from OD 180 to 210. Jump in the signal during OD184 is evident in the plots together with the 32 hours Transponder on period on OD 191-192. No evidence of a relevant change during the debug procedure applied during OD204 is clearly visible. A further remark is the behaviour of the RCA26 – 10 before and after the transponder long heating; it is evident that while detector 11 has gone back to its previous status, detector 10 has an increased baseline.

An overall view of the R1D0 sky signal and R1D1 ref signal during a range of about 30 days, from OD 180 to 209 (Figure 10), does not show changes comparable to the OD 184 jump during the recovery procedure.

In the two following figures, it is however evident the different behaviours of the two detectors before and after the OD192 long transponder heatup : RCA26 – 10 detector shows a discontinuity in the trend that was not recovered in the following days.

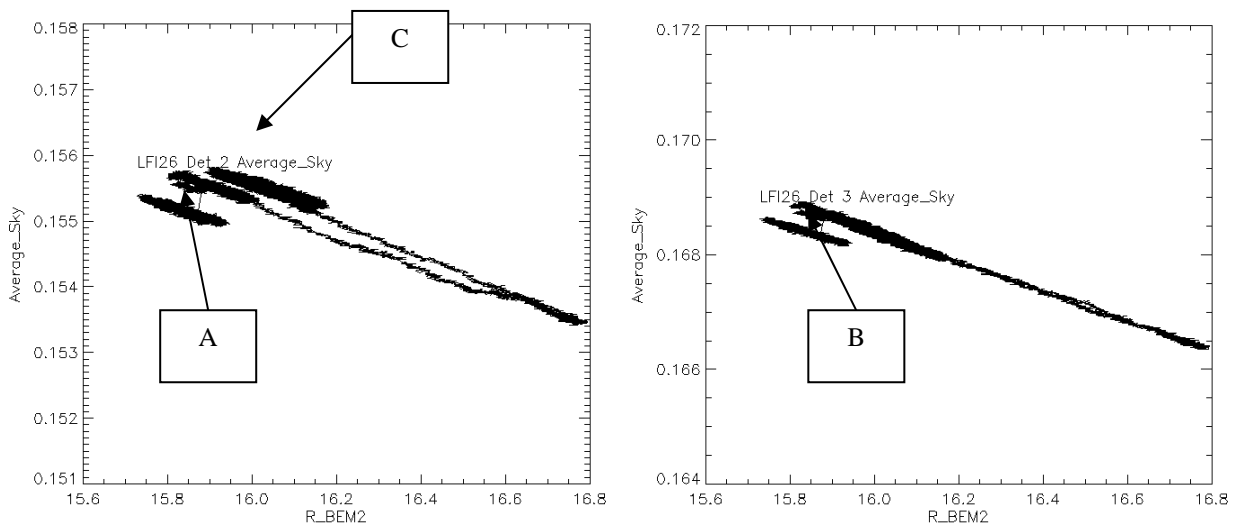
Figure 11 Correlation between RBEM temperature and sky signal on R1D0 (left) and R1D1 (right). In both panels it is evident the discontinuity due to the Voltage (A, B) jump: however, in

R1D0 we observe also a second discontinuity (C) due to the non recovered voltage change following the transponder effect.

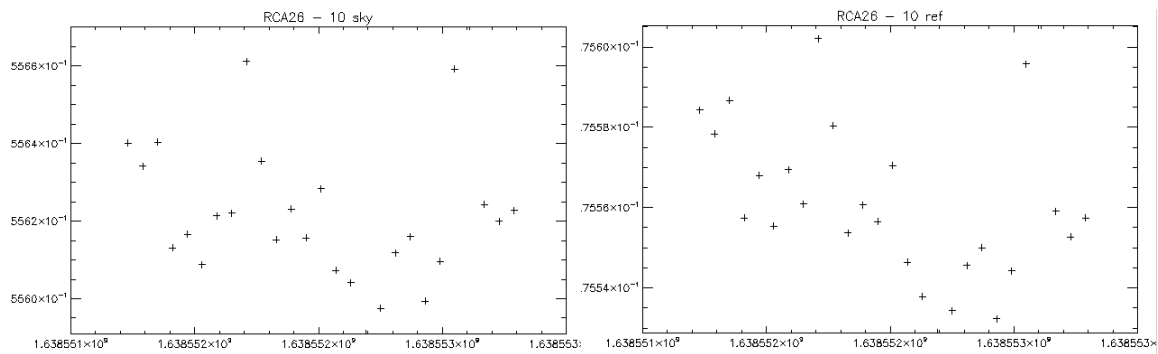
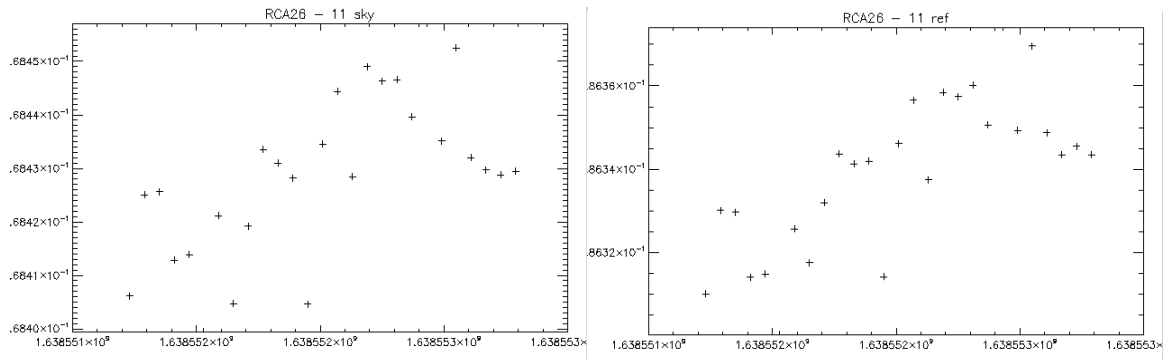
Figure 12 Each point in the plots is the average of 40 seconds of data starting from second 10 to 50 of each minute, from 17:07 to 17:35. So the first 3 points are taken before the procedure is applied, than 16 points report the values for each of the procedure steps and last points give the behaviour until the end of Real Time science acquisition. There is no evidence of a sudden change towards a systematic different level.

As a first analysis, the average signal was evaluated for each minute (starting from 17:07), on the 40 central seconds, i.e. cutting first and last 10 seconds. Results are reported in the Figure 12. Time range is from 17:07 to 17:35, when the dedicated scientific real time visibility ended. First three points are taken as a reference before the first setting (Gain) is applied. Last two steps, separated by only 30 seconds, are mixed in a single point.

In the detector R1D0 a change in both the sky and ref level is visible after the third point, i.e. as the first setting was applied, but the dispersion of the subsequent points show it is not really a definite jump.

In the detector R1D0 the mean value of the first points is at a lower level than in the final part, but no clear and systematic discontinuity or jump is visible.

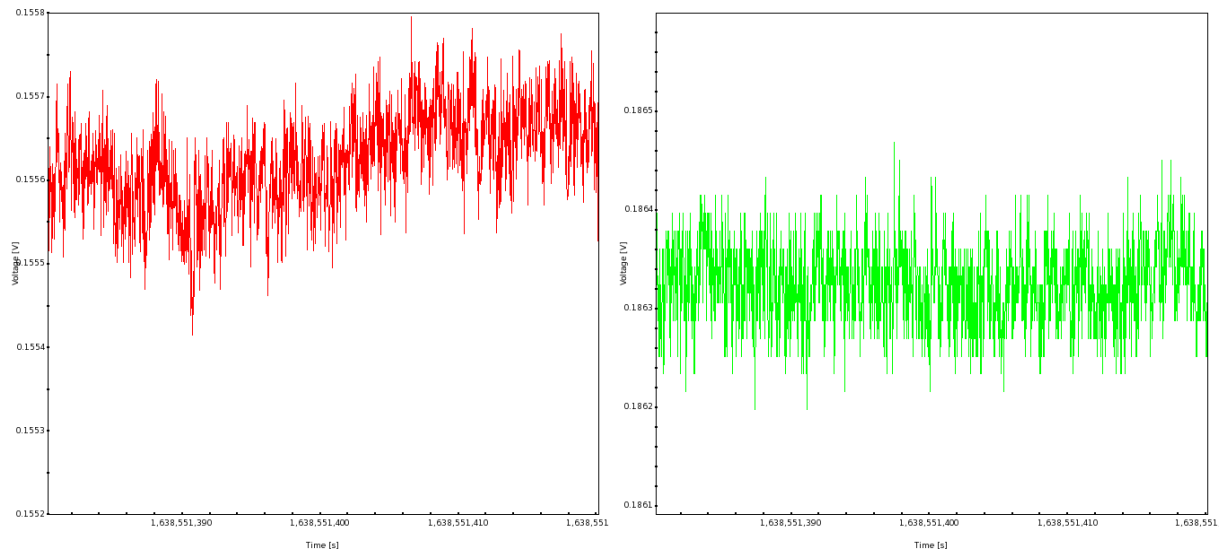
17:10

A zoom of 20 seconds, centered on the TC application time, of the R1D1 ref signal and R1D0 sky, as representatives of the whole radiometer is reported for each minute. The TC is applied in the central point of the graph which is the point referring to the time reported above each of the plots.
