Metis INSTRUMENT
for the
Solar Orbiter Mission

Metis Commissioning IT-3 Activity Report

Week 11 (9 March 2020 - 15 March 2020)

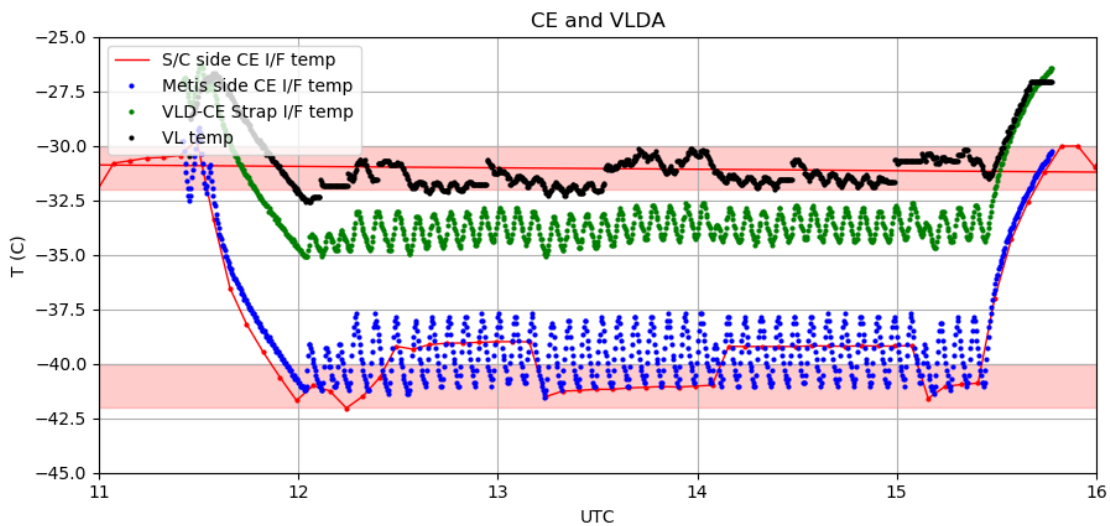
Figure 1: CE interface temperature during the test

We monitored that the temperature of the S/C interfaces at Metis CE and ME were in the expected ranges. Here below is reported the graph of the CE temperature for one of the temperature sensors of the SC.

The test initial condition were to have Metis OFF and the decontamination heaters off. Indeed both CE and ME interfaces were found within the respective Non-OP range (see Figure 1 and Figure 2).

The transition from the non-op to the op range of the CE I/F lasted about 30 min (see Figure 1)

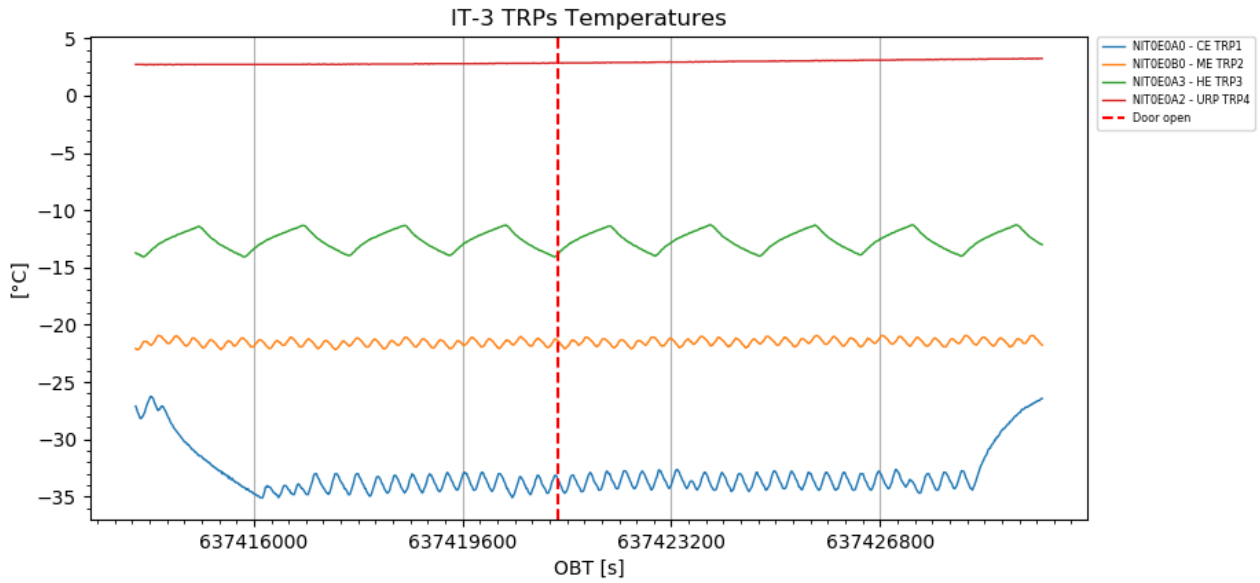
Figure 3: Thermal Reference Points temperatures

In the following figures the temperature of other subsystems are plotted.

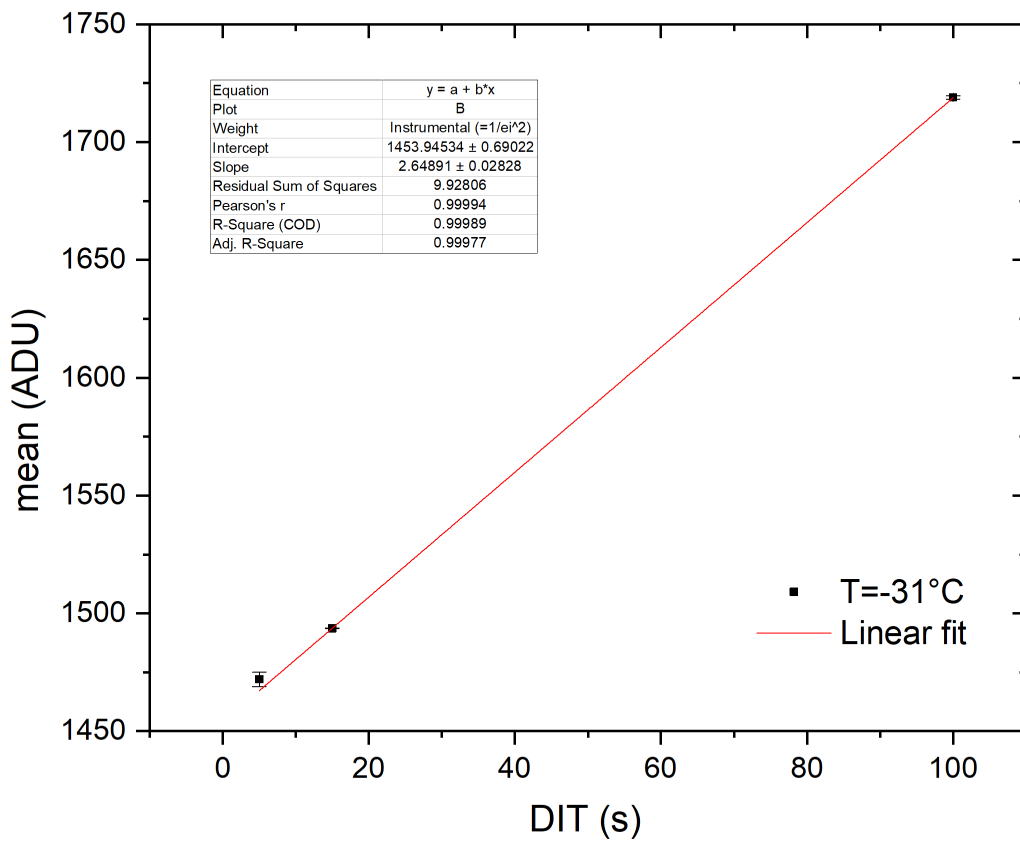
Figure 6: Linear fit of the measured dark current

A preliminary analysis on the images shows that the level of the dark current as a function of the integration time follows the expected nearly linear behaviour. The slope of the linear fit gives a dark current estimate of 2.65 ± 0.03 ADU/(pixel s), which correspond to 20.5 ± 0.3 e⁻/(pixel s), see well This is consistent with the dark current measured during on-ground calibration .

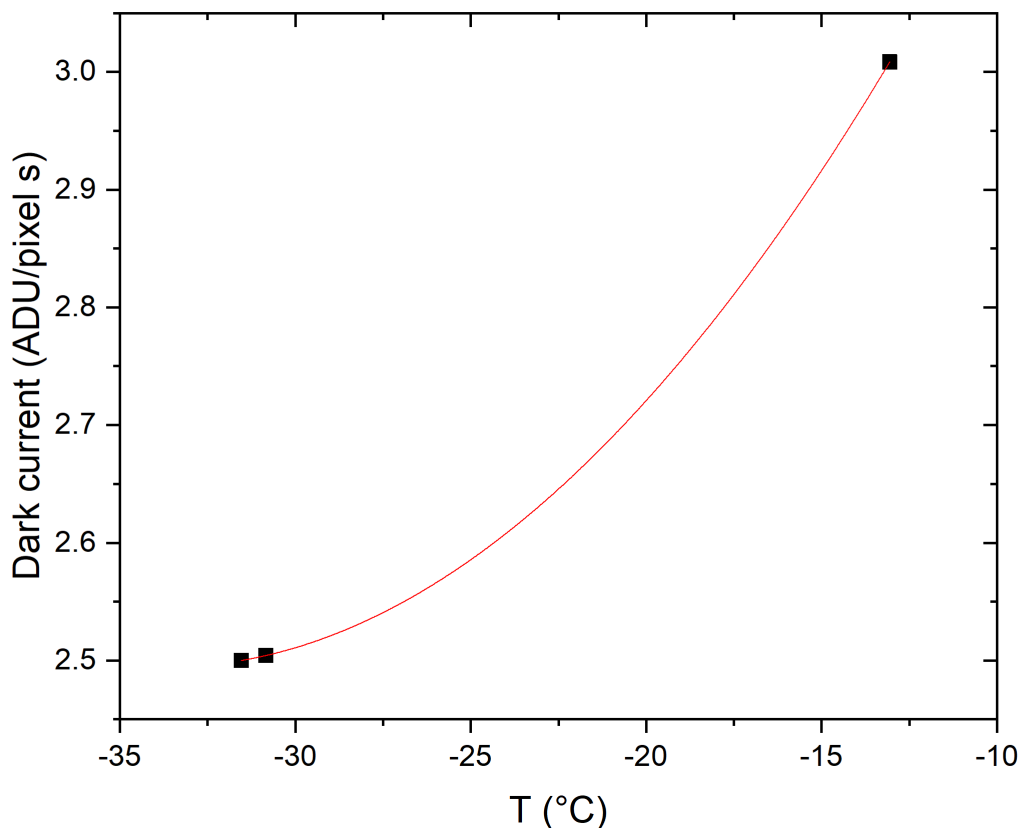
Figure 7: In flight dark current acquisitions comparison as function of T

In Figure 7 the inflight dark current acquisitions are compared as function of the temperature. Despite the limited number of points the results confirm the theoretical expectations.
