Rapporti Tecnici INAF INAF Technical Reports

AAVS1 Hybrid Cable's assembly and testing procedure

This document describes the procedure whereby the 440 AAVS1 (Aperture Array Verification System) FEM were reworked by Lightech s.r.l. to be compatible with the pyramid assembly created by UCAM. Then there is a description of the reworking verification and the final testing procedure of the HC (Hybrid Cables).

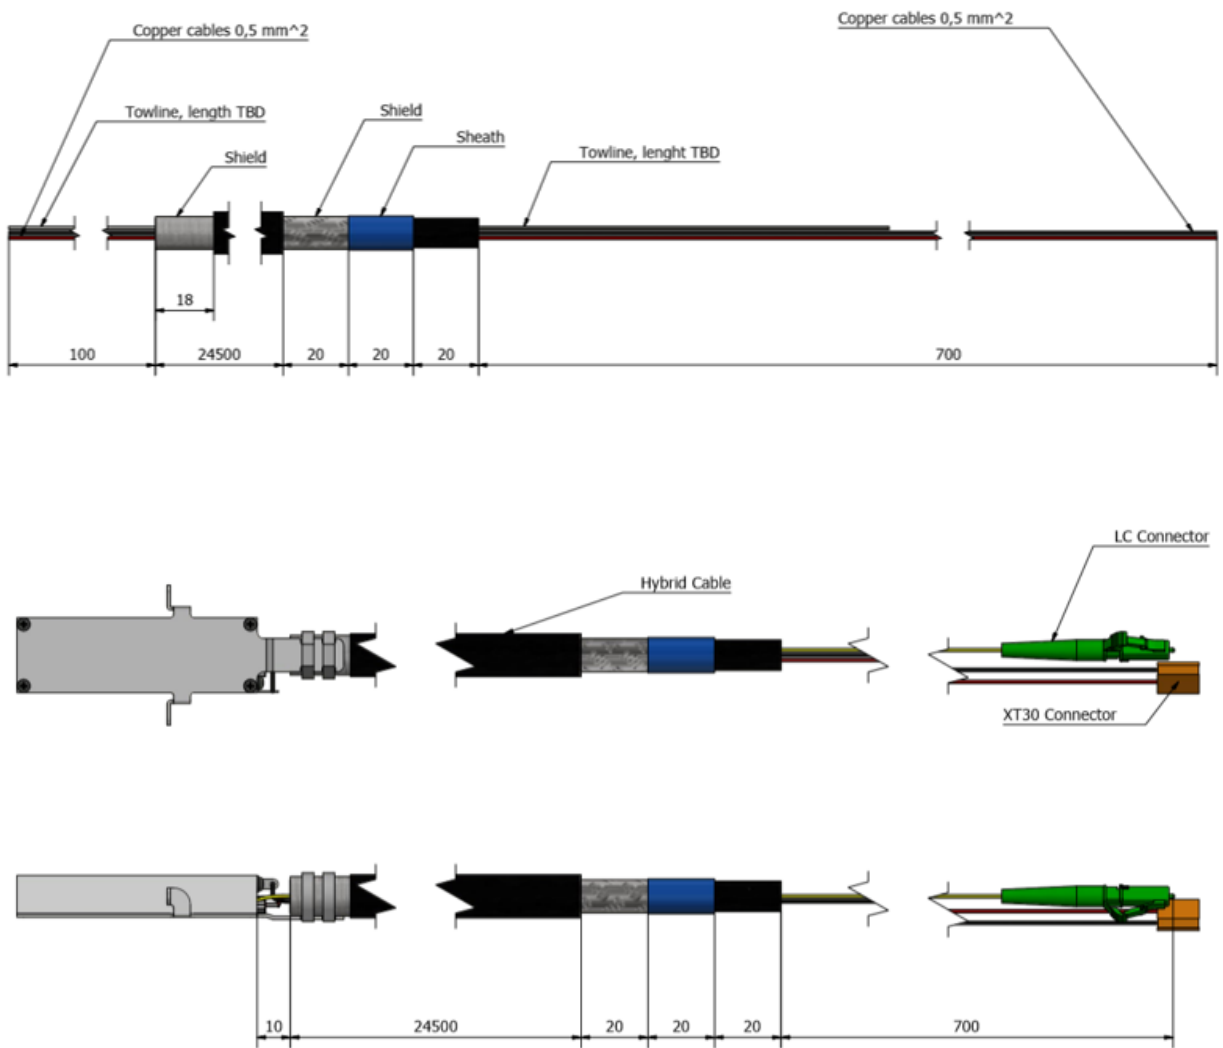
Figure 1: Hybrid cable preparation.

1. Preparation of the HC as depicted in Figure 1.

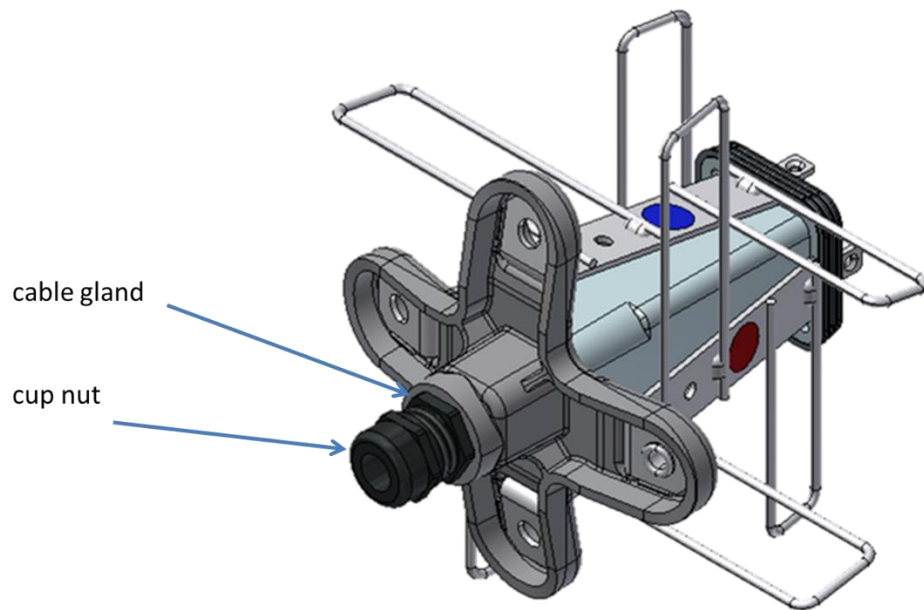
2. Make sure that the cable gland is fixed to the trumpet body and loosen the cup nut as in the figure below.

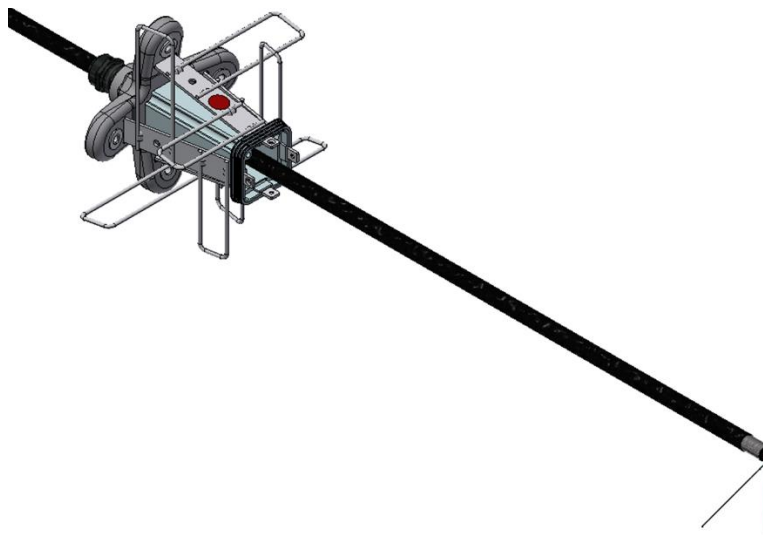
Figure 2: Trumpet insertion into the hybrid cable.

3. Insert the hybrid cable inside the trumpet, from the FEM side (as shown in Figure 2 **Errore. L'origine riferimento non è stata trovata.**).

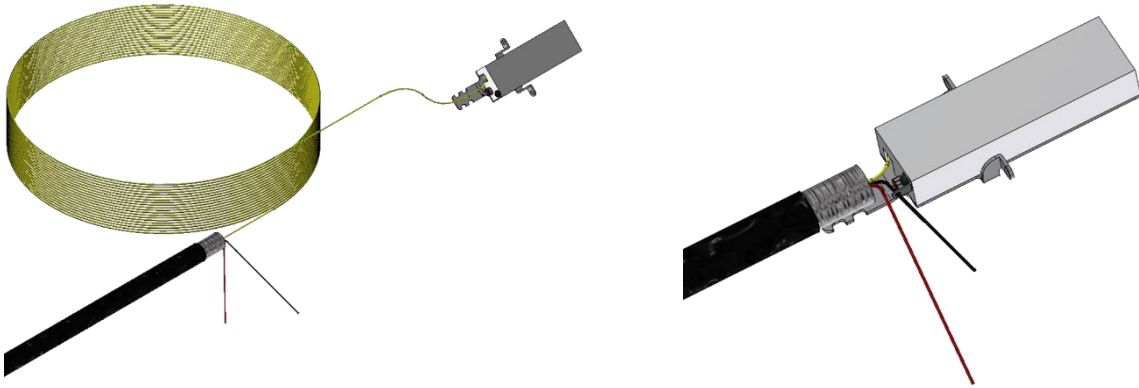
Figure 3: Threading the fiber into the hybrid cable.

5. Cut the LC/APC optical connector and pull the fiber inside the hybrid cable from the FEM's opposite side, since to have 10mm between the hybrid cable to the module.

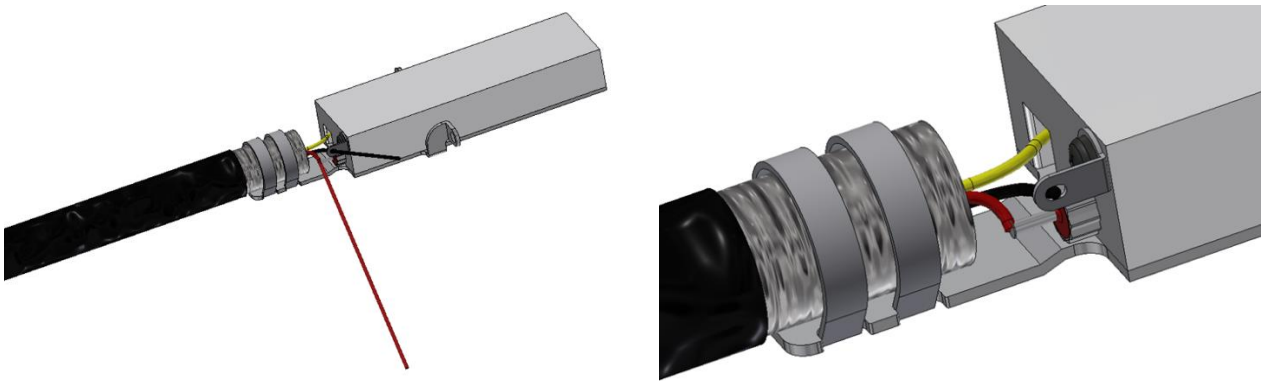
Figure 4: FEM attachment and electrical wiring.

6. Fix the module to the hybrid cable with two plastic cable ties. Make sure there is a good contact between the cable armor and the FEM cover. Then cut and connect the copper cables to the feed trough and the tab, as shown in Figure 4.

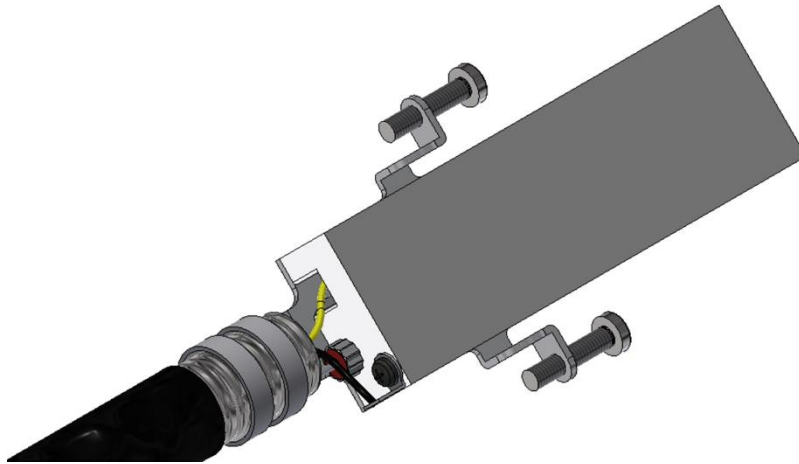
7. Place the two screws in order to simplify the connection of the module inside the trumpet, as shown in the figure below.

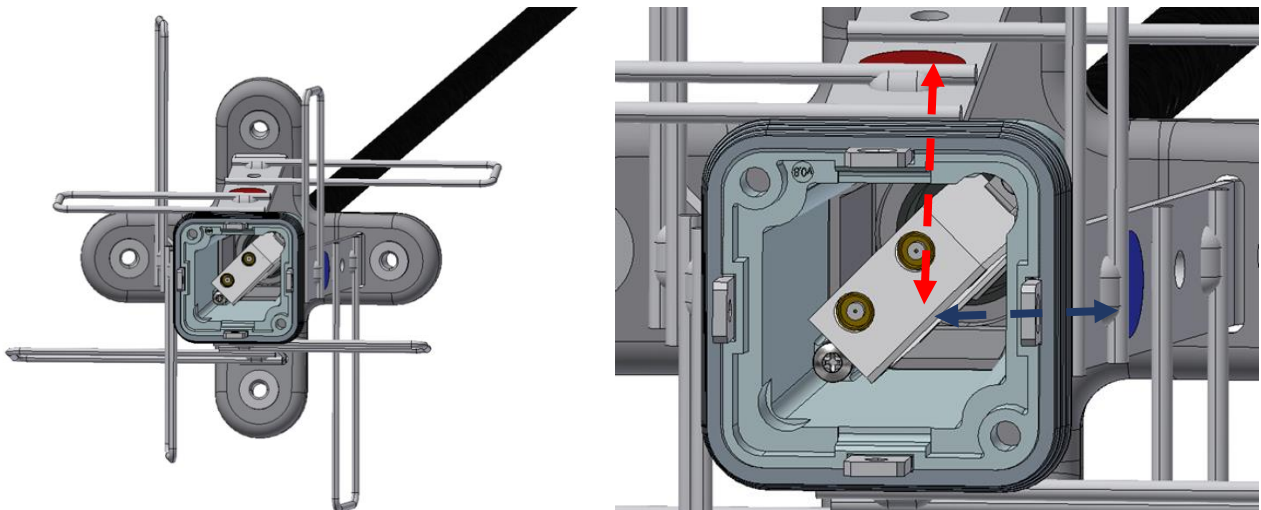
Figure 5: FEM correct position inside the trumpet assembly.

8. Insert the FEM inside the trumpet with the orientation explained in Figure 5 (the cover must be in front of the blue dot, and opposite to the red dot).

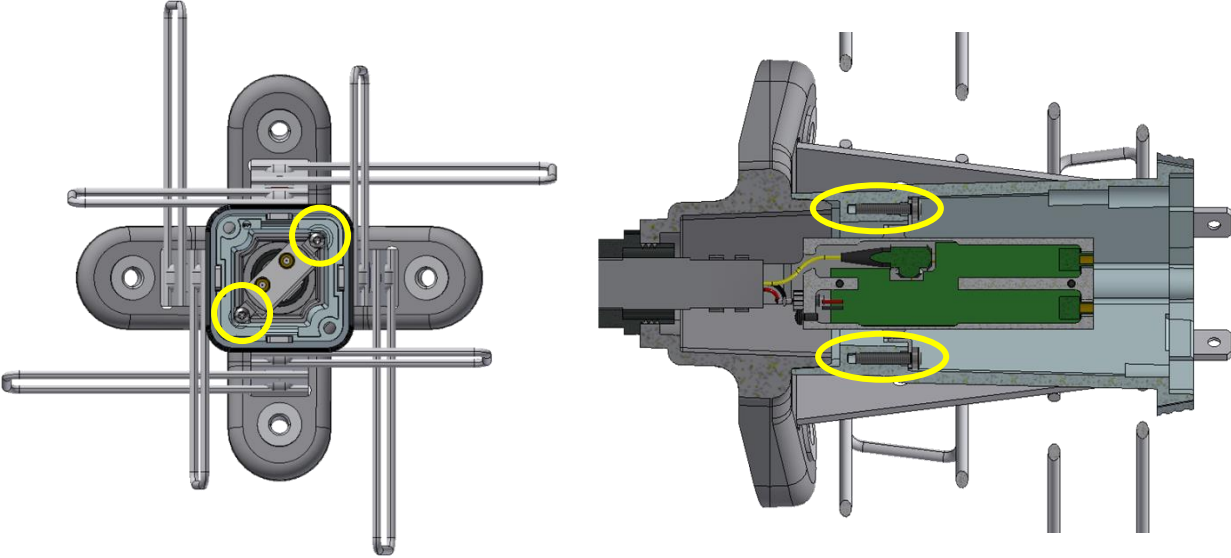
Figure 6: Screws position inside the trumpet.

9. Tighten the two screws with T10 screwdriver to fix the FEM as shown in Figure 6.

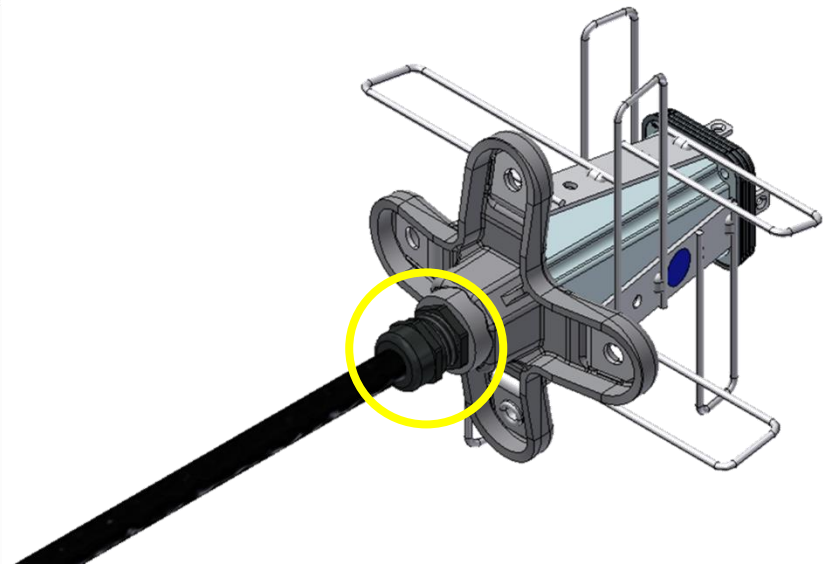
10. Tighten the cable gland to the hybrid cable.

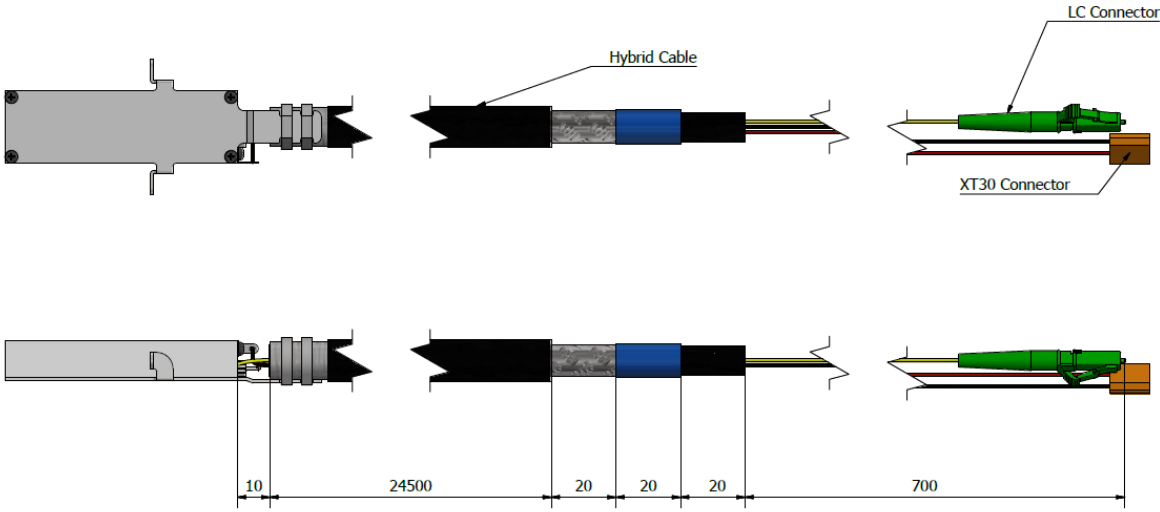
Figure 7: Hybrid cable part's dimensions.

11. Make sure that the different hybrid cable lengths are respected as shown in Figure 7.

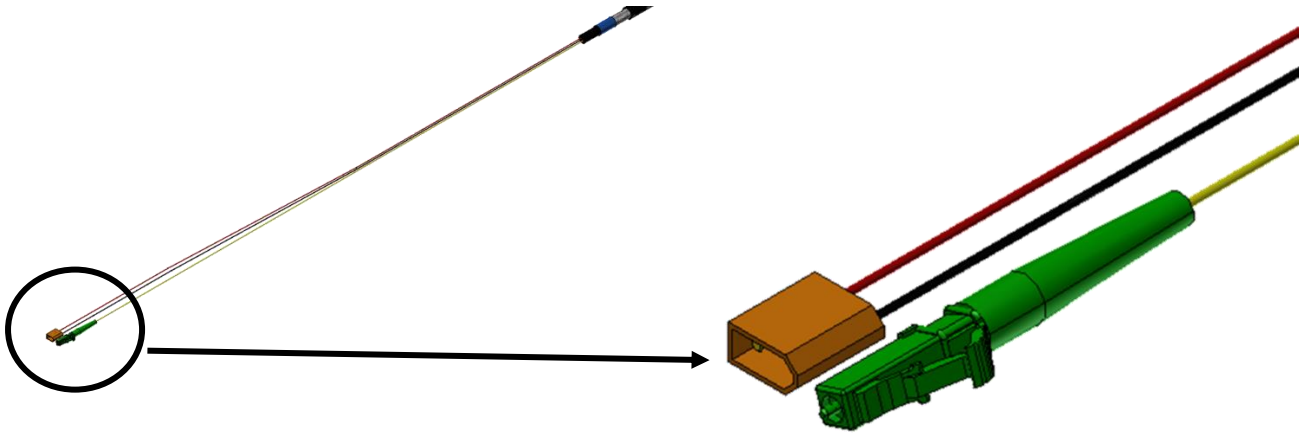
12. Weld the connectors and join an LC pigtail as shown in figure below.

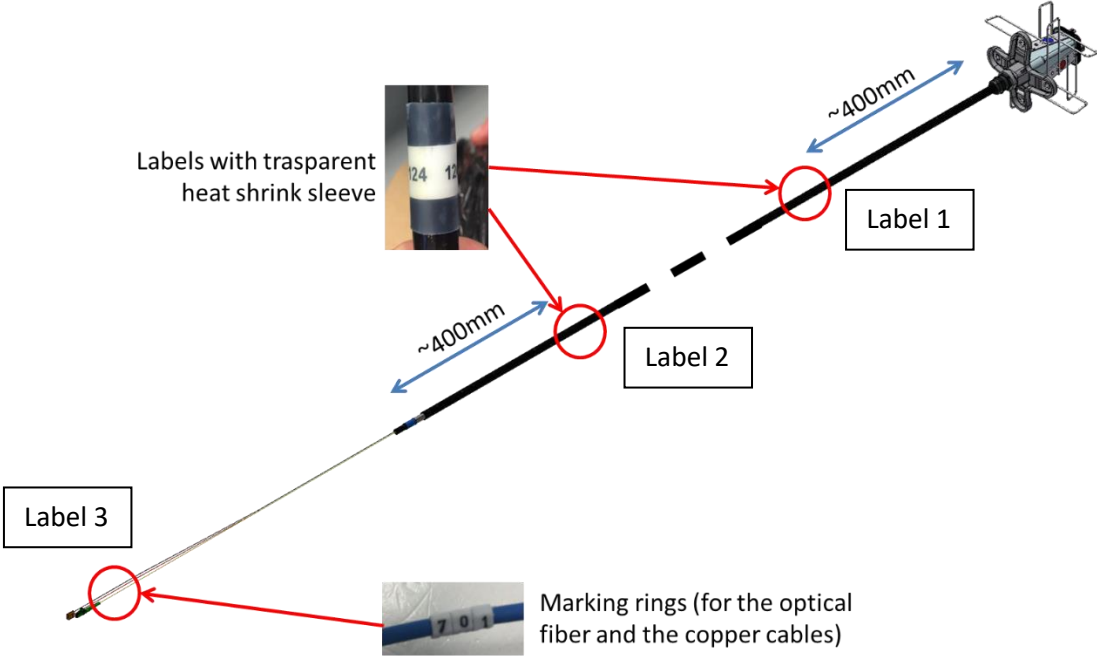
Figure 8: Hybrid cables label numbering.

13. Put the labels with the serial numbers, in the positions shown in Figure 8.

1. Labelling check: verification of the presence of the three labels on the HC showed in Figure 8 and matching the number with the FEM label (three digits in the red box in the Figure 9).

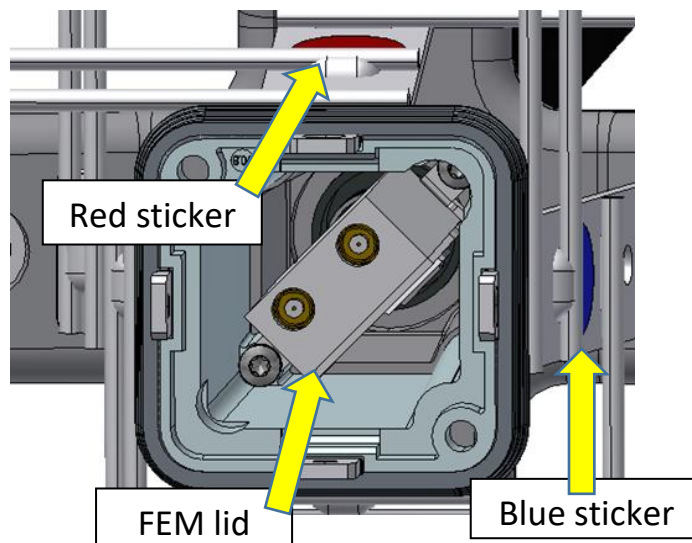
4. FEM orientation: verify the correct orientation of the optical module. The lid should be opposite to the RED sticker and facing the BLUE sticker.

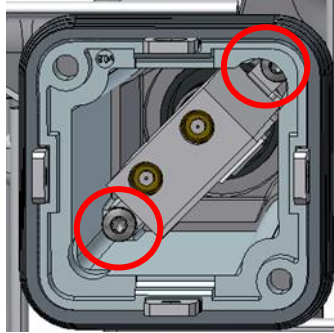
Figure 12: FEM's anchoring screws position inside the trumpet.

5. Tightening screws: verify the correct tightening of the screws indicated by the red circles in Figure 12.

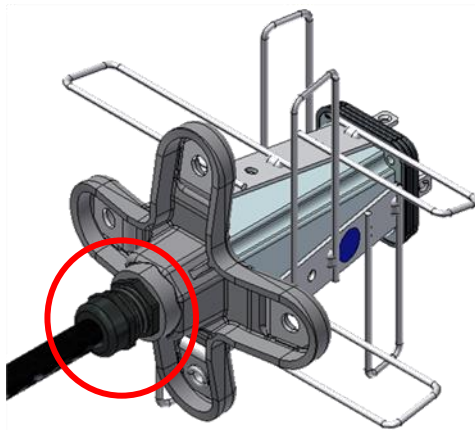
6. Cable gland tightening: check the tightening of the cable gland body on the trumpet and tightening the cable gland head on the HC (the HC must not rotate over the trumpet).

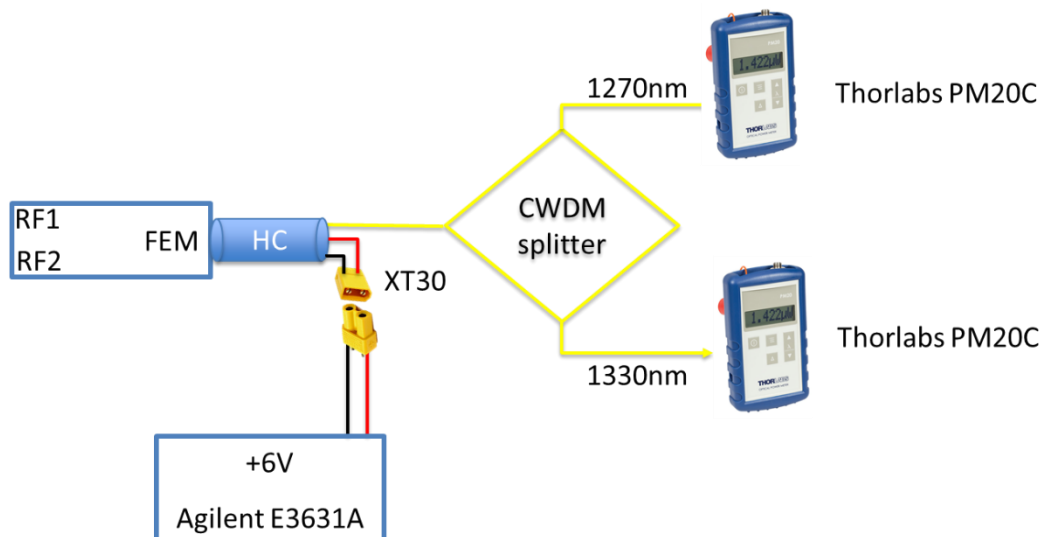
Figure 13: Bench test scheme.

Point 7 consist in evaluating the optical power emitted downstream the hybrid cable at two different wavelengths (1270 and 1330nm) using a CWDM splitter and two optical power meters Thorlabs PM20C. These values were compared to those measured during RX tests done before the hybrid cable reworking and some assumptions have been made to determine whether assembly problems have occurred (Fail) or not (Pass).

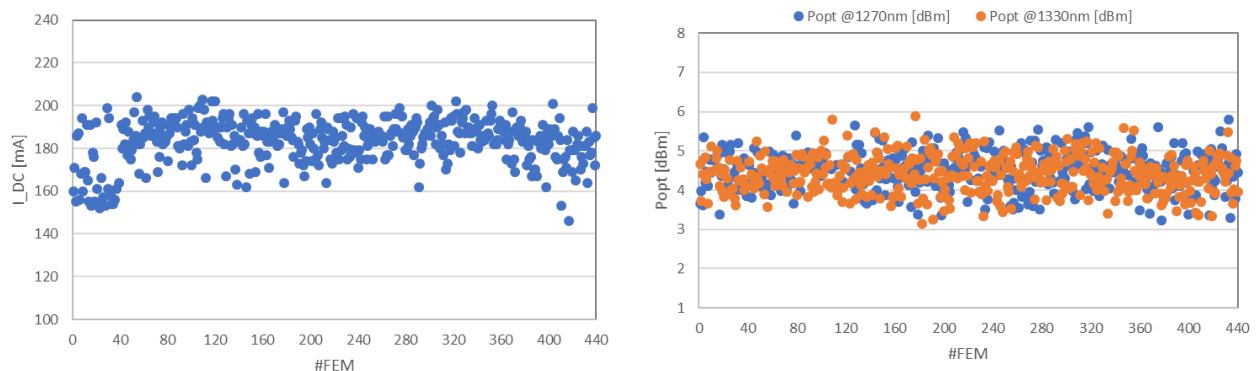
Figure 16: Measurement results.

From the measurements results could be noticed that optical power is reduced, and this is due to fiber stress and joints during HC reworking. Sometimes it was found that optical power was increased probably because when the measurement had previously been made the connector could have been dirty or not well made.

DC current could change because probably of the different temperature conditions and different time between the power on and the measurement, if compared to the measurements done before the reworking, which can cause an increase of consumption due to the thermalization of the internal components (i.e. gain block, laser diode). If the optical power and DC current consumption deviation from the pre-HC reworking measurements was reasonably limited (within a few tenths of optical dB and some mA) the test was considered Passed otherwise was Fail.

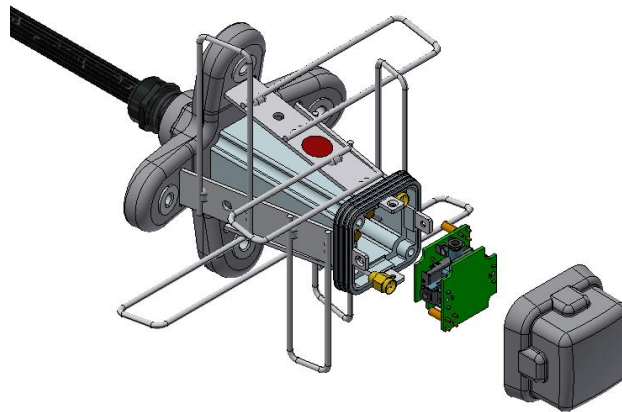
Figure 17: Pyramid hat and LNA removing.

1. Remove the trumpet hat unscrewing the two plastic screws. Remove the two LNA boards from the pyramid assembly unscrewing the four torx socket countersunk head cap screws and two SMA connectors.

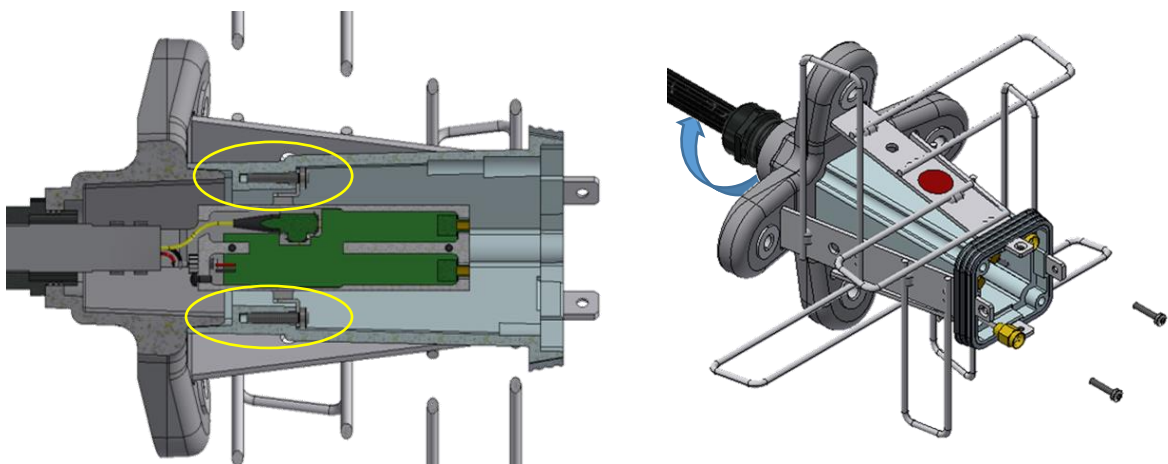
Figure 18: Torx screws positions (top) and cup nut loosening direction.

2. Unscrew the two torx socket pan head tapping screws that fix the optical transmitter to the trumpet body (a torx screwdriver is recommended) and then loose the cup nut of the cable gland.

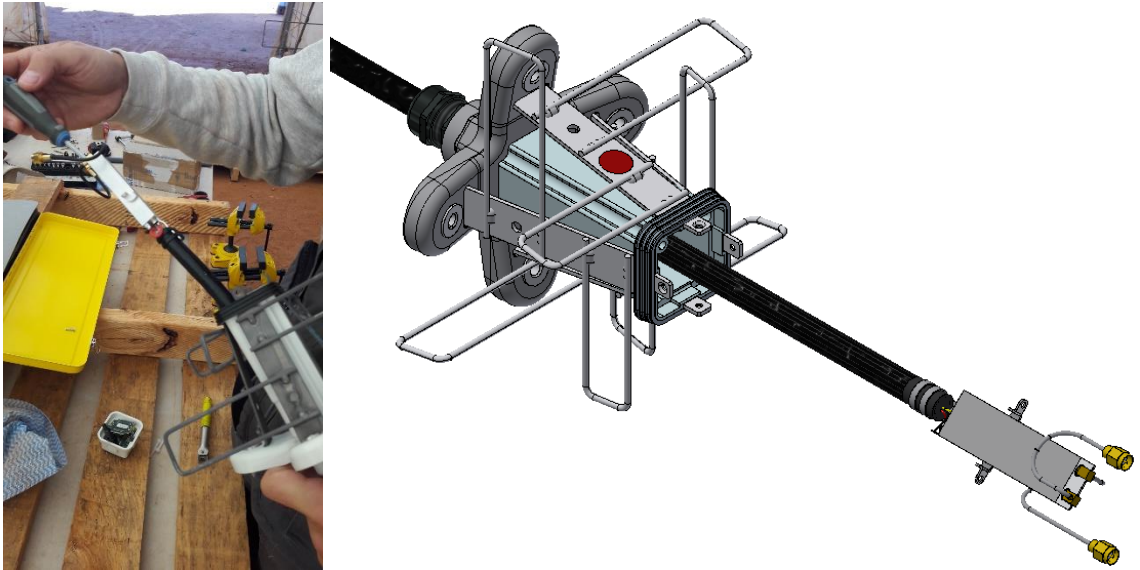
Figure 19: Optical transmitter displacement respect to the trumpet.

3. Push the transmitter out of the trumpet by acting on the cable 400 mm is enough.

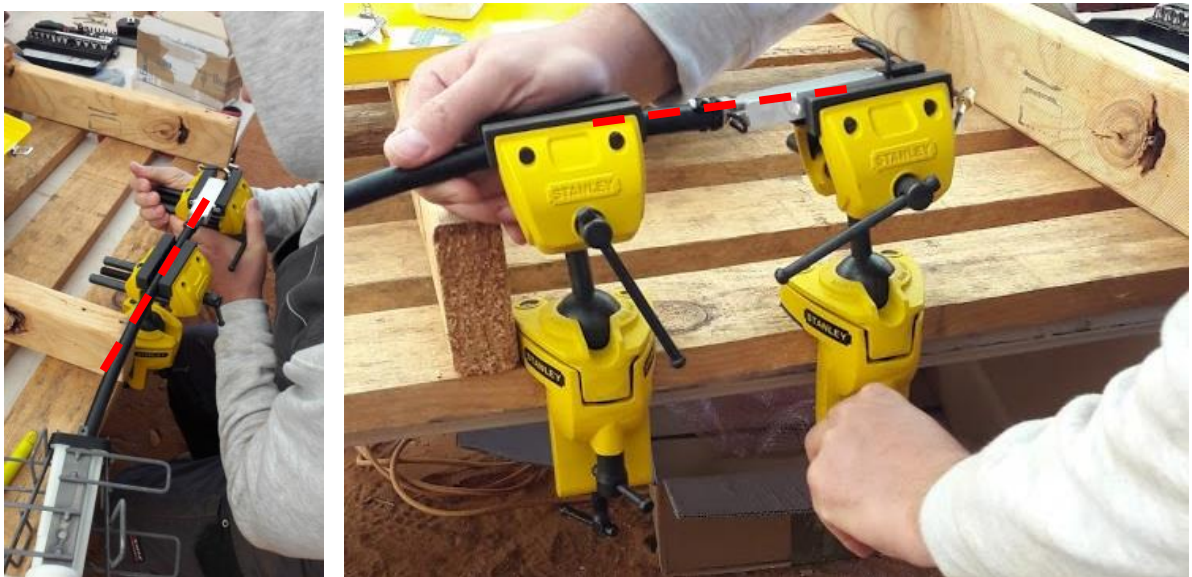
Figure 20: TX module and hybrid cable alignment.

4. Tight the transmitter module and the hybrid cable in two aligned clamps. The module and the cable must be well aligned.

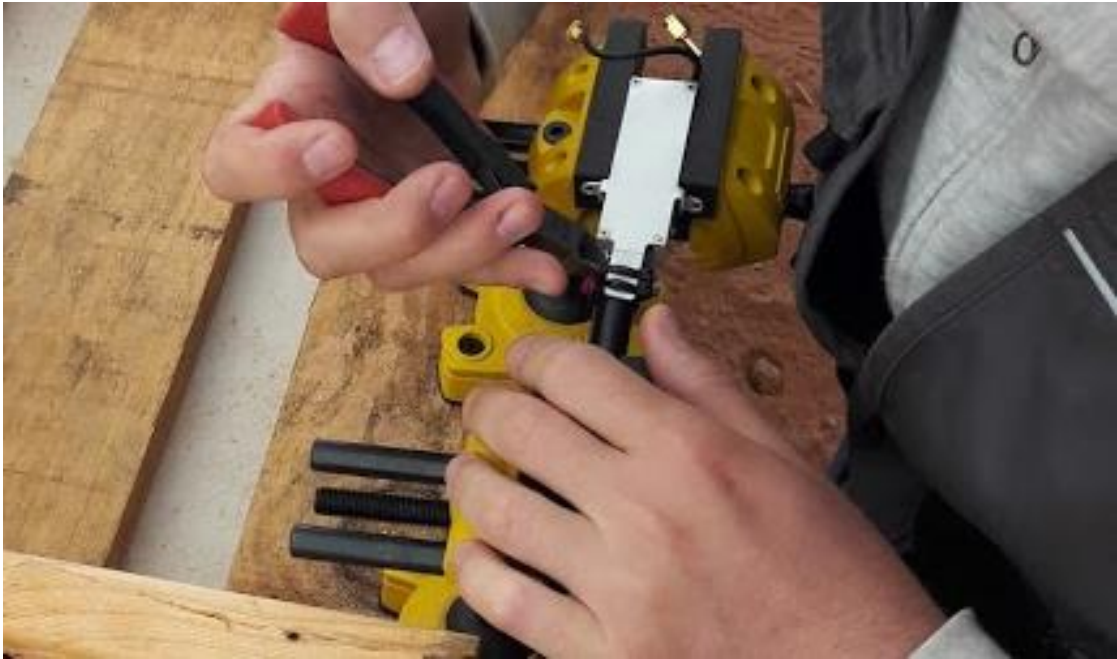
Figure 21: Cable ties cutting.

5. Cut the two cable ties. Make sure that the hybrid cable doesn't rotate in the clamp.

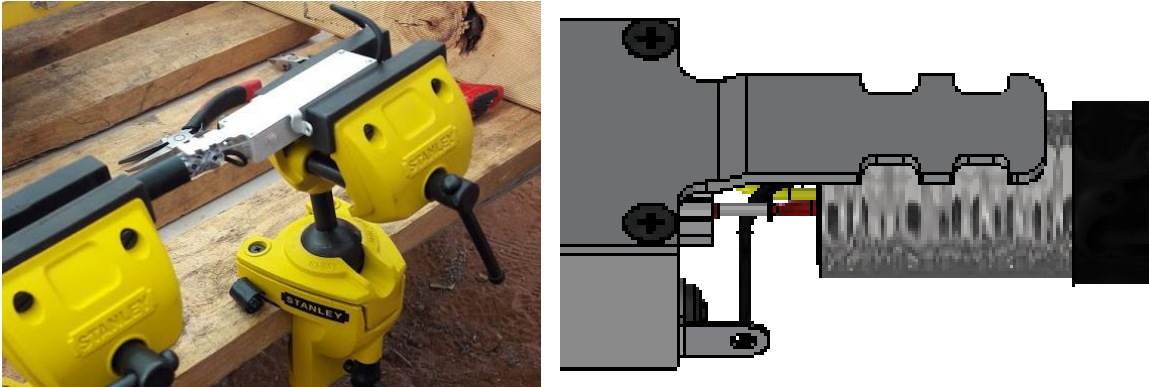
Figure 22: Outer jacket removing.

6. With a cutter remove the outer jacket of the hybrid cable close to the module cover, as indicated in the pictures. Be careful about the cover integrity.

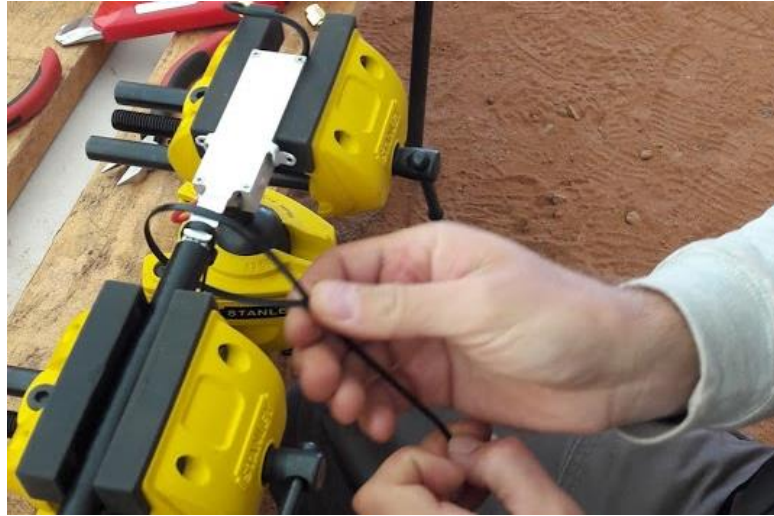
Figure 23: Cable ties tightening.

7. Tight two cable ties to connect the module to the hybrid cable. After that is possible to remove the assembly from the two clamps. Check if there are any short between the power lines.

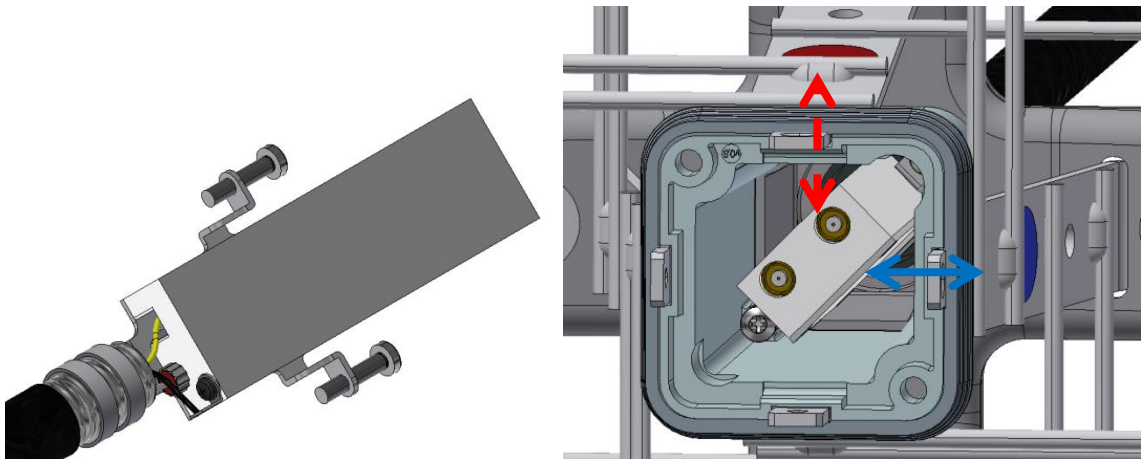
Figure 24: TX module fixing and orientation.

8. Place the two torx socket pan head tapping screws as shown in the figure, to simplify the connection of the module inside the trumpet. After that, by pulling the hybrid cable, insert the transmitter module into the trumpet and fix it screwing the two torx socket pan head tapping screws. There are two possible orientations of the module inside the trumpet. The right one is with the FE label faced towards the red dot and the FE cover to the blue dot. Then tight the cable gland nut.

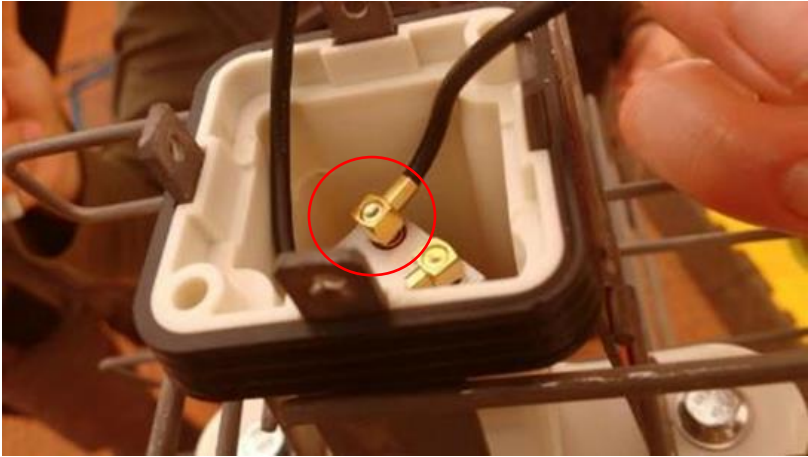
Figure 25: Connections check.

9. Check the connections of the coaxial cables with the MCX connectors of the FE module.

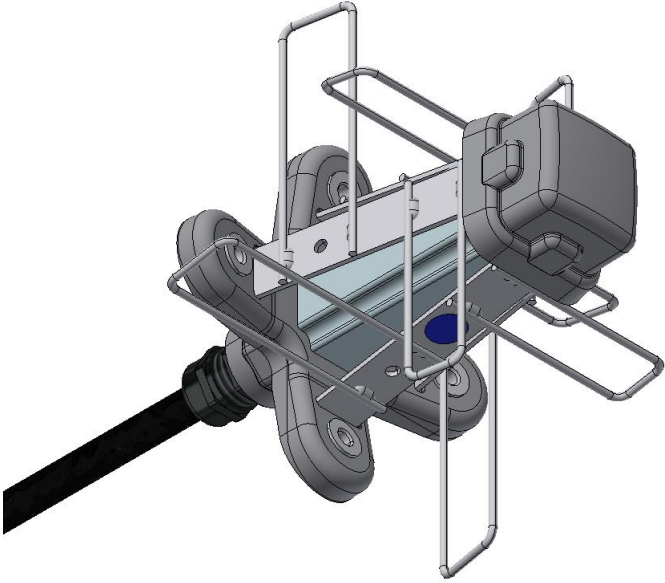
Figure 26: Pyramid assembled.

10. Re-install the two LNA boards and the trumpet hat.
