TITLE: **Current Drop Noise in RCA 23 FEM**

DOC. TYPE: **TECHNICAL NOTE**

PROJECT REF.: **PL-LFI-PST-TN-079** **PAGE:** I of IV, 7

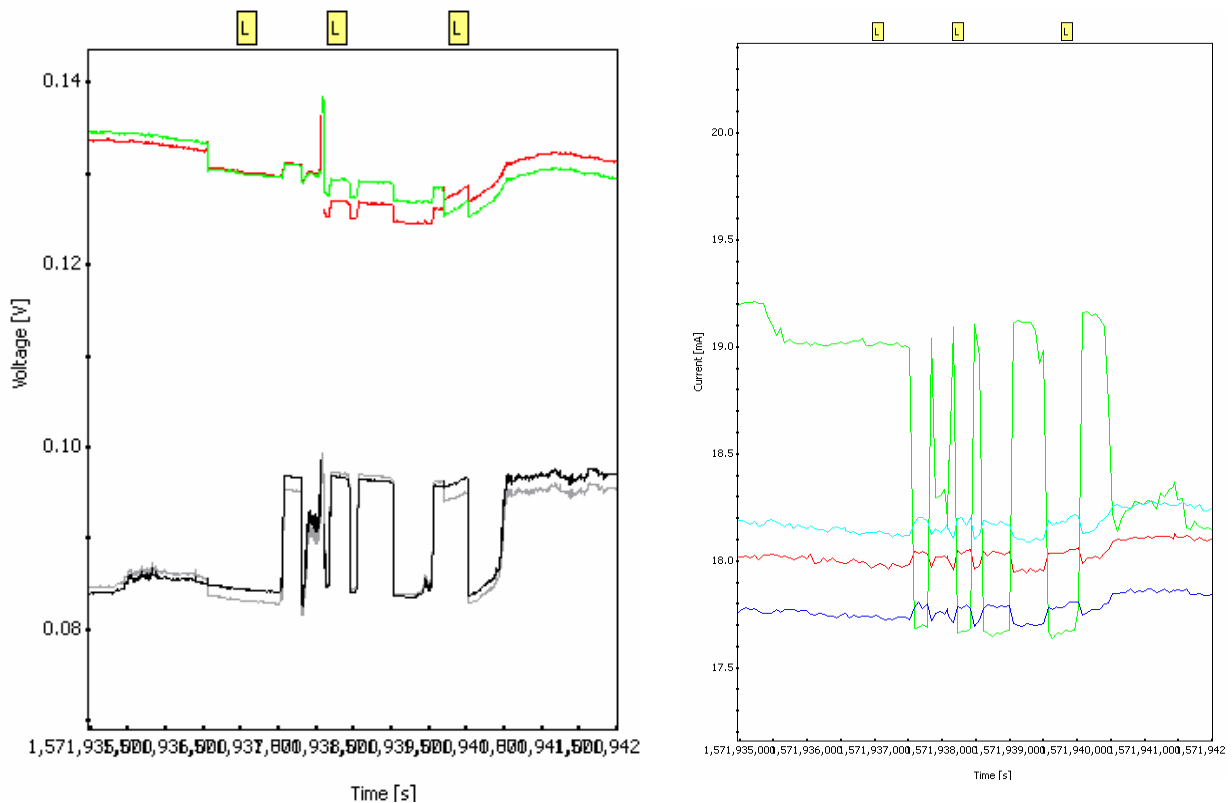
Fig. 1. RCA23 Burst Noise AMB_0114

a) Scientific Output (Volt)

b) I drain (mA) DAE HK

In the above figure the output from the detector R1D1 (in gray) and the output from the detector R0D0 (In red and green) are shown. A quite high “Burst Noise like” is visible in both outputs where no changes in LFI configuration were expected.

Looking at I drain current values (fig 1 b) from the House Keeping it is quite evident that the current of the LNA associated to S1 is changing within three different values (*high low* and *middle* values). The change in the S1 is somehow reflected in the currents of the others LNA and this is also visible in voltage output. The order of magnitude of the current changes is about 1.5mA (peak to peak).

The feature is visible for 1 hour and the I drain of S1 stabilize at a *middle* value. In this configuration the change in percentage of the current respect to WFT test that is our reference point is more than 5%, while at the beginning of the test when the current was in his *higher* state the difference respect to WFT was lower than 0.8%. The current remains in this *middle* values all along the test until the end.

The first time the feature appears in AMB_0113 at the 14:09:06 just when the LUT of the SCS were uploaded via TC, anyway there is no direct connection between the two event because the LUT were uploaded also at 9:44:52 and no feature was visible at that time.

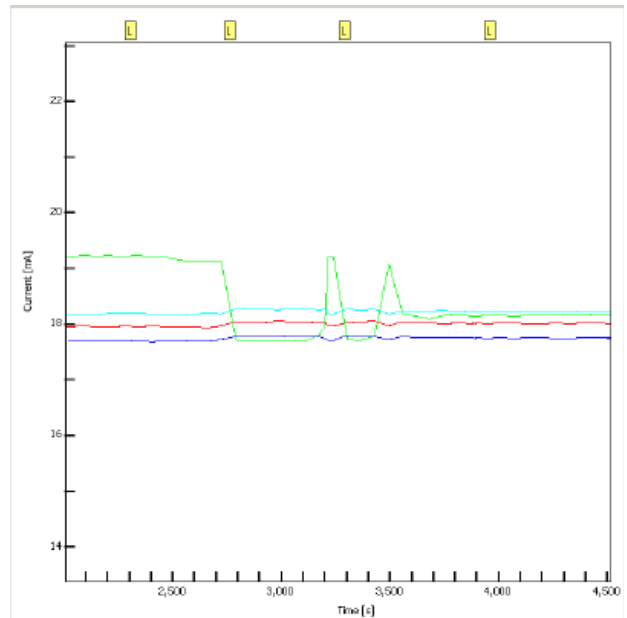
a) Scientific Output (Volt)

b) I drain (mA) DAE HK

The above picture refers to data collected during FM test AMB_0090 [RD01]. It is visible the current noise of the same order of magnitude of the one found in system level, $\sim 1.5\text{mA}$. The Burst noise was found before and after the FM calibration in cryogenic condition and a NCR was open at that time to keep trace of the unexpected behaviour.
