BC-SIM-IAPSUPA-TR-001
HRIC NECP report

The present document has been issued with the aim of describing the NECP (Near Earth Commissioning Phase) Tests of HRIC.

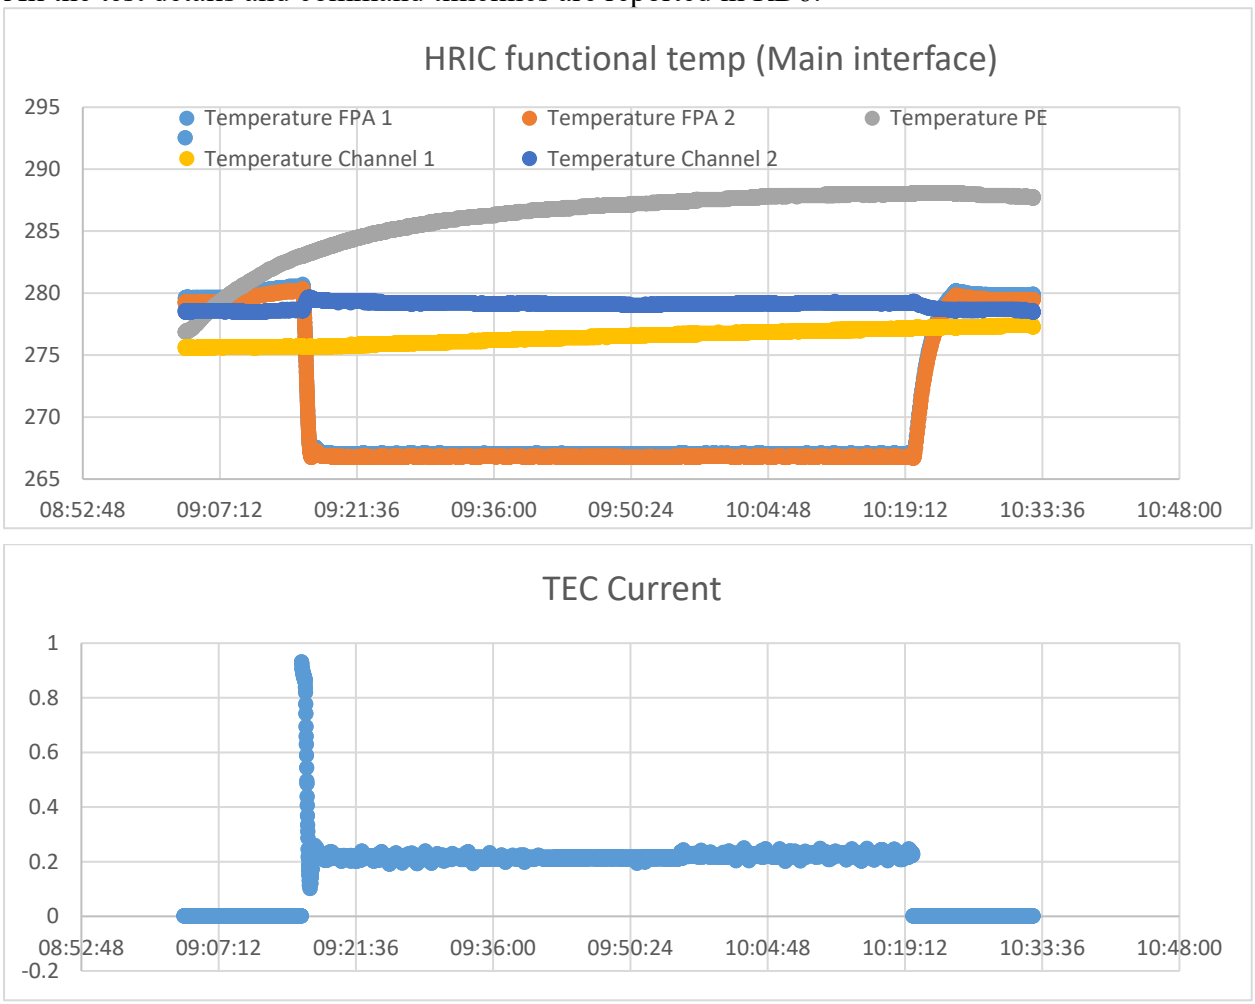
Figure 2 Temperatures and Tec Current sensors for the first day of the functional test main of NECP.

The diagram of Figure 2, shows the trends of the HK related to the temperatures (upper panel) and TEC current (lower panel) during the functional test of HRIC. The temperatures trends show expected behaviour: since the PE power on, PE temperature start to grow up reaching at the end of the test a maximum value of about 287 K. The temperature sensors linked to the detector show a trend connected to the operations: the temperatures after the switch on of the TEC drops down to the setting point. The Temperature Channel 2 that is connected to the external case of the FPA show a trend linked to the TEC and FPA activation with a small temperature increase. The Temperature channel 1 shows a small increasing trend from the beginning of the test: the increase of the temperature during the test is less than 1 °C.

The current of the TEC (lower panel) shows a peak at the switch on: this is due to the small temperature difference between the commanded set point and the actual temperature of the FPA at the switch on and

due to wrong parameters values for the TEC used. In Fact, the bad parameters for the soft start of the TEC were not able to limit the current to the device. This error was checked by the team in the following test.

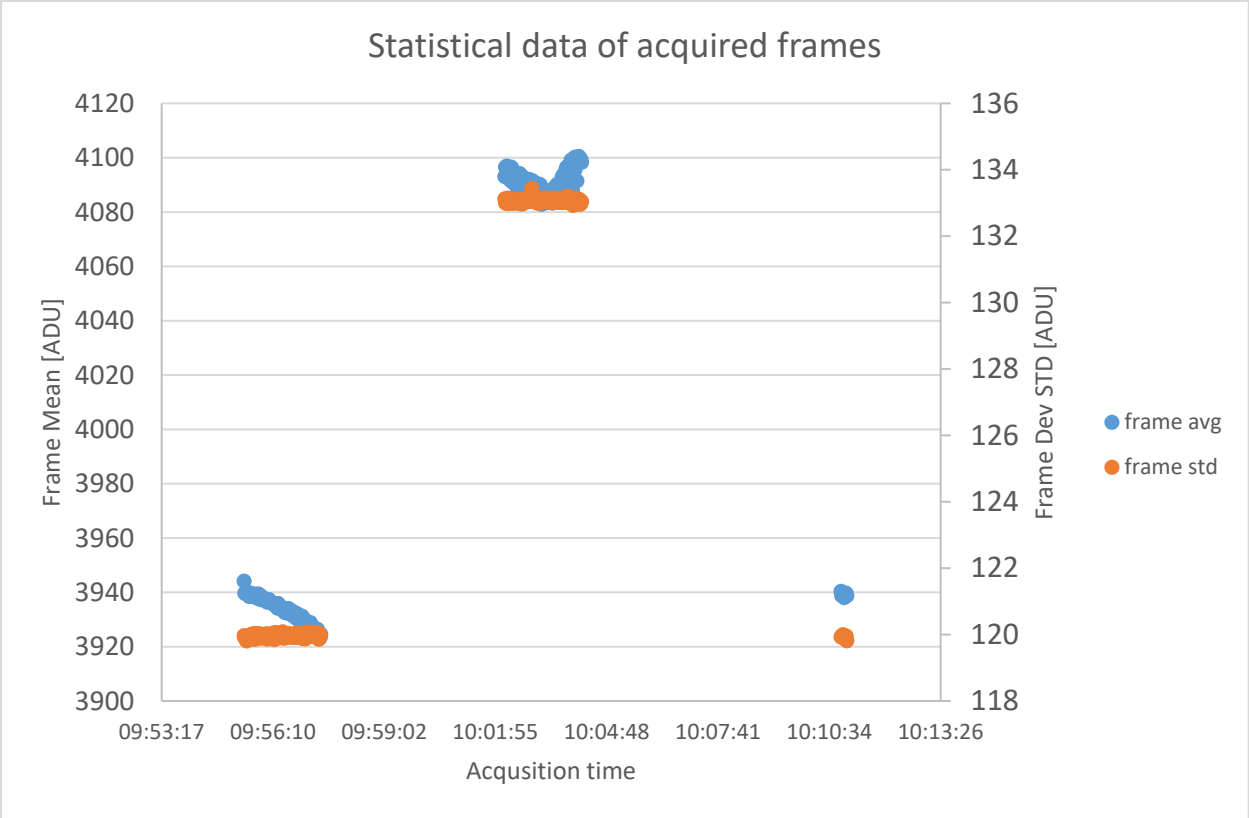
Figure 3 In the plot are reported the average and the standard deviation over the whole frame for the pixel readings. The frames have been acquired in three steps changing the integration time: a) short integration time .000038 s; b) long integration time 0.3148 s; c) short integration time 0.000038 s.

The analysis of the frames acquired during the functional test show that the signals read from the detector are compatible with the values characterized during the on-ground calibrations. Average Signal Level and Standard deviation measured on the frames are compatibles with the same parameters acquired in similar conditions during the calibration campaign.

For both the measurements at short integration times and long integrations times the average values show small (in amplitude) trends. These do not show any simple correlation with the housekeeping parameters. Further investigation are ongoing to explain the observed trends.

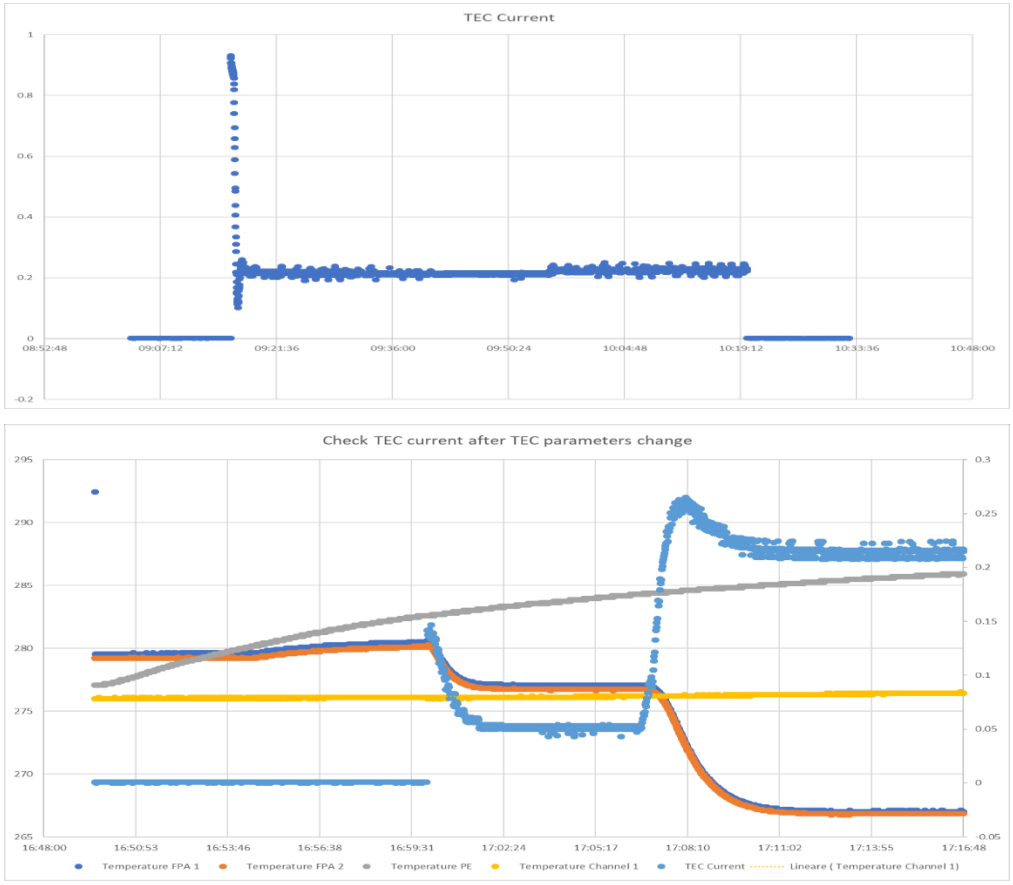
Figure 4 TEC current and Temperatures trends obtained before (upper panel) and after (lower panel) the correction of the TEC parameters. With the correct values for the parameters the TEC current trend (blue dots on the lower panel) show the soft start as expected. In the plot the current trend show two different steps: this is because the TEC set point was changed during the test, as evident by the Temperature trends.

In **Figure 4** are reported the current Trends for the TEC and the FPA temperatures. In the Upper panel the behavior observed during the functional test with the high current peak at the switch-on of the TEC. In the lower panel the TEC behavior after setting the right parameters for the TEC: at the first switch-on of the TEC the current raise at about 0.1A (much lower than the safe limit for the device). When the FPA Temperature was set to the nominal values the TEC current raise slowly within several second, after a small overshot the current reach a safe value of about 0.2 A when the FPA temperature reached the set point.

In order to check the TEC soft-start and the parameters settings, during the first day of the NECP a dedicated, un-foreseen, test session was setup. During this test, the TEC parameters were set as reported in the relevant section of RD1. To avoid any over-stress of the device and consequently also for the FPA the test was setup in the safest way: a first activation of the TEC with a very small

difference between the actual value and the set point for the FPA temperature, and a second step with the nominal Temperature set point for the FPA.

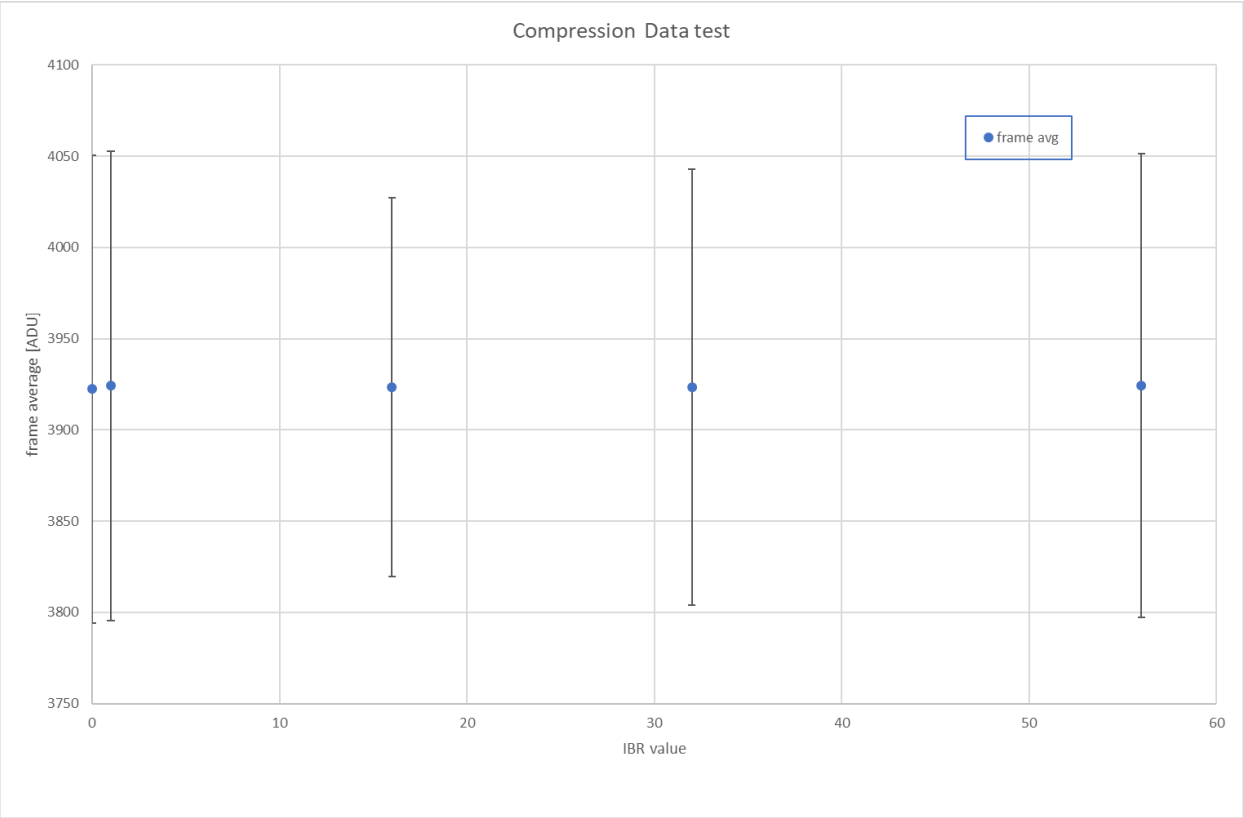
Figure 5 Frame Average and standard deviation (reported as error bars) for acquisitions with same integration times.

During this test the same detector was acquired using the same integration time (96ms) and 5 different values of the compression (ibr=0,1,16,32,56 corresponding to compression levels: bit packing, lossless, 14, 7, 3.5). The differences between the acquisition considering the average and the standard deviation on the pixel values are negligible for the acquired scene (almost uniform dark image).

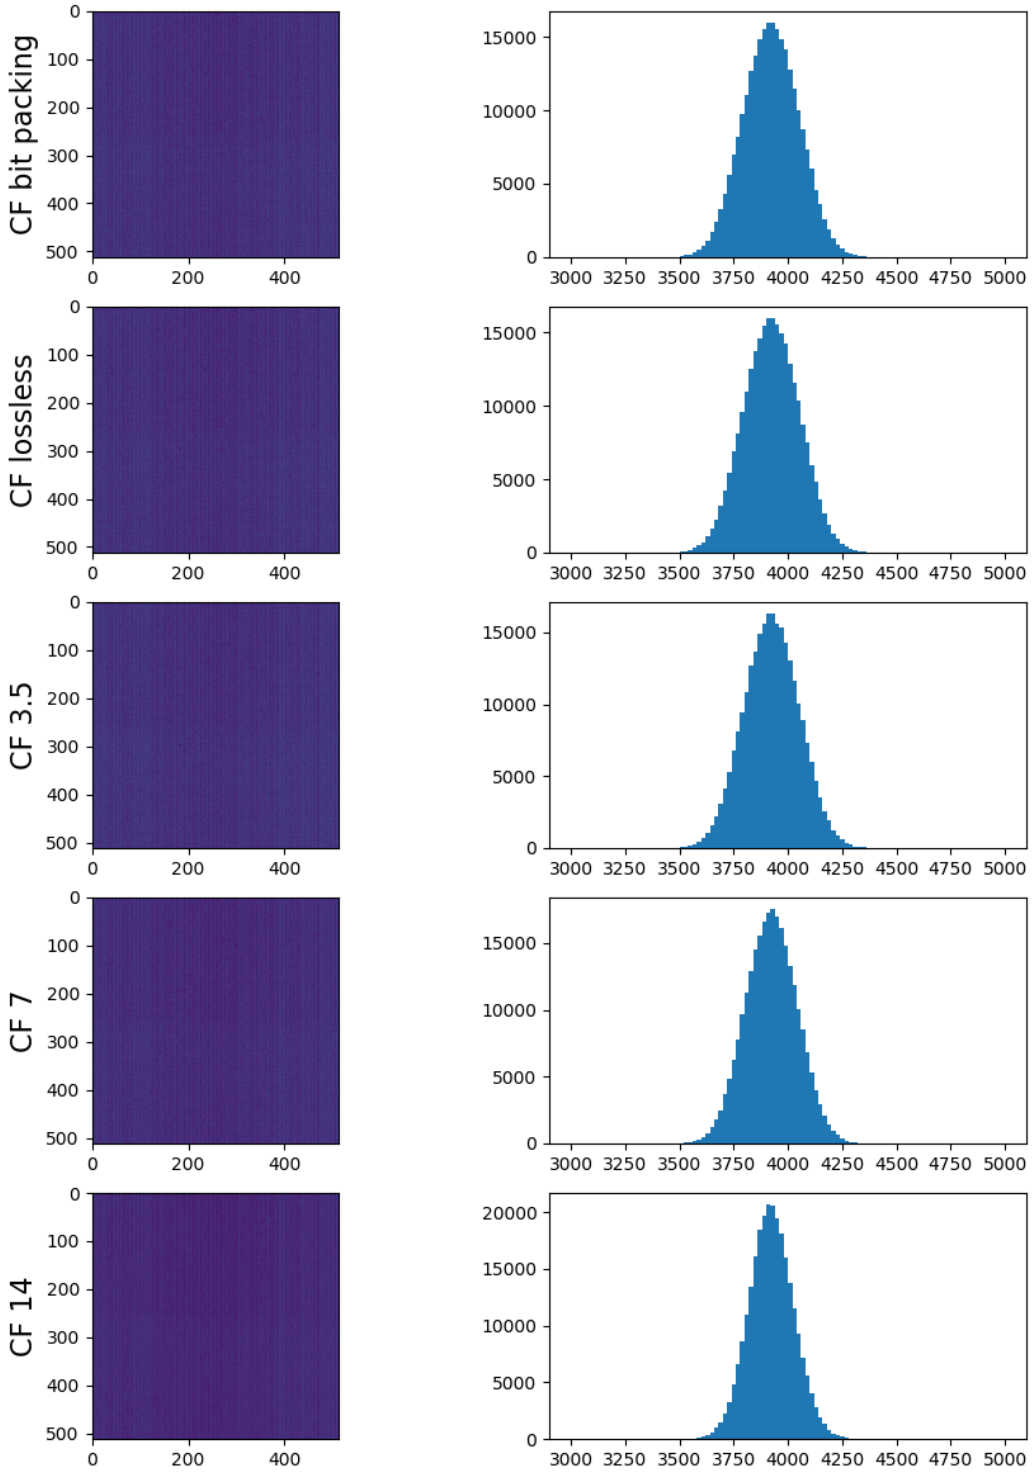
Figure 6 Frame acquired (left column) and the corresponding Histograms of the pixel values (right column) for 5 different compression level.

Considering the Frames and the pixel values histograms as expected the distribution of the pixel values is less disperse as the compression factor increases. In fact, the effect of applying an increasing compression factor results in the removal of high frequency variation in the pixels.

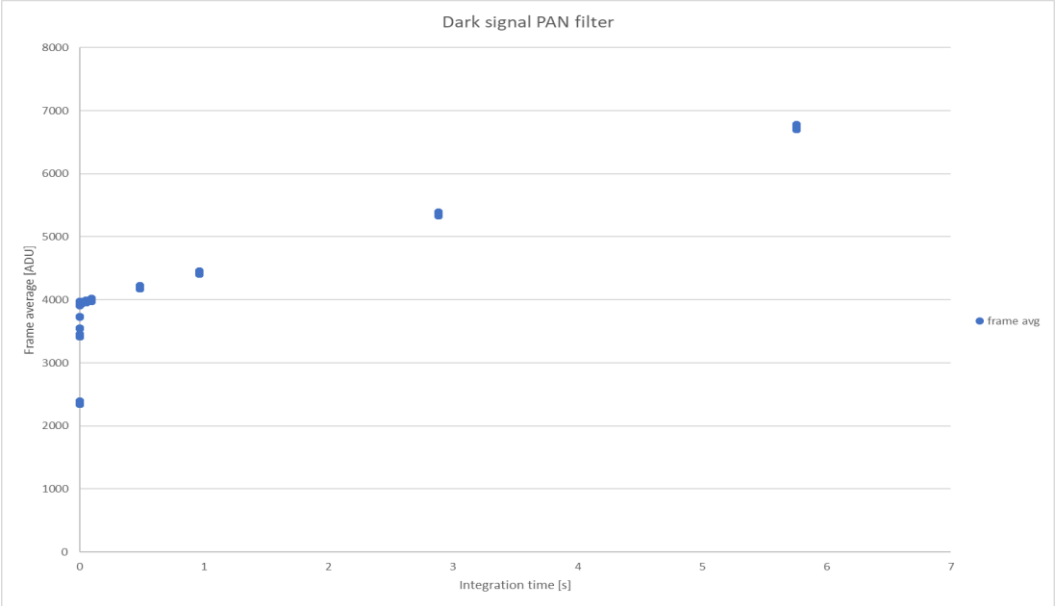
During Dark test/measurement the areas of the detector corresponding to the Panchromatic, and to the three Broad Band filters have been acquired with different integration times starting from the minimal (400 nano-seconds in the configuration used for the ROIC) up to about 6 seconds. The values of the average of the acquired frames are reported in **Figure 7** and **Figure 8**. The trend shown in the plot is compatibles with the trends measured during the calibration campaign on ground and reported in RD7.

Figure 7 Average of the pixel values over the frames acquired during the DARK test. In the plot are reported the values of the average of the frame for the Panchromatic filter.

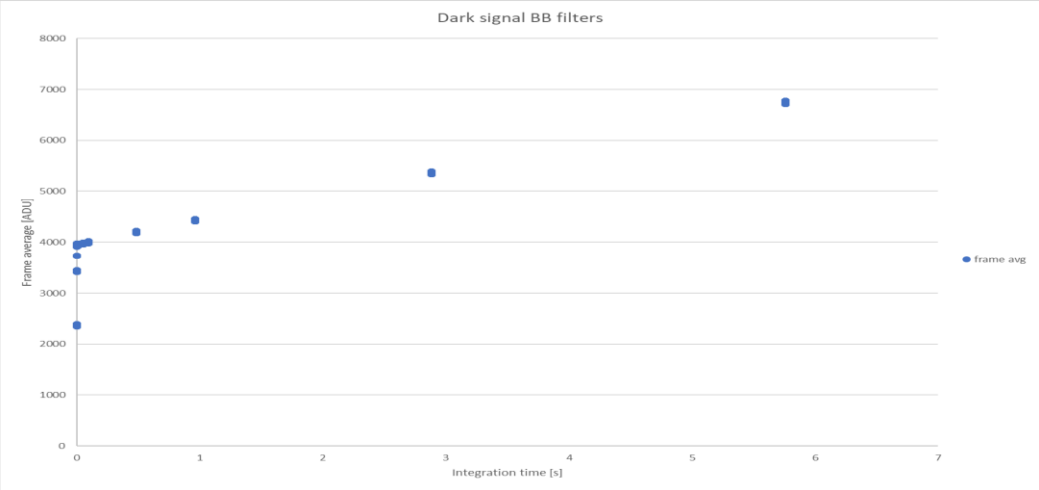
Figure 8 Average of the pixel values over the frames acquired during the DARK test. In the plot are reported the values of the average of the frame for the BroadBand filters.

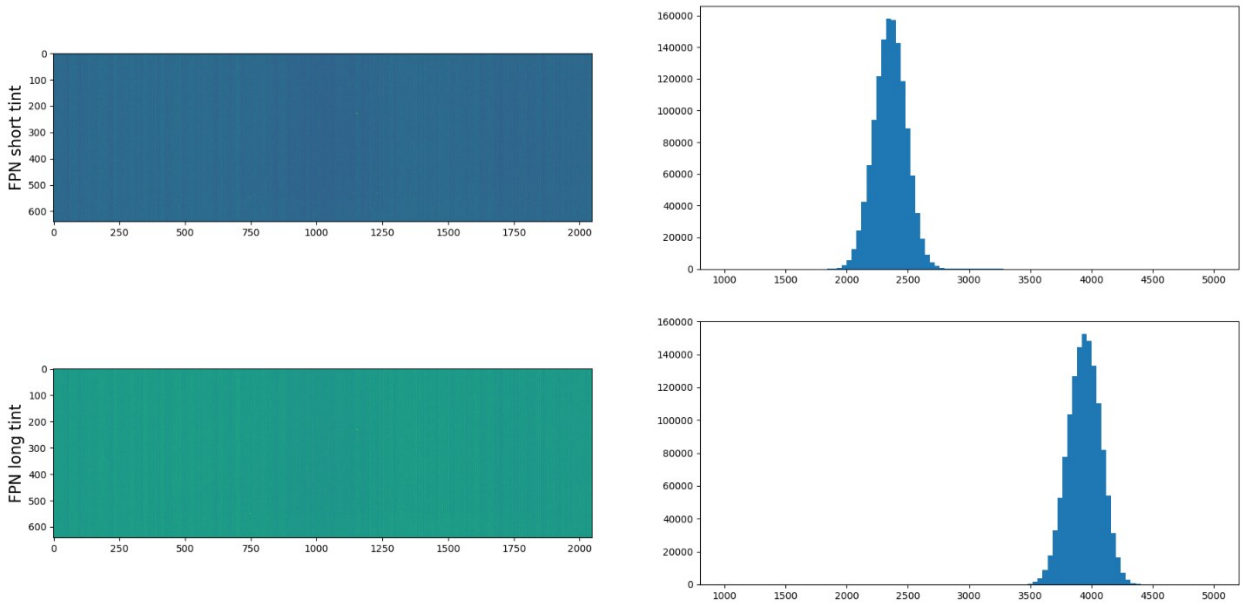
Using the data collected during the DARK measurements also the FPN and the RON of the detector have been checked w.r.t the values obtained during the calibration campaign. The values obtained for both FPN and RON are in good agreement with the values obtained in RD7 (**Figure 9** and **Figure 10**).

Figure 9 FPN frame at short time (average of 10 acquisition at minimum integration time (upper panel) and 48 microseconds (lower panel).

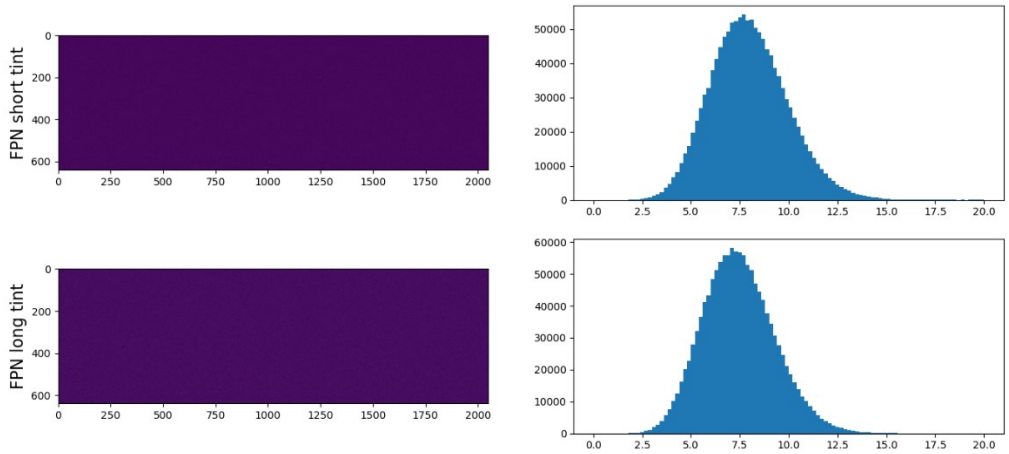
Figure 10 RON frame at short time (average of 10 acquisition at minimum integration time (upper panel) and 48 microseconds (lower panel).

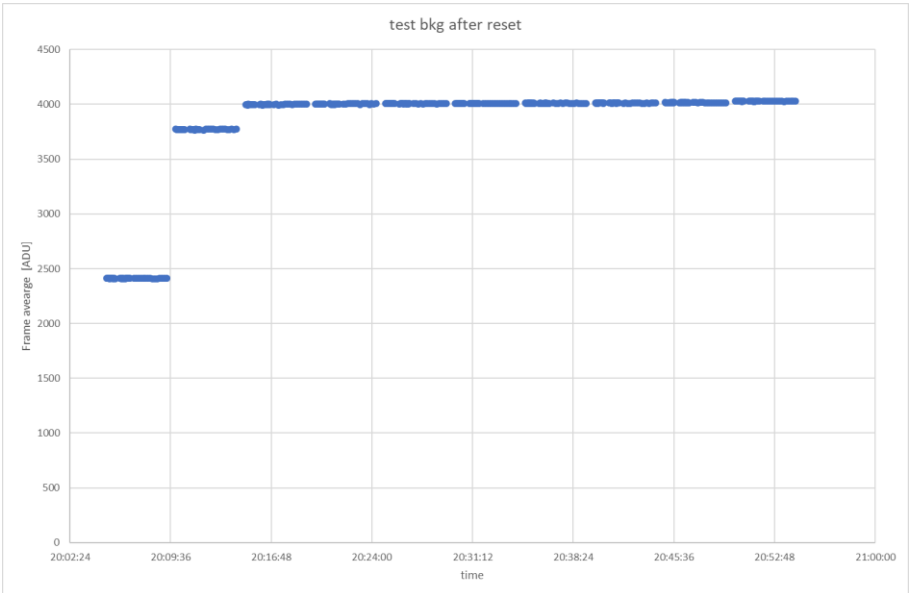
In order to check if is present an issue of charge accumulation on the pixels between 2 resets without image acquisition, several frames have been acquired with different integration times and delays between the frames. The average of the frames pixels values is plotted in **Figure 11** w.r.t. the acquisition time. The values during the sequence of acquisition are quite stable the only difference between the series is due to the DARK behaviour. As checked before the launch no reset issue is present on the HRIC detector (within the RON of the detector).

Figure 11 Value of the average of the pixel values obtained in the frame acquired to check the behaviour of the detector pixels reset after acquisition.

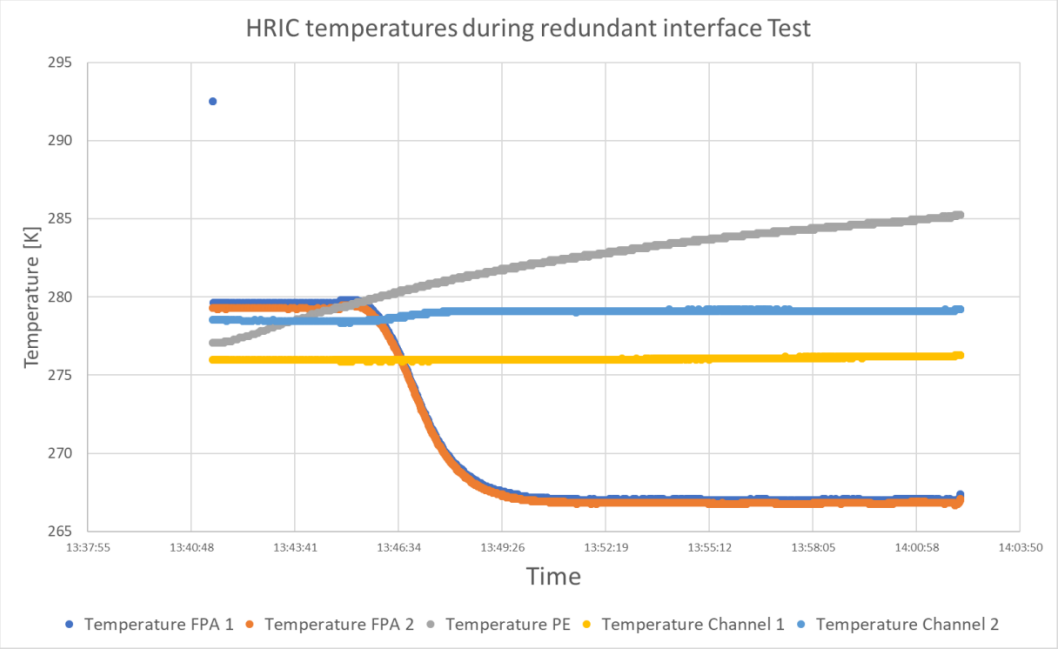
The functional tests on the redundant interface were a subset of the tests performed on the main interface: only a reduced number of images have been acquired. In **Figure 12** are reported the temperature trends during the test. All the trends are nominal, in this case the thermometer on the TIRD did not show any trend coupled with the PE temperature, probably because of the short duration of the test, in any case this behaviour will be checked in the next check-out of the instrument. The TEC current behaviour is nominal (**Figure 13**). The statistical analysis of the acquired frame didn't show any trend and the behaviour is nominal (**Figure 14**).

Figure 12 HRIC Temperature trends during the functional tests on the redundant interface.

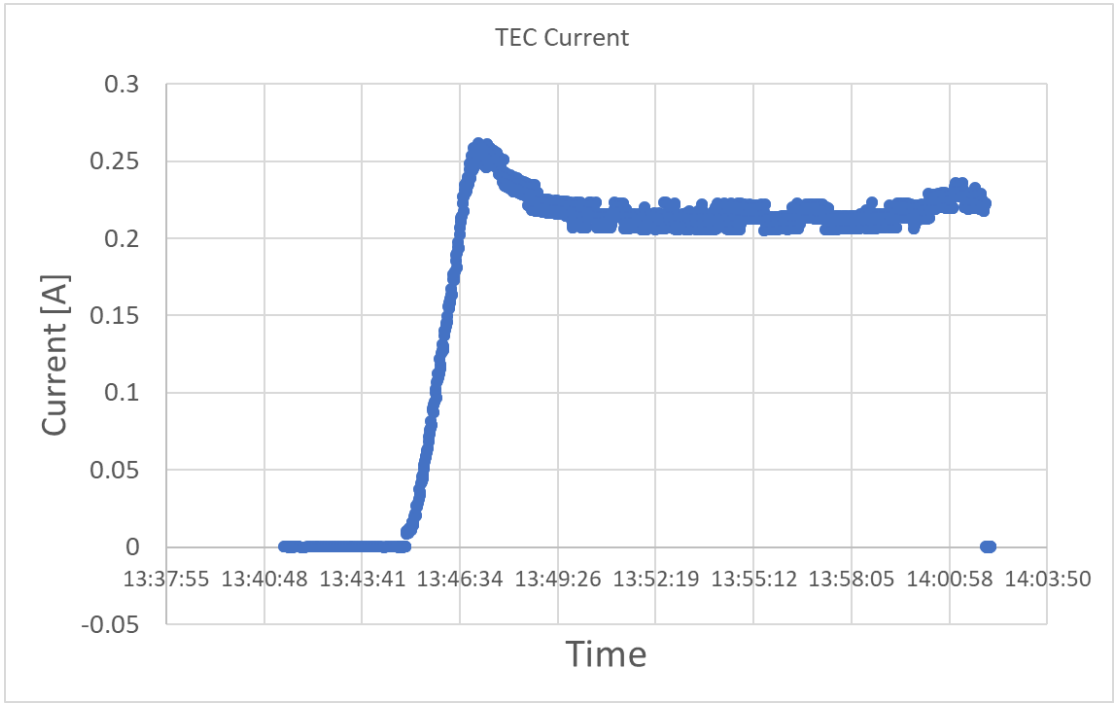
Figure 13 TEC current trend during the Redundant interface switch on of HRIC.

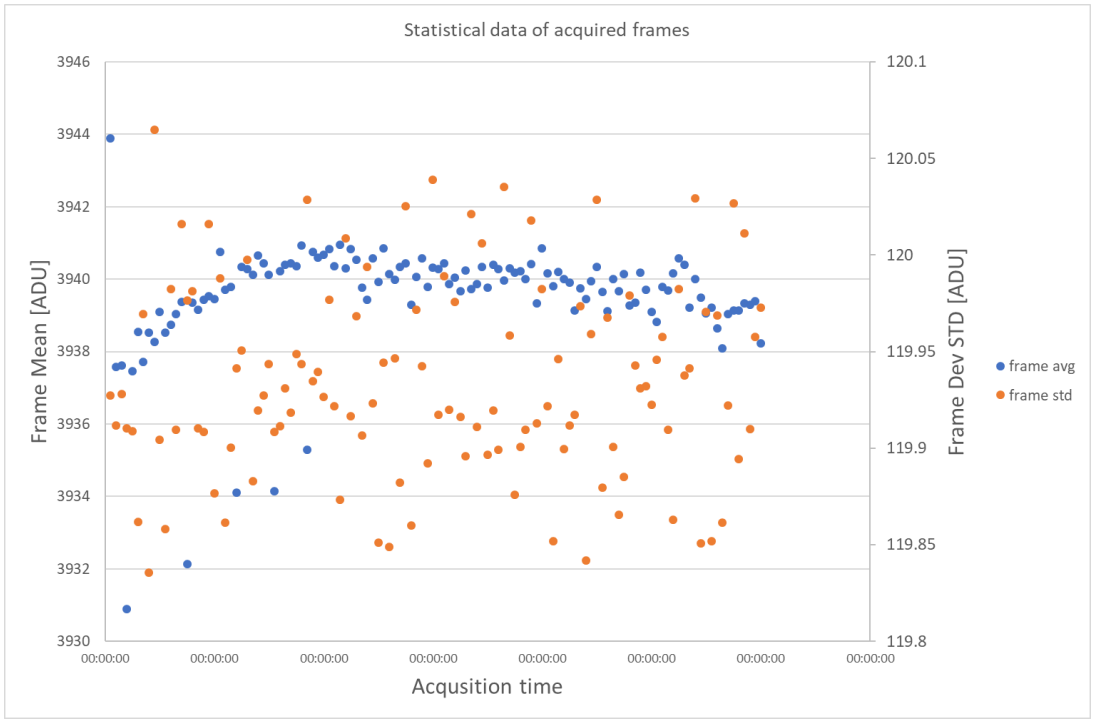
Figure 14 Averages and standard deviations of the frames acquired by HRIC during the functional test on the redundant interface.
