Test report of NISP dedicated test activities during the CSL campaign

Ref : EUCL-IBO-TR-7-007
Issue : 1.0
Date: 09/06/2021
Page: 1/37

TITLE:	Test Report of NISP dedicated test activities during the CSL campaign - DCU-SCE Communication issue		
Date:	09/06/2021	Issue:	1.0
Reference:	EUCL-IBO-TR-7-007		
Custodian:	Eduardo Medinaceli

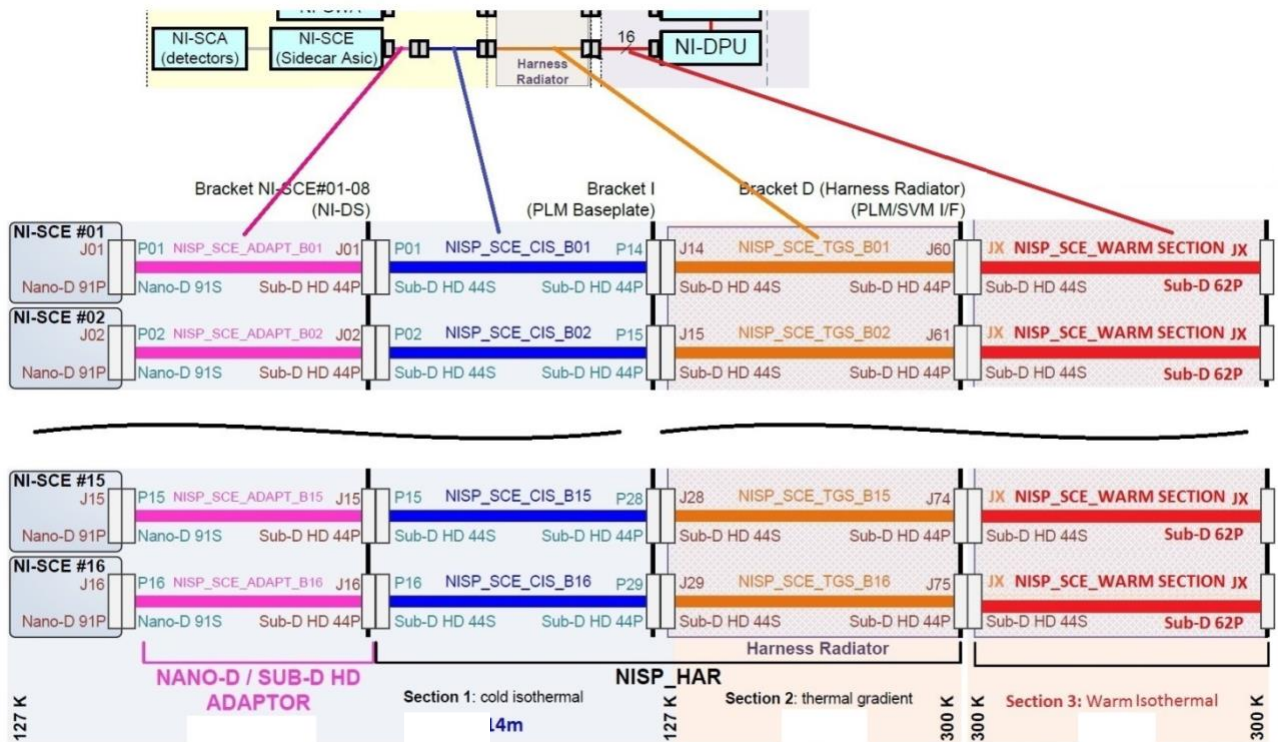
NISP is configured in the nominal Flight setup using a dedicated 3m extension (in addition to the nominal 5.5m long) of the harnesses (DCU-SCE). The NI harness is composed by three sections to thermally isolate the focal plane from the warm electronics (“hot”- “thermal gradient” – “cold”); the extension is added in the “hot” section-warm isothermal, the harness is mainly made by copper wires, only the Thermal Gradient part is made by PhBr, for all the detectors.

The 3m extension cable added to Section 3 – warm isothermal is not shown in the scheme above

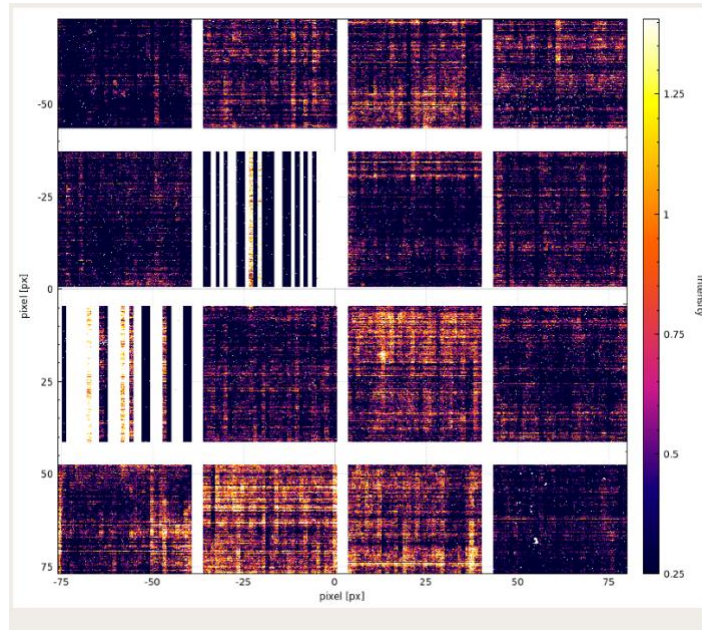
Then, during the second test run an artifact was seen only in detector SCS#31 (detector SCS#22 was recovered from the image quality point of view) as shown below.

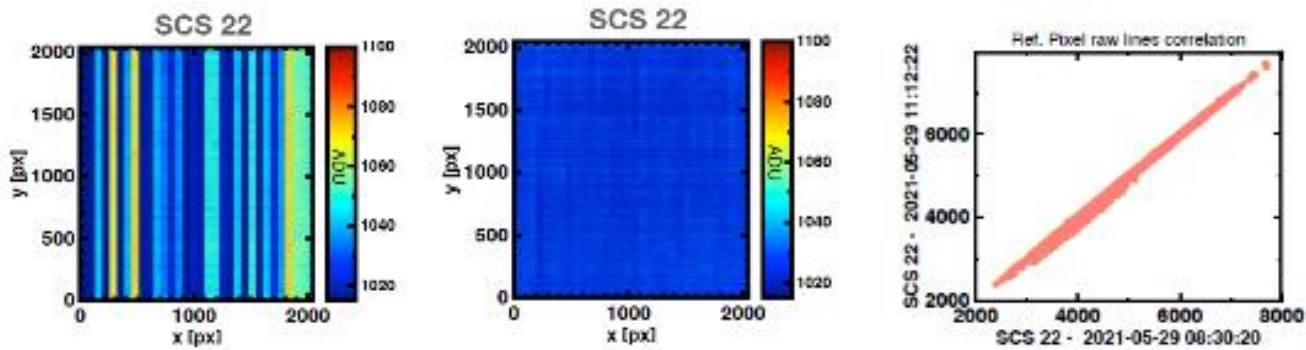
Reference pixels signal from raw lines comparison

the same figure is plotted the comparison of reference pixels signal from raw lines showing the expected correlation (same values).

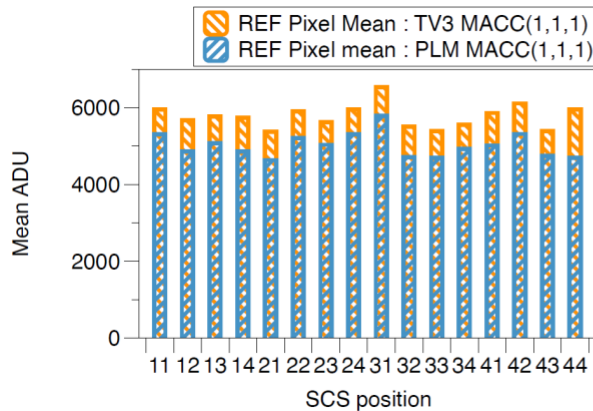
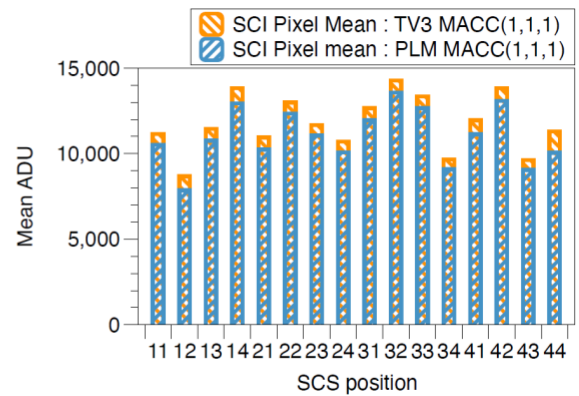
Also, the baseline was verified and found compatible with TV3 (considering the Temperature differences – slightly hotter than TV3 ~ 3K at SCA level); the following histograms shows the comparison between PLM and TV3 baselines, on the left for the reference pixels, while on the right for science pixels.

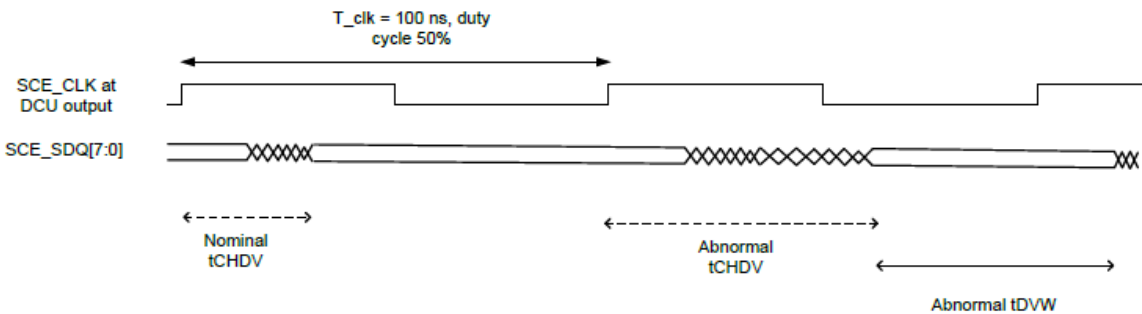
Figure 6-6: SIDECAR science IF abnormal waveform model

The communication uses a parallel interface with two FIFOs sampling asynchronously with a delay of 50ns between them. SCE clock is 10 MHz (100 ns).
