Test report of NISP dedicated test activities during the CSL campaign

Ref : EUCL-IBO-TR-7-007
Issue : 1.0
Date: 09/06/2021
Page: 1/37

TITLE:	Test Report of NISP dedicated test activities during the CSL campaign - DCU-SCE Communication issue		
Date:	09/06/2021	Issue:	1.0
Reference:	EUCL-IBO-TR-7-007		
Custodian:	Eduardo Medinaceli

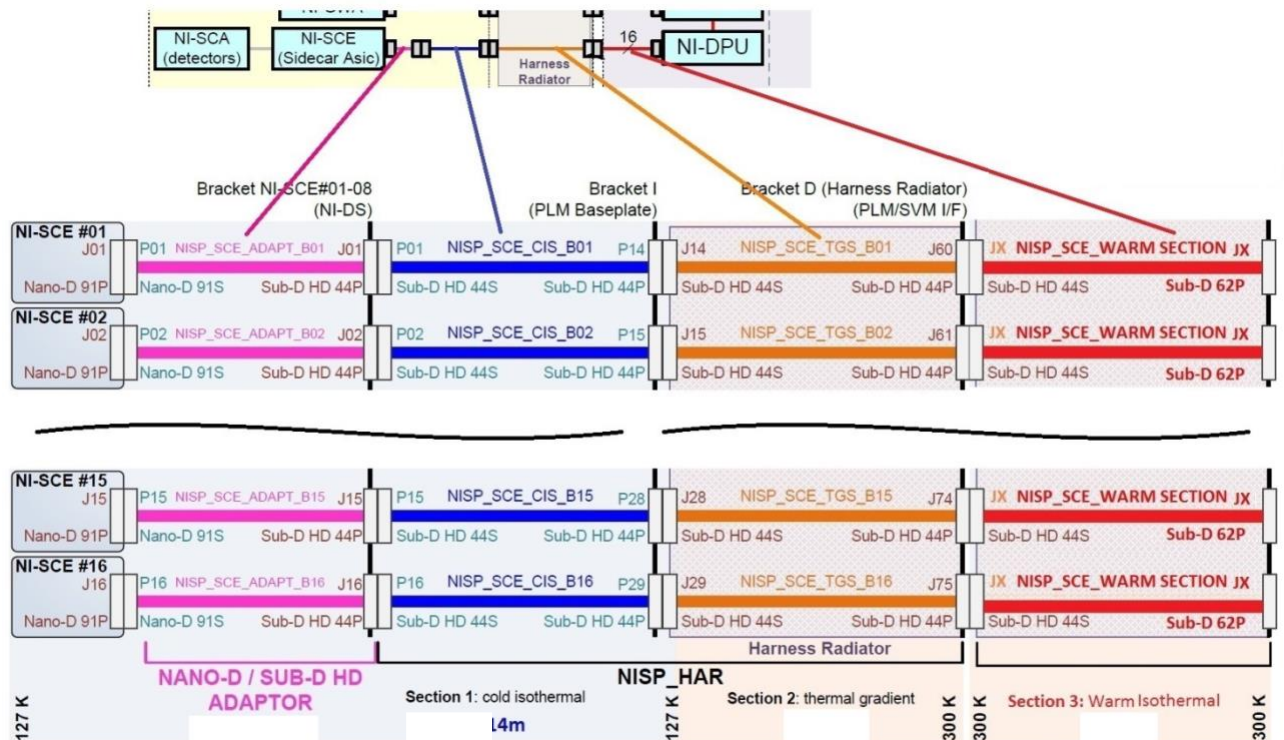
NISP is configured in the nominal Flight setup using a dedicated 3m extension (in addition to the nominal 5.5m long) of the harnesses (DCU-SCE). The NI harness is composed by three sections to thermally isolate the focal plane from the warm electronics (“hot”- “thermal gradient” – “cold”); the extension is added in the “hot” section-warm isothermal, the harness is mainly made by copper wires, only the Thermal Gradient part is made by PhBr, for all the detectors.

The 3m extension cable added to Section 3 – warm isothermal is not shown in the scheme above

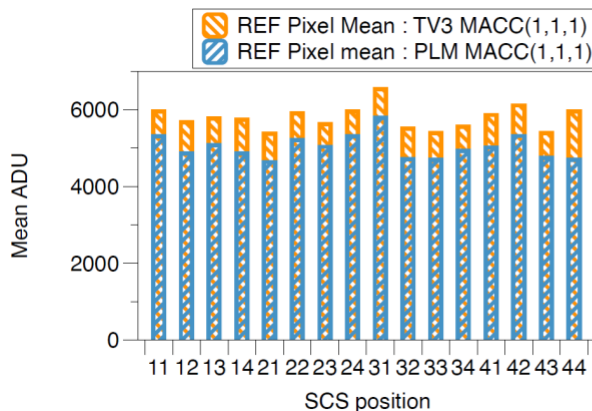
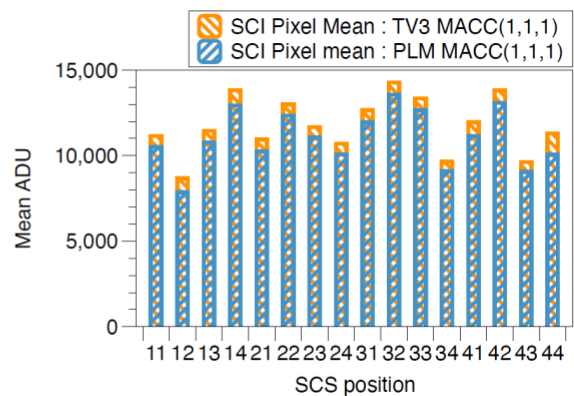
Also, the baseline was verified and found compatible with TV3 (considering the Temperature differences – slightly hotter than TV3 ~ 3K at SCA level); the following histograms shows the comparison between PLM and TV3 baselines, on the left for the reference pixels, while on the right for science pixels.

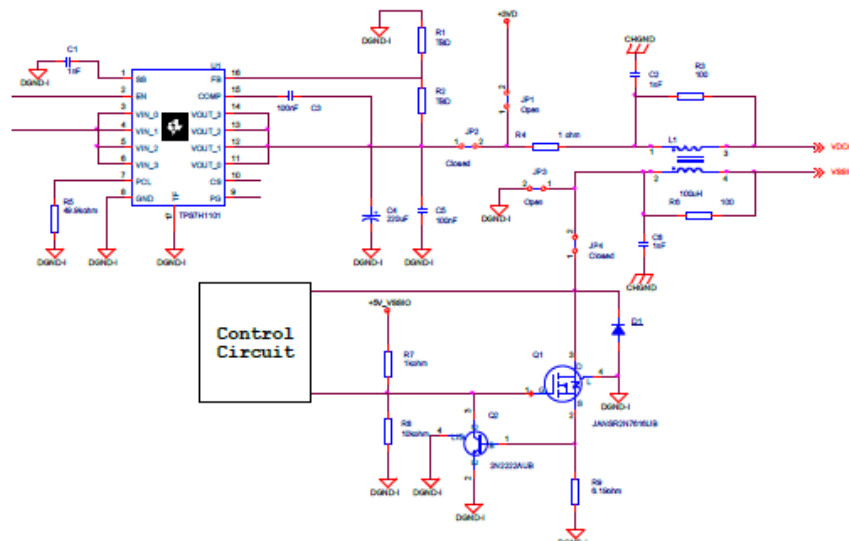
Figure 6-6: VDDIO and VSSIO power supply simplified circuit diagram

The VSSIO value can be set using resistors to be soldered on the DCU board. VSSIO current is drained by the DCU.

VSSIO power supply can be bypassed to provide 0V output at the SCS with a jumper on the DCU.

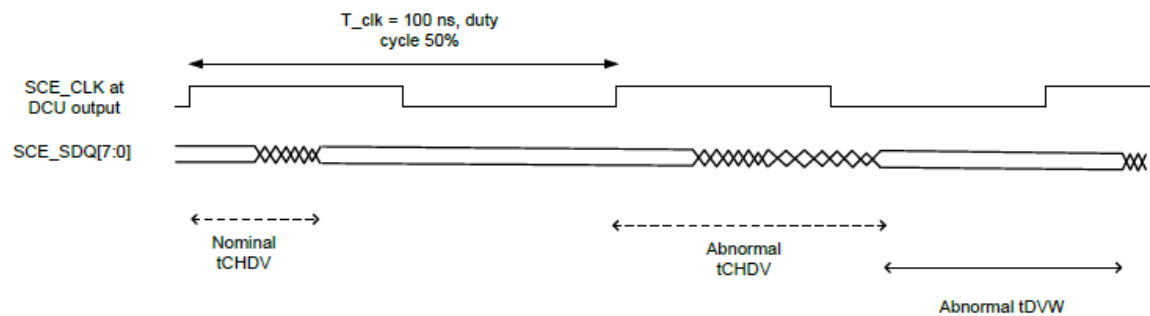
Figure 6-6: SIDECAR science IF abnormal waveform model

The communication uses a parallel interface with two FIFOs sampling asynchronously with a delay of 50ns between them. SCE clock is 10 MHz (100 ns).

Examples of nominal and non-nominal IF between DCU and SCE

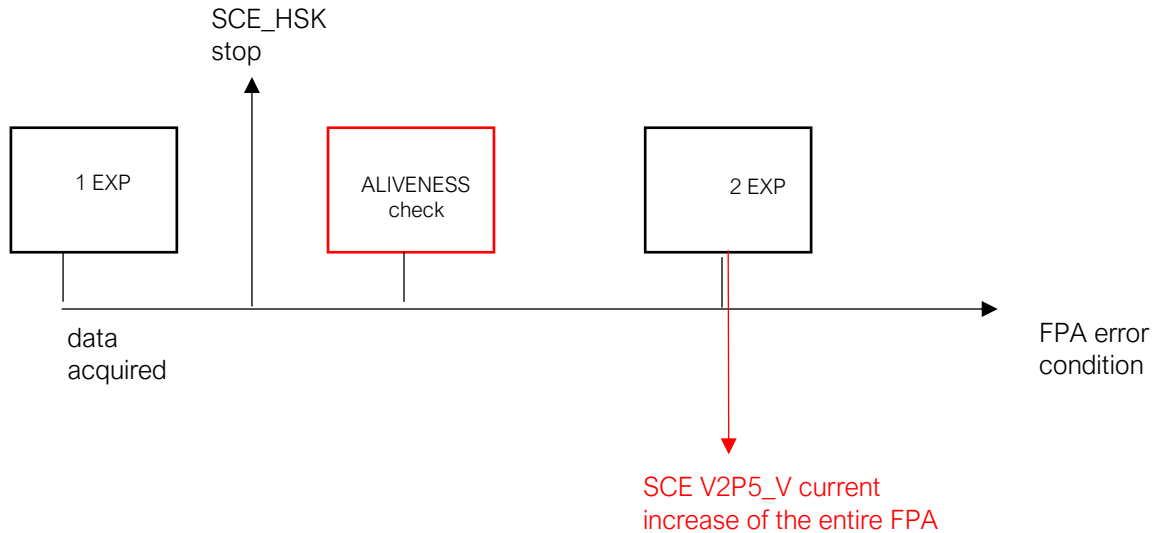
Results of the previous sequence are summarized in the following table:

After the first exposure, 7 out of 16 DCUs signal errors during transmission, and give an error during the Aliveness check execution. Later, the second exposition failed for the entire FPA.

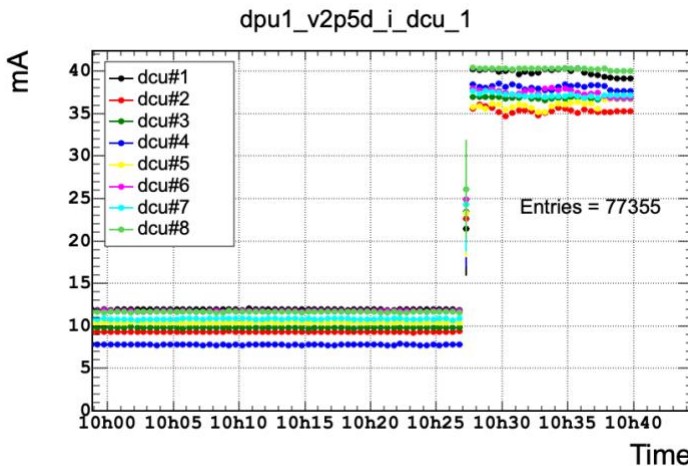
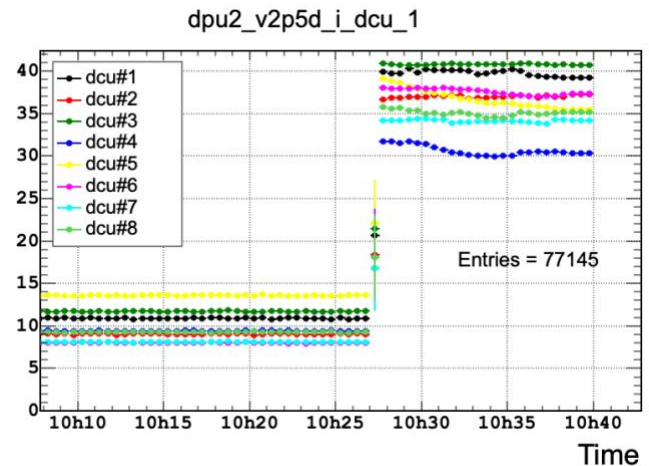
The image below (left) shows the data acquired during the 1st exposure (errors and artifacts can be seen in the plot), DPU1-DCU8 failed to transmit the data due to the SCE line errors. (On the right is the map of the DCU/SCE IDs).

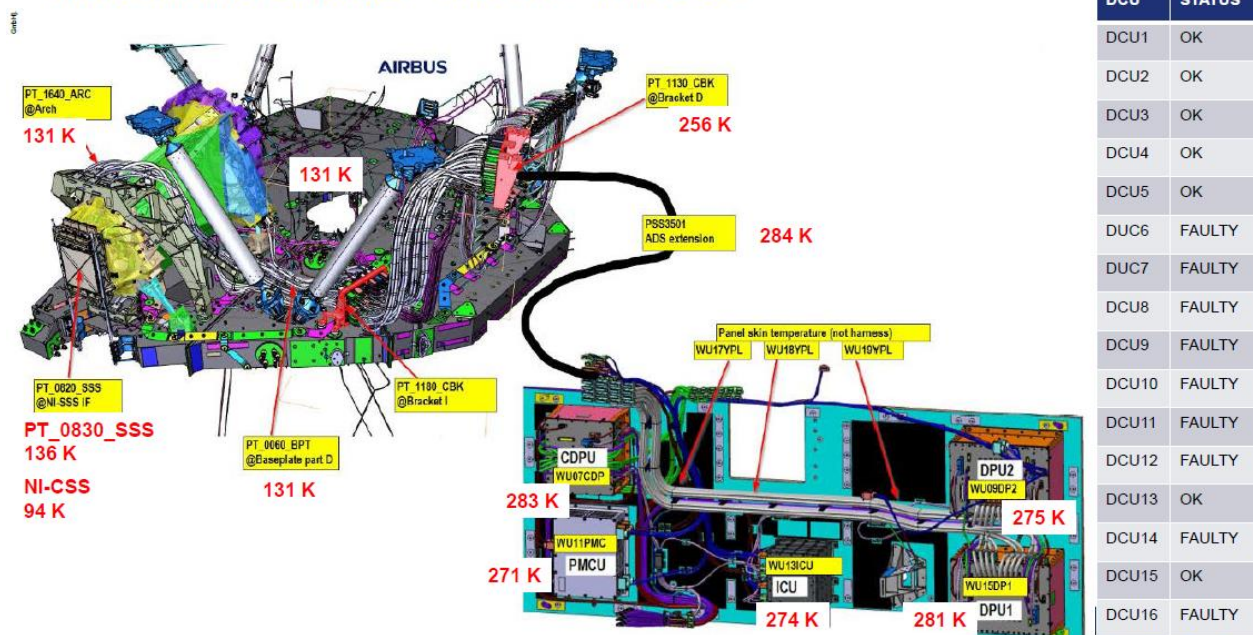
First Occurrence: 29/05/2021 – 08:30 UTC – PHASE 50c

A dependence of the number of detector chains working nominally (without entering in the error condition described above, nor in the two consecutive exposures error condition) with the Temperature was found.

Results are given in the following pictures (courtesy of ADS), where the Temperatures of the different components are indicated; as well as a table with the DCU ID (from 1-8 for DPU1 and from 9-16 for DPU2) and the STATUS which indicates units correctly operating (OK) and the ones entering in the error condition (FAULTY).
