**TITLE: PLANCK OPTICAL SHIELD 2:  
CRYO TESTS ON  
REPRESENTATIVE PANELS**

**DOC. TYPE: Test Report**

**PROJECT REF.: PL-LFI-PST-RP-026 PAGE: I of III, 26**

**ISSUE/REV.: 1.0 DATE: January 2008**

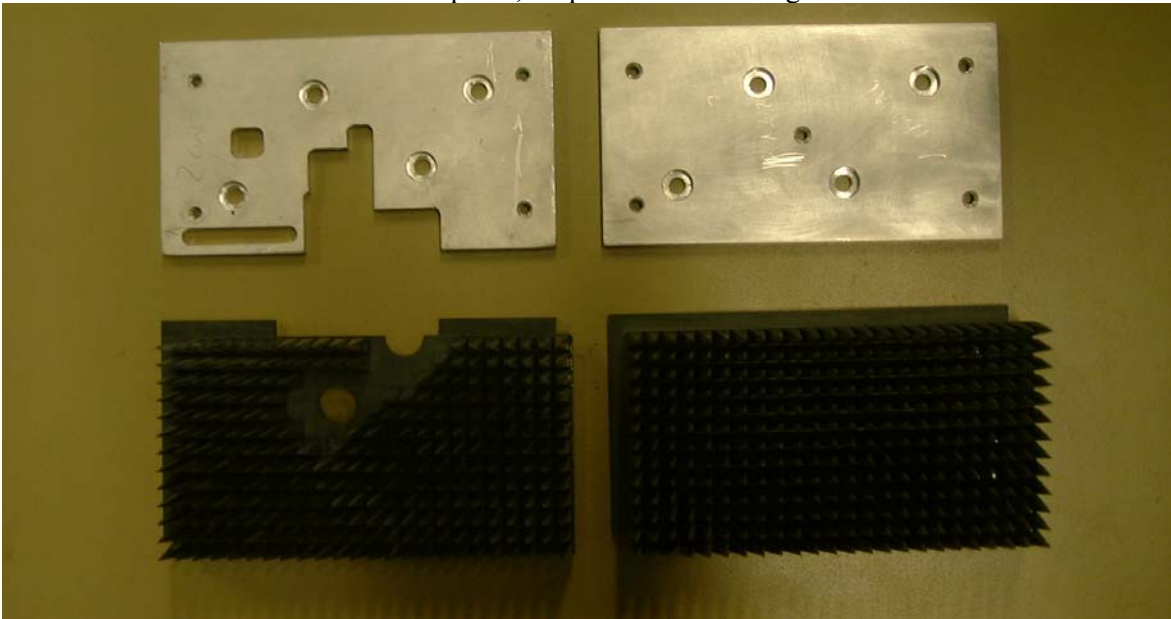
Figure 1 the two panels under test together (above in the picture) with their back metal plate: special panel (left side) and standard panel (right side)

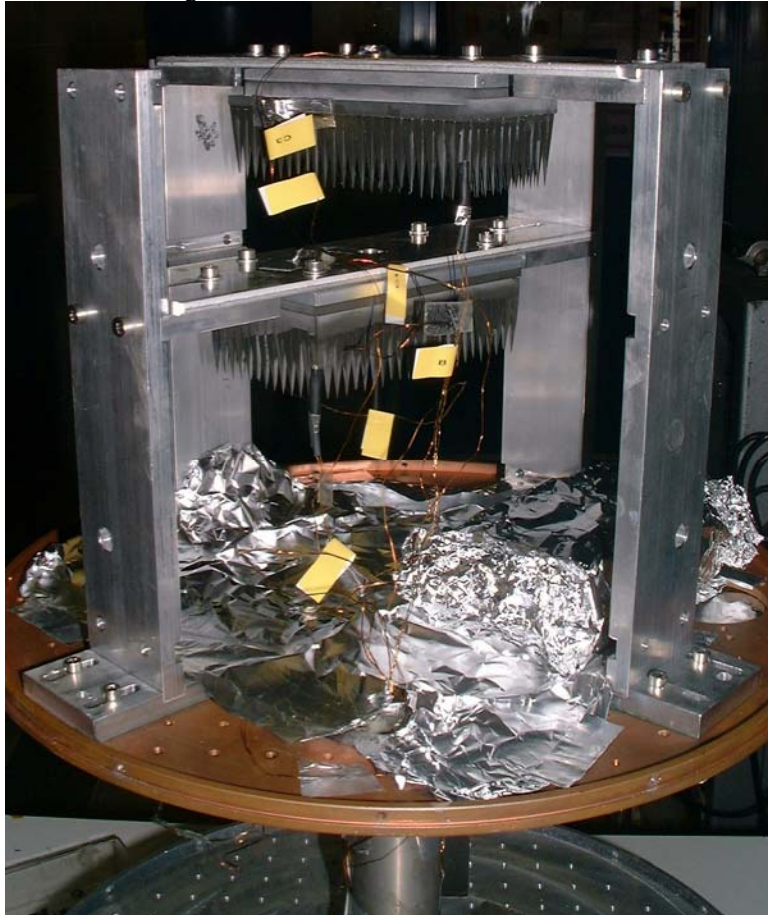
**Figure 2 mounting structures inside the cryo facility.**

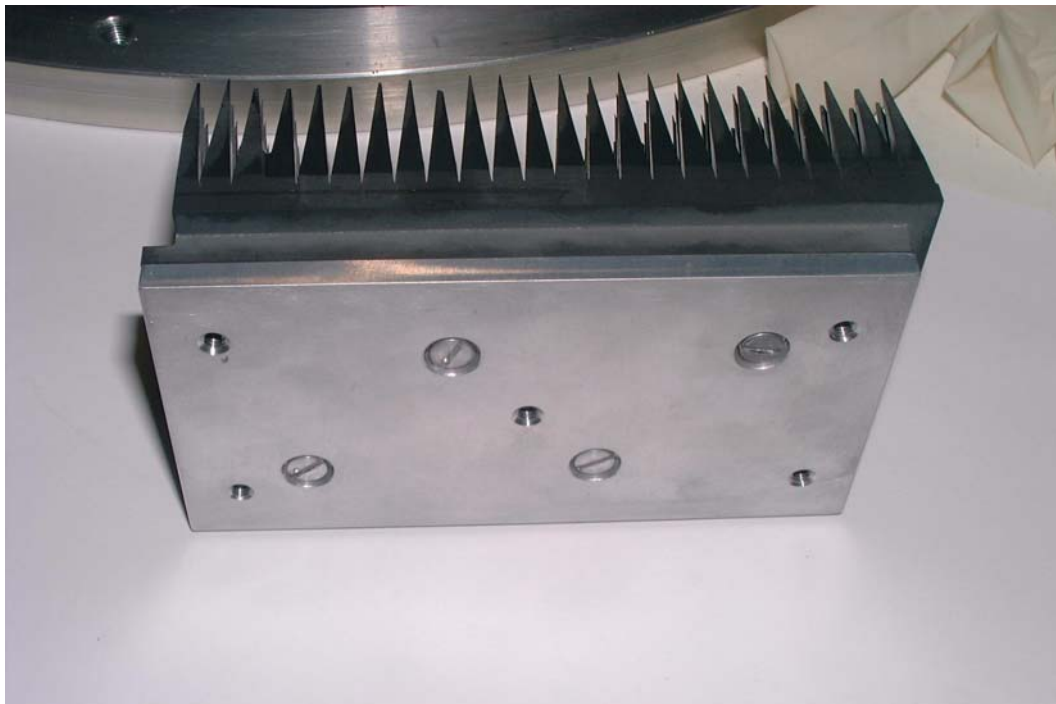
No evidence of change was observed in the panels: no broken parts (example Eccosorb tips) have been found on the aluminium foil put on the flange in order to collect eventual parts falling down from the panels.

Figure 18 standard panel from the back after dismounting from aluminium interface with cryo facility supports.

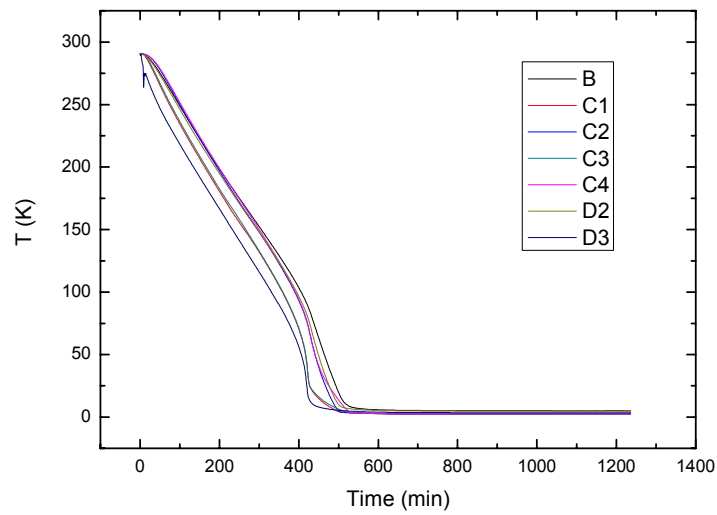
Figure 20 7<sup>th</sup> cooldown

During cycles, from 7<sup>th</sup> to 9<sup>th</sup>, one of the 7 thermal sensors showed instabilities and in the last two cycles did not reach the temperature foreseen. However, this sensor was used just to monitor the cold flange of the cryostat: hence, this failure did not affect the validity of the test.

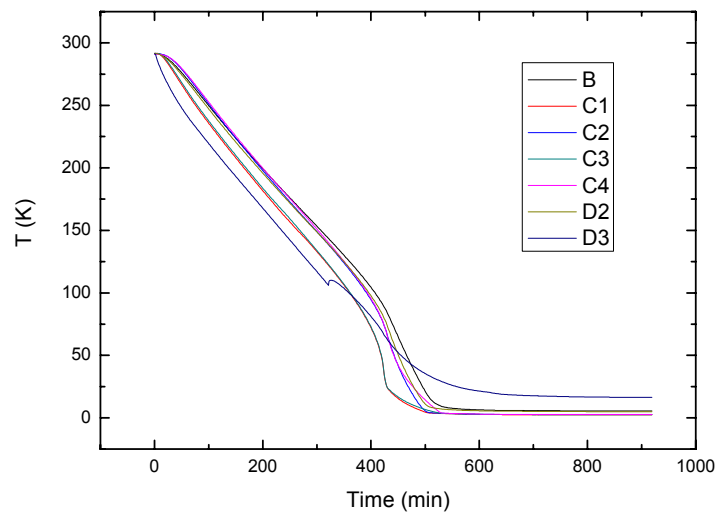
Figure 22 9<sup>th</sup> cooldown

CYCLE	B	C1	C2	C3	C4	D2	D3	Steady state (min)
6	6.119	2.764	2.911	2.818	2.954	5.420	6.640	392
7	6.041	2.812	2.953	2.866	3.005	5.458	4.087	651
8	5.937	2.820	2.967	2.870	3.023	5.552	<b>15.069</b>	309
9	6.479	2.832	2.985	2.889	3.052	5.719	<b>21.750</b>	324

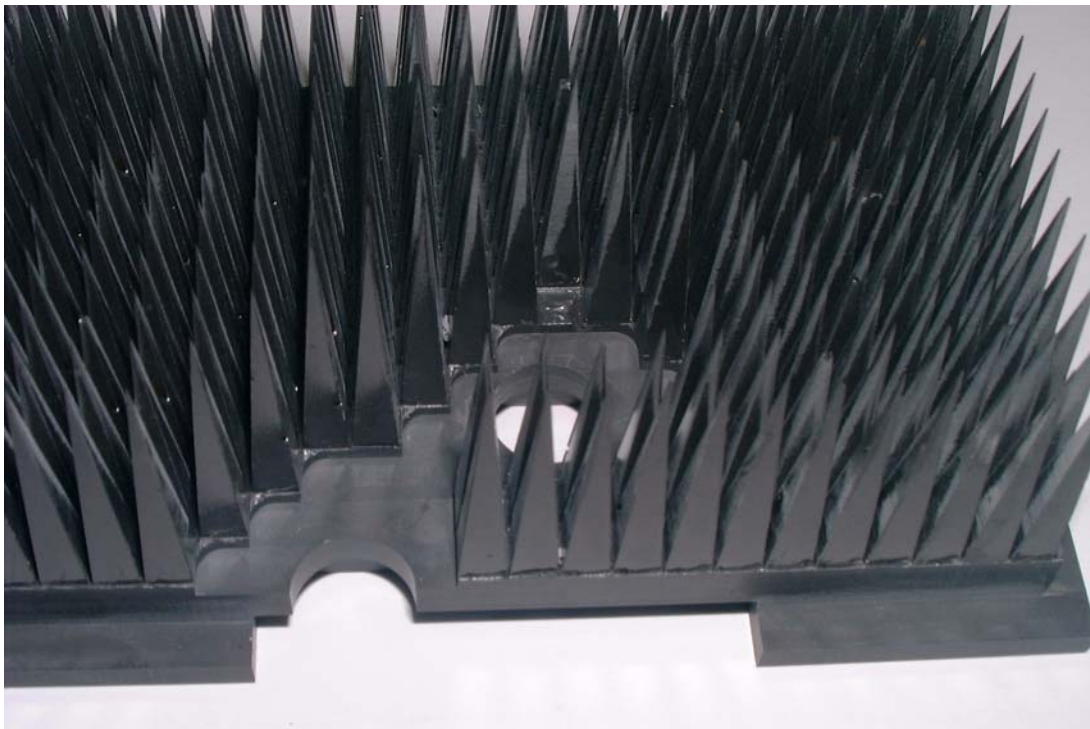
Panels have been then inspected by binocular: nothing new seems to be observed. Comparison with the initial map reporting broken tips and other defects seems to confirm this result.

**Figure 31 special panel: zoom on the region lodging sources**
