TITLE: **ECCOSORB failure analysis**

DOC. TYPE: TECHNICAL NOTE

PROJECT REF.: PL-LFI-TES-TN-015

A failure on some of the 4KRL QM parts was observed after the cryo cycles. A detailed activity was started to study the failure, to identify its causes, to find a solution before the assembly of the FM unit.

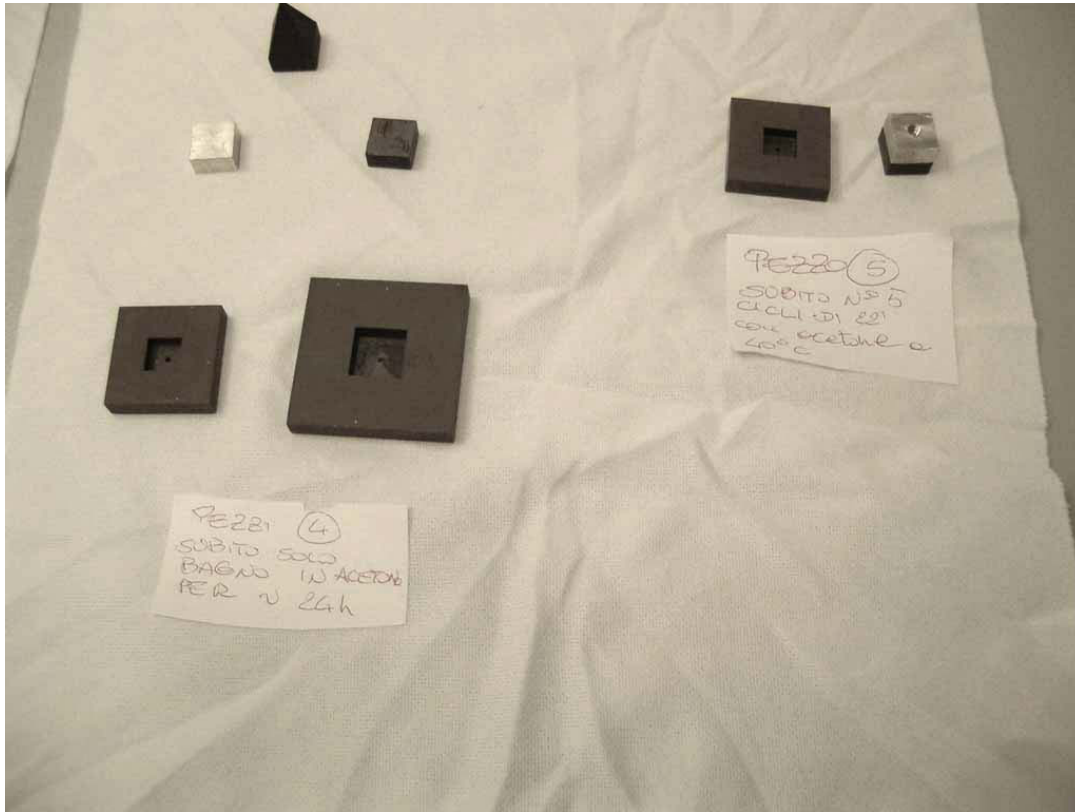
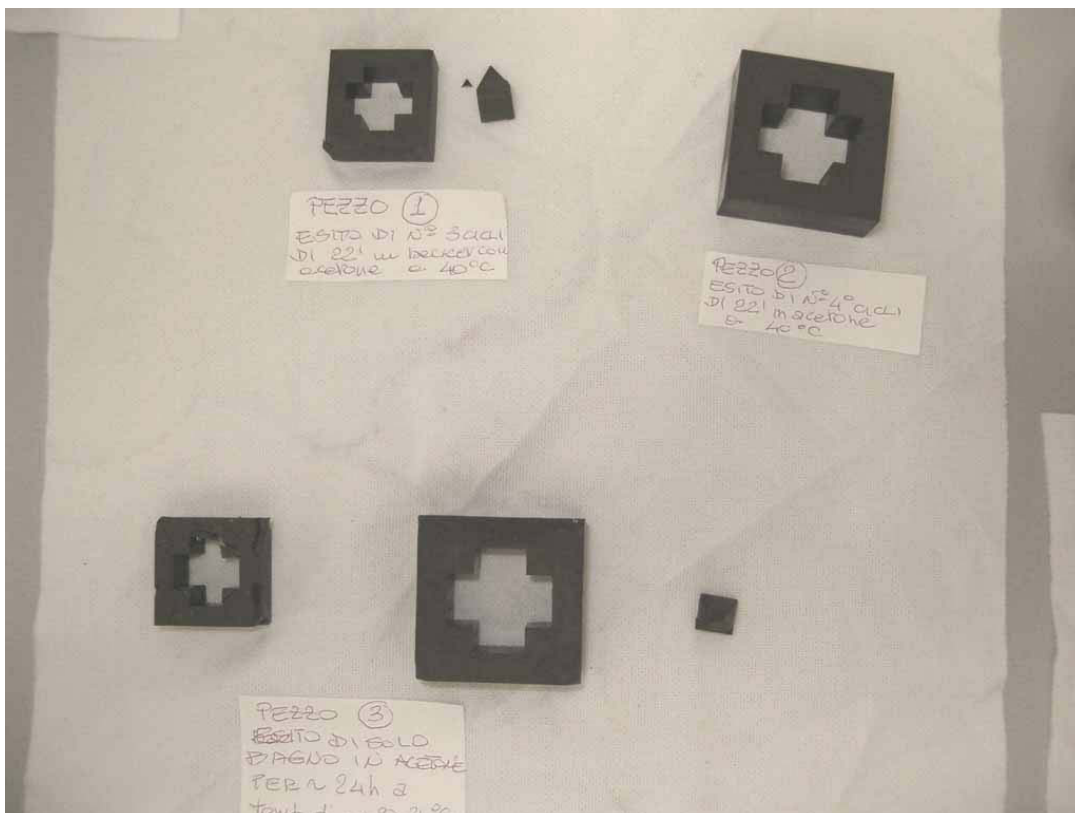
DATE	TIME	TEST CONDITION	NOTE
15/03/05	15.30		The specimen is partially covered with GE glue reactivated with toluene.
16/03/05	9.55		Visual Inspection: there aren't visible defects.
17/03/05	14.00		Visual Inspection: there aren't visible defects.
18/03/05	12.10		Visual Inspection: there aren't visible defects.
21/03/05	15.00		Visual Inspection: there aren't visible defects.
