**TITLE: PLANCK OPTICAL SHIELD 2:
CRYO TESTS ON
REPRESENTATIVE PANELS**

DOC. TYPE: Test Report

PROJECT REF.: PL-LFI-PST-RP-026 PAGE: I of III, 26

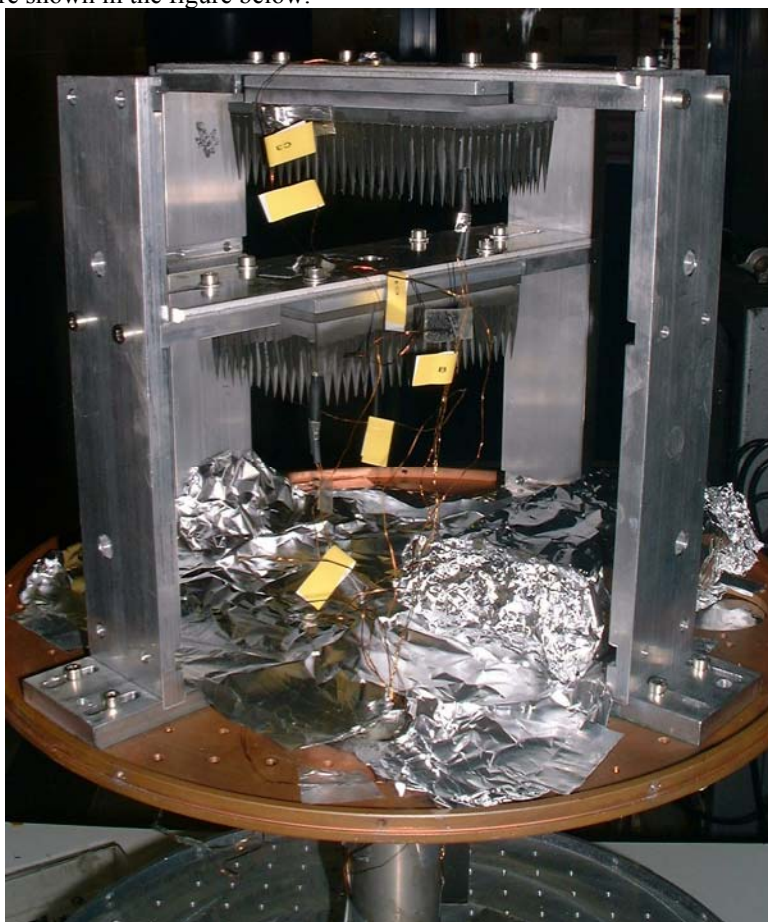
Figure 2 mounting structures inside the cryo facility.

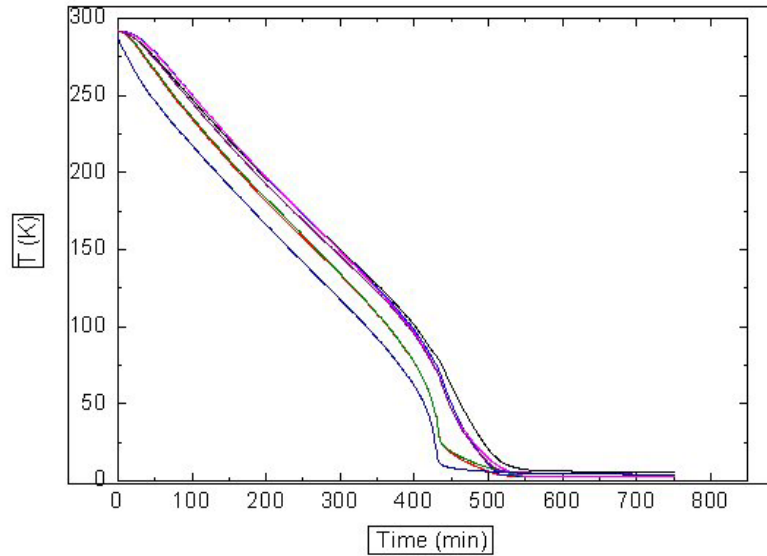
The 1st cooldown started on Wednesday 12/12/2007 at 21:00 and finished on 13/12/2007 at 07:00
the 1st warmup started on 13/12/2007 14:30 and finished on Friday 14/12/2007 at 11:30
temperatures in cold state: between 3K and 7K, depending on location of sensors (Req: 5K -3/+5 K)
duration of the flat (< 1K/hr gradient) step in steady state conditions >3 hr (Req 1hr)

Plot 1 cooldown curve 1st cycle

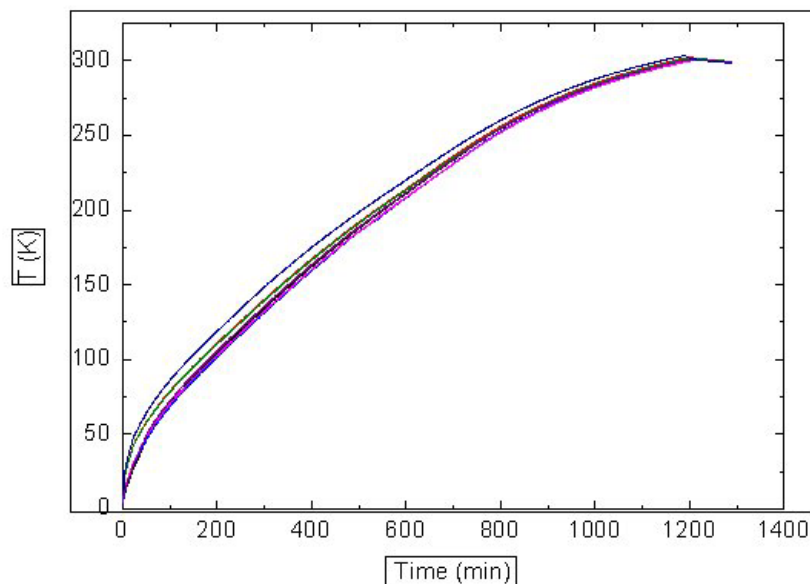
Plot 2 warmup curve

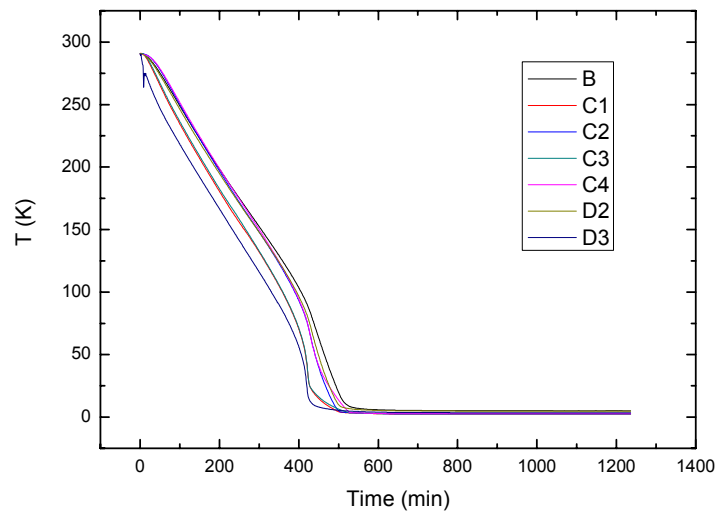
Figure 20 7th cooldown

During cycles, from 7th to 9th, one of the 7 thermal sensors showed instabilities and in the last two cycles did not reach the temperature foreseen. However, this sensor was used just to monitor the cold flange of the cryostat: hence, this failure did not affect the validity of the test.
