BC-SIM-TR-032 HRIC
ICO4 REPORT

The present document has been issued to describe the Instrument Check Out Phase (ICO#4) Tests of HRIC, channel of the Spectrometers and Imagers for MPO BepiColombo Integrated Observatory SYStem (SIMBIO-SYS).

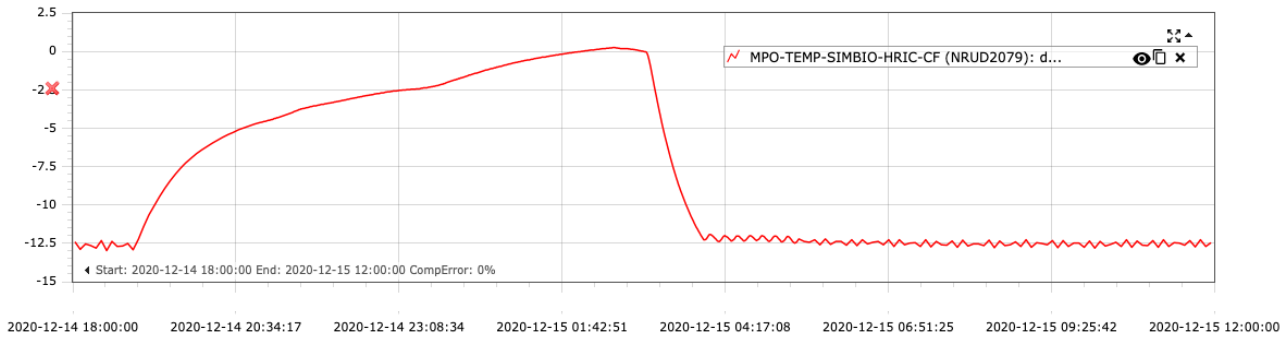
Figure 3: HRIC Cold Finger temperature evolution during the ICO#04 tests. Temperature is reported in °C.

To note that **the HRIC CF reached its nominal operative temperature only at the end of the test**; this not nominal behaviour affected the obtained results (see following sections) causing the partial failure of the checkout (i.e., no errors in the sequence execution but useless data).

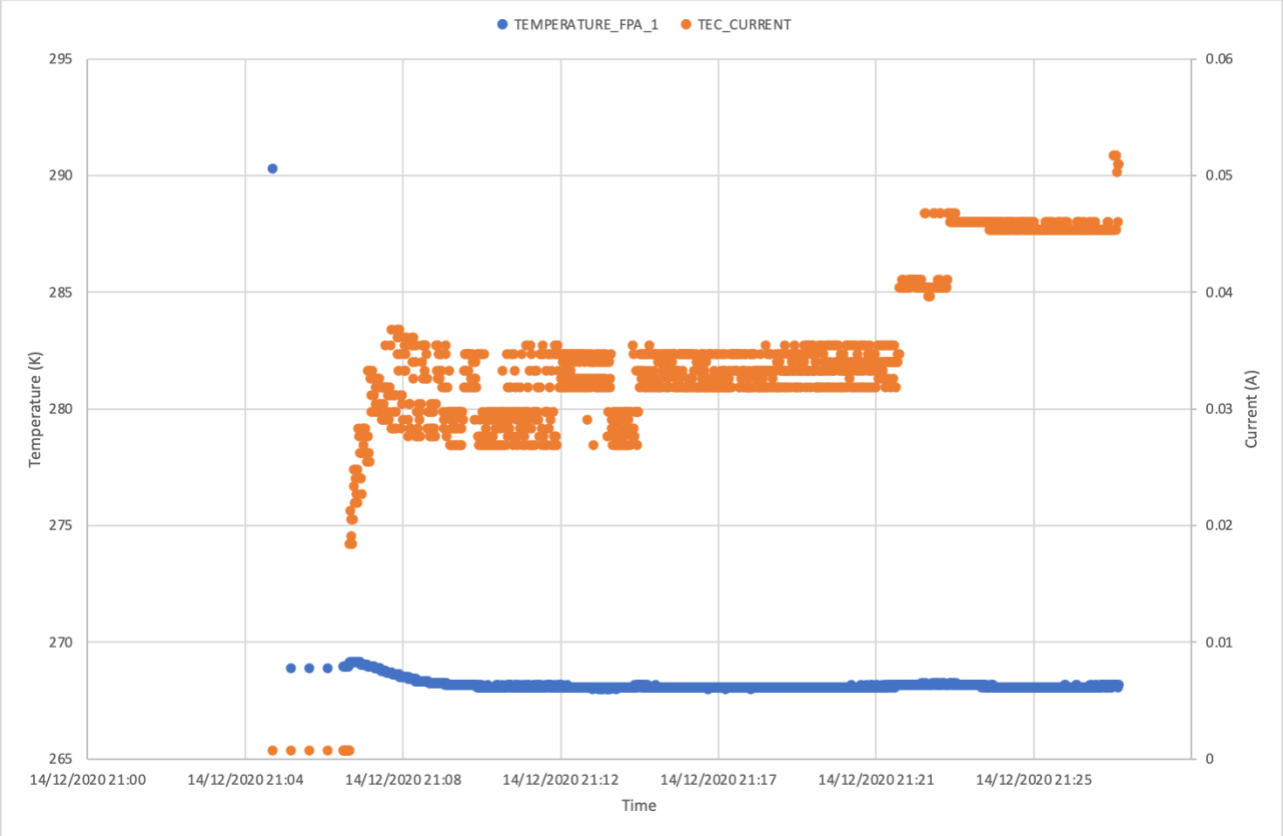
The test was performed using the nominal parameters for the TEC and imposing a difference between the target temperature for the detector and the external interface larger than the values need to activate the soft start for the PID control of the TEC. The analysis of the HKs (Figure 4) **shows a not nominal** trend for the FPA temperature and TEC current (see Sections 3.1.3 of previous HRIC Test Report) due to the not stable thermal environment showed in Figure 3. In particular, two effects can be seen:

1. at TEC activation the FPA temperature changes a little since the thermal environment is colder with respect to its nominal state after the SIMBIO-SYS Thermal Settings Adjustment activities planned at the beginning of every SIMBIO-SYS ICO
2. TEC current is a little increasing (during the Functional Test) due to the on-going SIMBIO-SYS Thermal Settings Adjustment activities (that ends few minutes before the completion of SIMBIO-SYS ICO activities)

Figure 4: HRIC TEC current and focal plane temperature trends at the switch on during the functional test of HRIC.

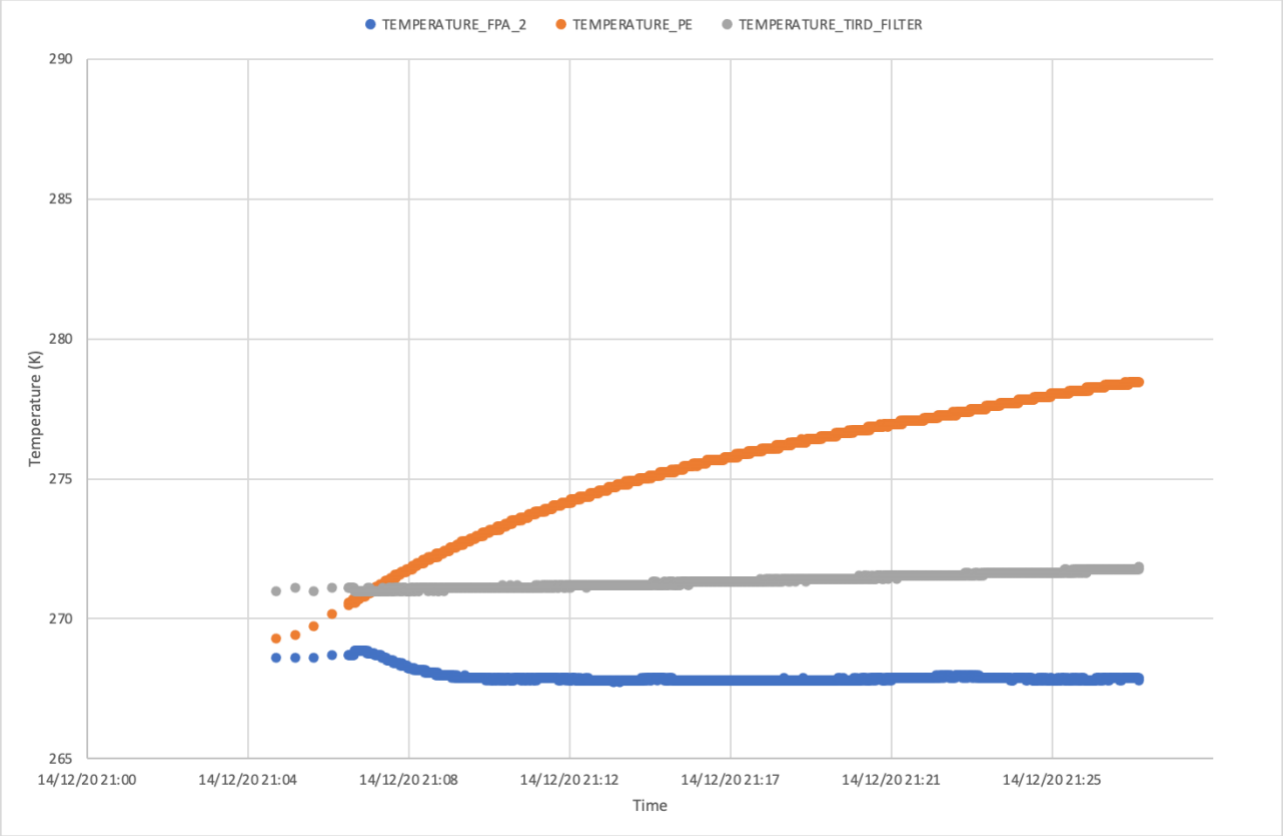
The temperatures trends for the other monitoring thermometers (FPA2, PE and TIRD filter) show again a **not nominal behaviour** for the FPA2 temperature due to the not stable thermal environment; as far as PE and TIRD temperature, a nominal behaviour has been observed (Figure 5).

Figure 5: Temperatures trends of the HRIC monitoring thermometers after the switch on.

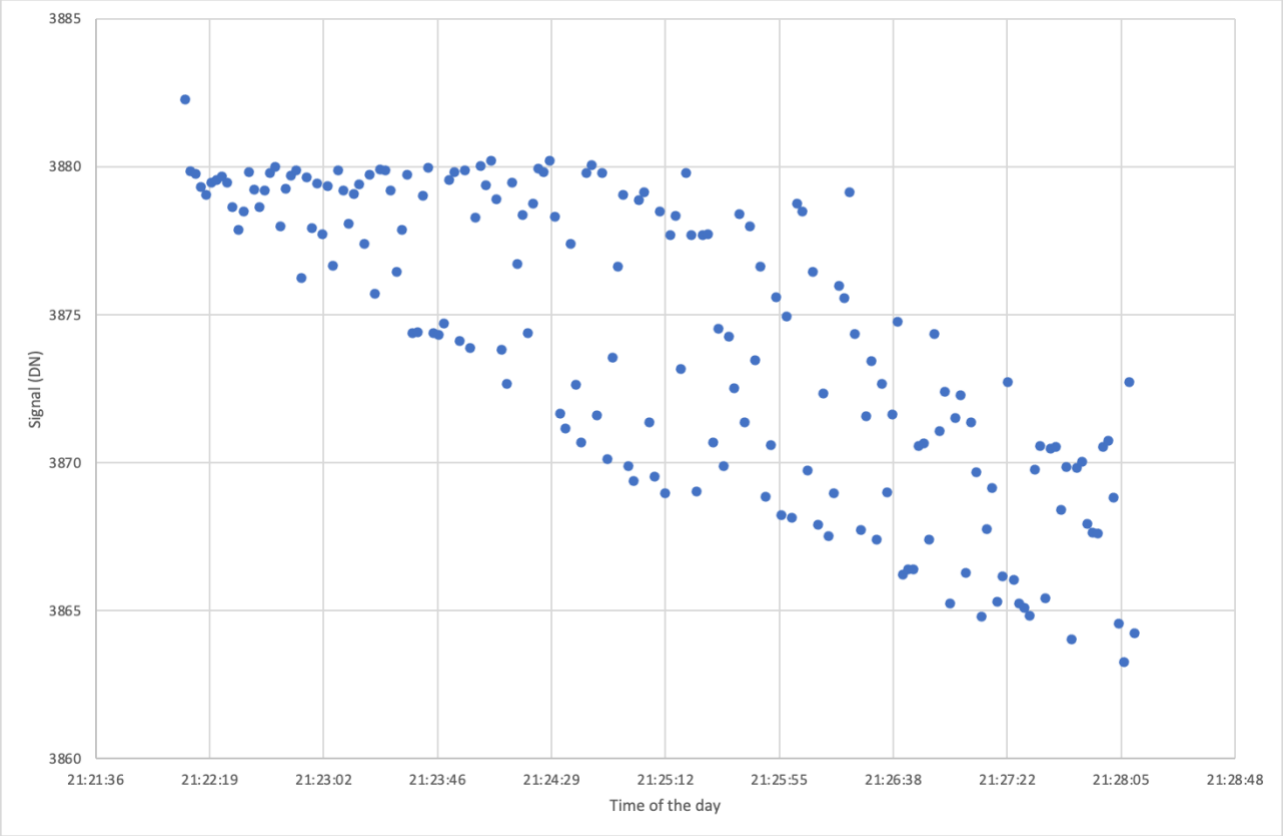
Differently from what seen in the same test run in the previous ICOs where a slow oscillation in the detector reset level is present, in this test **no oscillation is clearly visible** due to the not nominal thermal conditions present during the execution of the test (Figure 6). All other parameters in the acquired frames remain nominal.

Figure 6: Functional test averages of acquired frames.

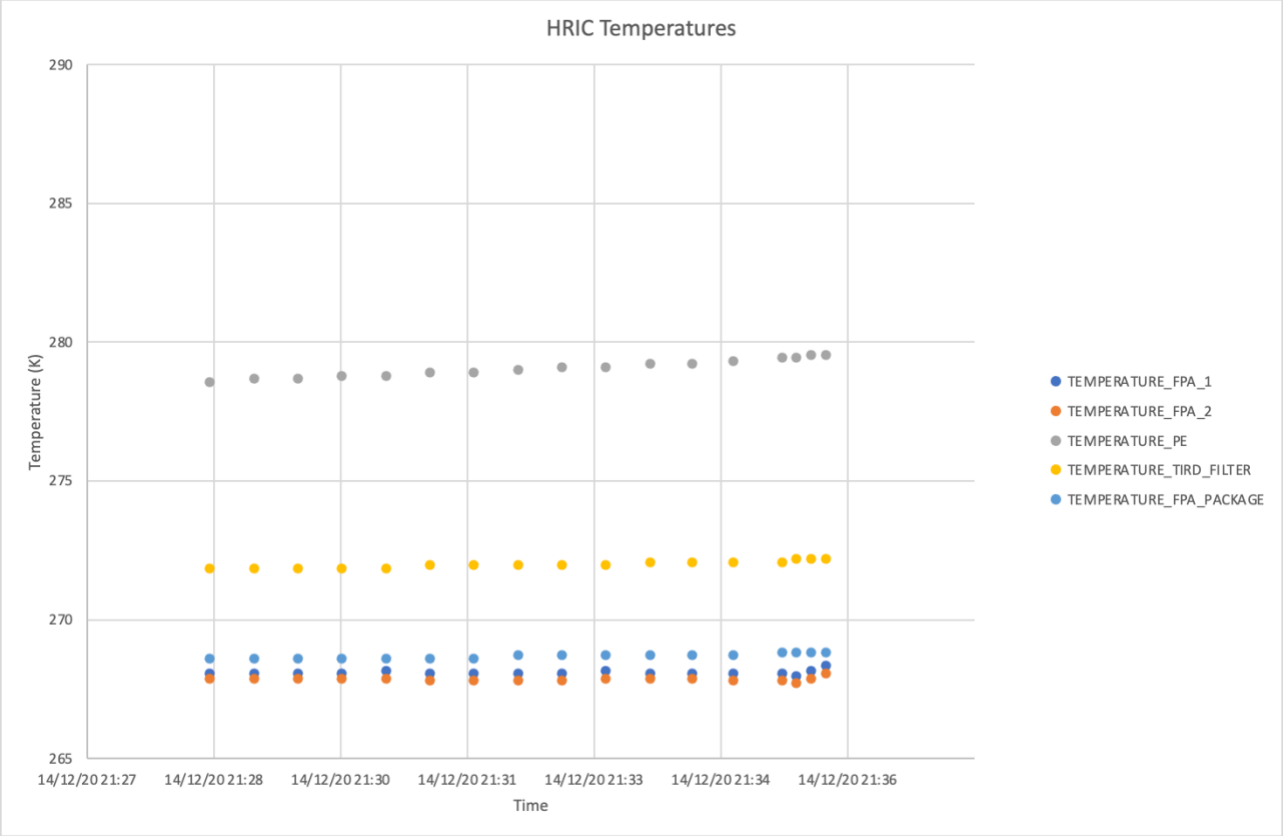
The analysis of the HK collected during performance test for HRIC shows a **not nominal behaviour** (see Sections 3.1.3 of previous HRIC Test Report) due to the not stable thermal environment showed in Figure 3 for both for temperatures (Figure 7) and Voltage and TEC current (Figure 8).

Figure 7: Temperatures of HRIC during performance tests.

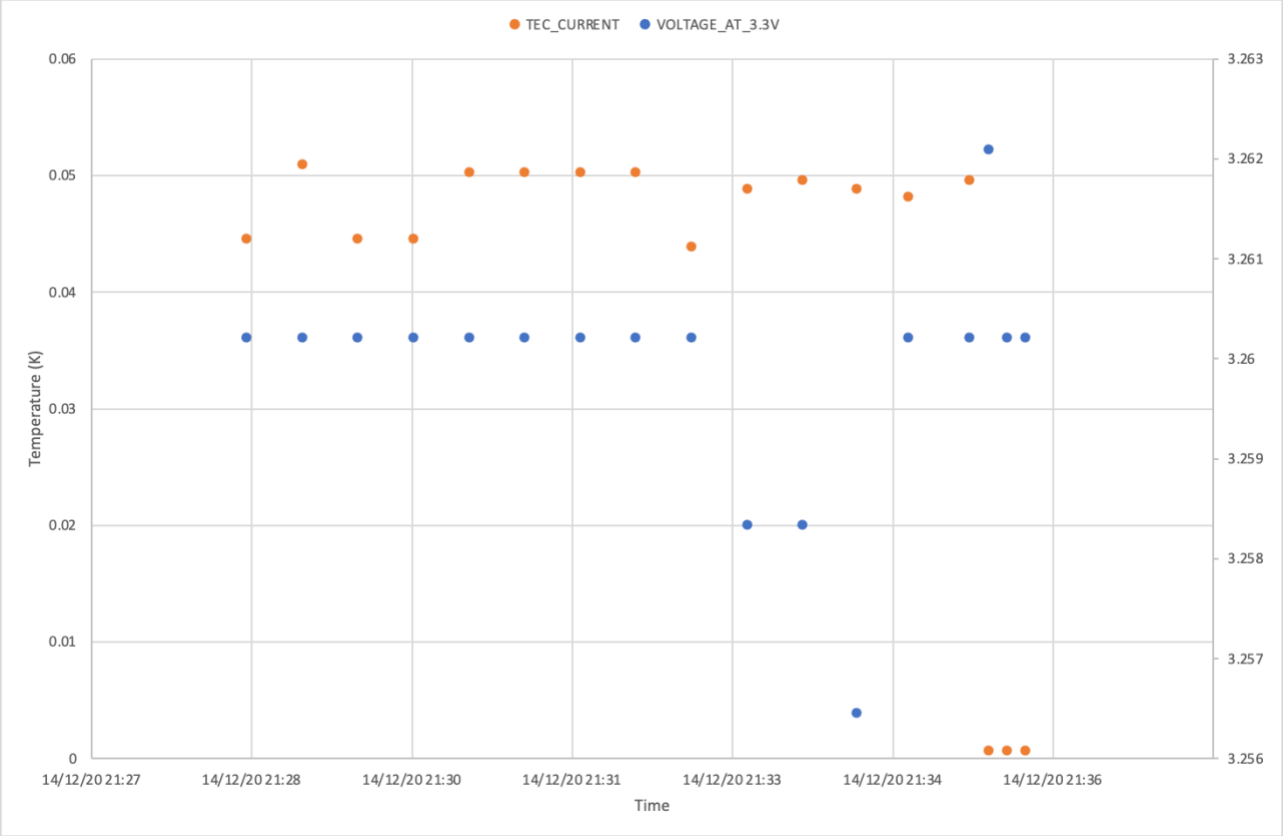
Figure 8: HRIC PE TEC current and Voltage.

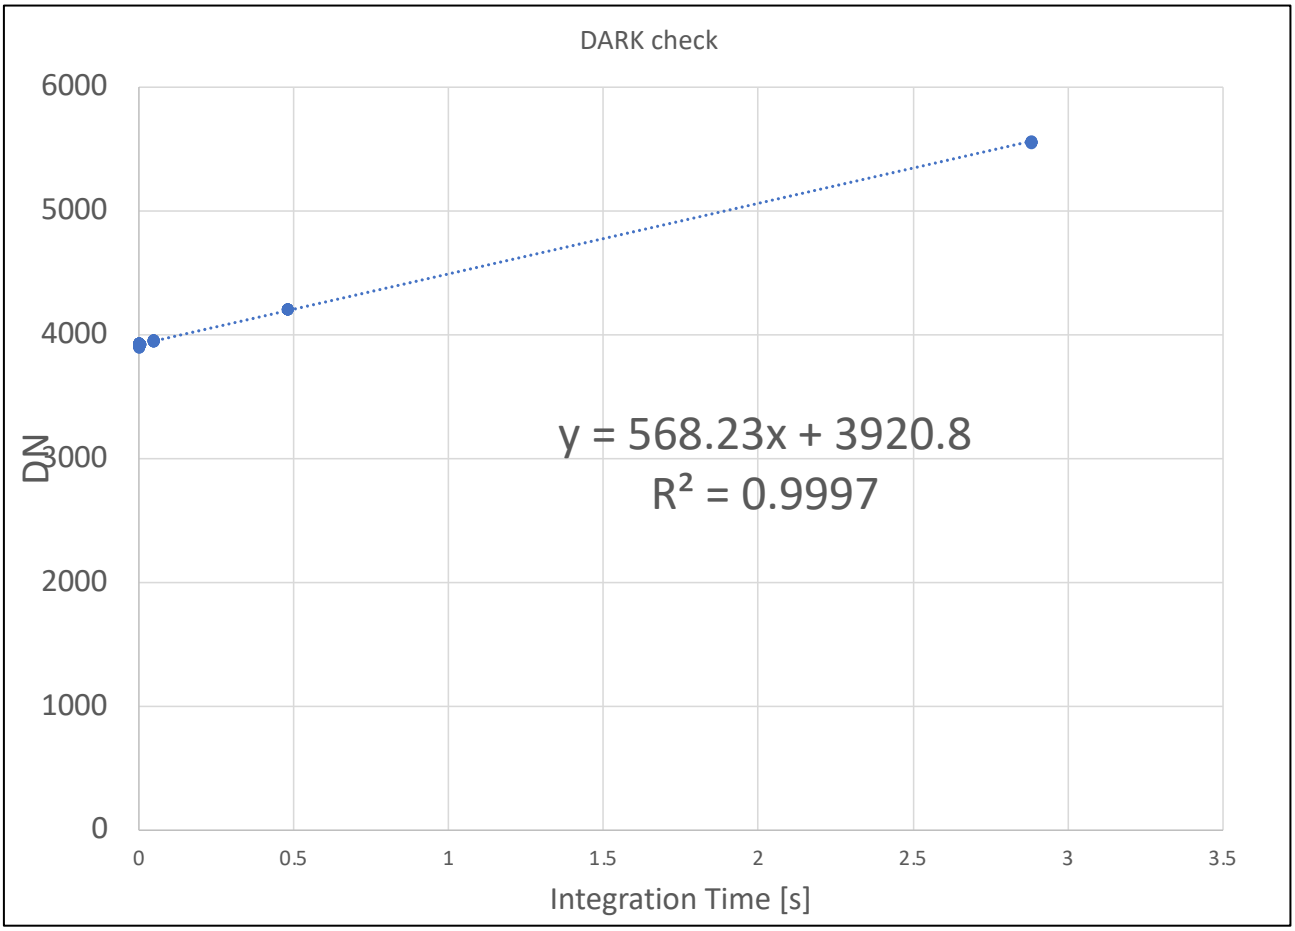
The performance test for HRIC channel consists in a series of acquisition to check the DARK current behavior. The acquisitions have been performed with a reduce set of IT with respect to previous ICOs. In order to compare results of the test with respect to previous analyses, the averages of the frames acquired were plotted vs the integration times used and a linear fit have been evaluated (Figure 9 and Table 9).
It can be seen that the DC behaviour is a **little different with respect to the previous ICOs due to the not nominal thermal environment state**.

Figure 9: DARK current vs integration time (in DN) for the HRIC channel, in the plot reported the average value of the acquired frames.
