# AMBIENT VIBRATIONS OF AGE-OLD MASONRY TOWERS: RESULTS OF LONG-TERM DYNAMIC MONITORING IN THE HISTORIC CENTRE OF LUCCA.

The paper presents the results of an ambient vibration monitoring campaign conducted on so-called “Clock Tower” (Torre delle Ore), one the best known and most visited monuments in the historic centre of Lucca.

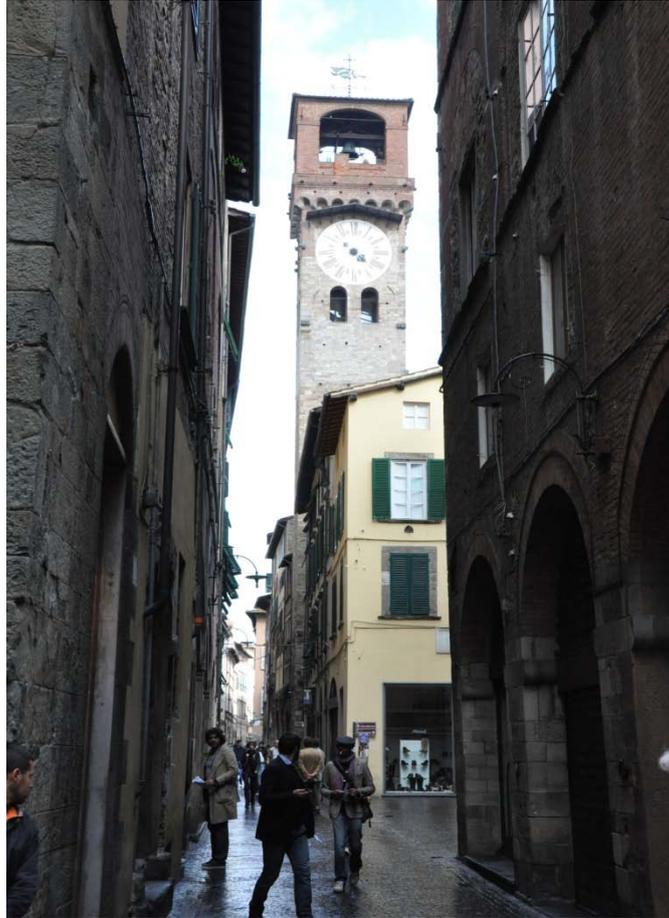
Figure 2. The Clock Tower: view from Via Fillungo.

clock visible on its southern facade (Figure 2). The Clock Tower rises at the corner between the roads named Via Arancio and Via Fillungo, one of the most popular in Lucca's historic centre; the adjacent buildings about the tower on two sides for a height of about 13 m and constitute asymmetric boundary conditions for the tower's structure. The Clock Tower is 48.4 m high at the top of the bell chamber; it has a rectangular cross section of about 5.1 x 7.1 m and walls of thickness varying from about 1.77 m at the base to 0.85 m at the top. Two barrel vaults are set inside the tower at heights of about 12.5 and 42.3 m. The bell chamber, made up of four masonry pillars connected by elliptical arches, stands on the upper barrel vault and is covered by a pavilion roof constructed of wooden trusses and rafters. With regard to the materials constituting the masonry tower, visual inspection reveals that the masonry from the base up to a height of 15 m is made up of regular stone blocks and thin mortar joints. The upper walls are instead composed of regular stone blocks and bricks, also with thin joints. The pillars of the bell chamber are made of brick masonry. On 25 November 2016, during a preliminary experimental campaign, the ambient vibrations of the Clock Tower were monitored for a few hours via four SARA SS20 three-axial seismometric stations. The instruments were moved along the tower's height by adopting three different layouts and combining data in order to identify four natural vibration frequencies and mode shapes of the tower, as described in (Pellegrini et al, 2017). Data collected in this experiment also allowed evaluating the mechanical properties of the tower's constituent materials via model updating procedures, as described in (Girardi et al., 2019).

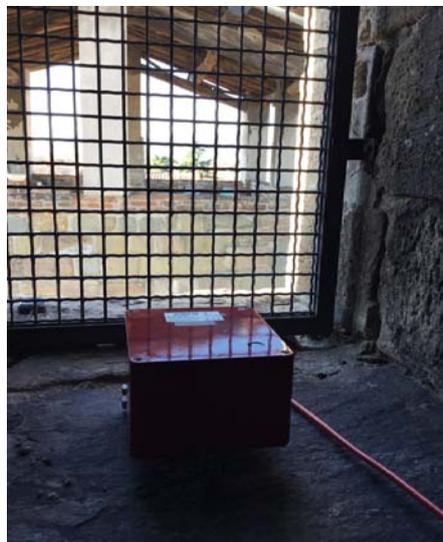
Figure 3. Sensor S.943 at level +24 m

In November 2017 a long-term ambient vibration monitoring experiment was begun with the fitting of six instruments along the tower's height: four Sara SS20 seismometric stations (tri-axial velocimeters, Fig. 3) from the INGV, named in the following S.942, S.943, S.944, S.945, and two tri-axial accelerometers (Fig. 4) provided by the firm Assist in Gravitation and Instrumentation (AGI S.r.l.), named in the following S.1 and S.2. The INGV sensors were coupled with a 24-bit digitizer and the signal was sampled at 100 sps. The AGI data were acquired by a laptop at a sampling frequency of 20 Hz using a 24-bit digitizer. With regard to the main characteristics of the instruments used in the monitoring campaign, the SS20 velocity transducers have a nominal sensitivity of 200 V/m/s, eigenfrequency of 2 Hz, and usable band from 0.1 to 250 Hz. The AGI accelerometers have an acceleration noise density of  $2 \cdot 10^{-8} \text{ g}/\sqrt{\text{Hz}}$  and usable band from  $10^{-5}$  to 50 Hz. It is worth noting that together the instruments can cover a very wide band of frequencies. The instrumentation was kept running on the tower up to March 2018. Figure 5 shows the layout of the sensors along the tower during the experiment: seismic station S.942 was placed at the base, collecting data from the ground, S.943 was at the height of 24 m above street level, the remaining two stations S.943 and S.944 were placed on the bell chamber, at about +42 m above street level. The AGI stations were both installed in the upper part of the structure, S.2 at +37 m and S.1 on the bell chamber level.

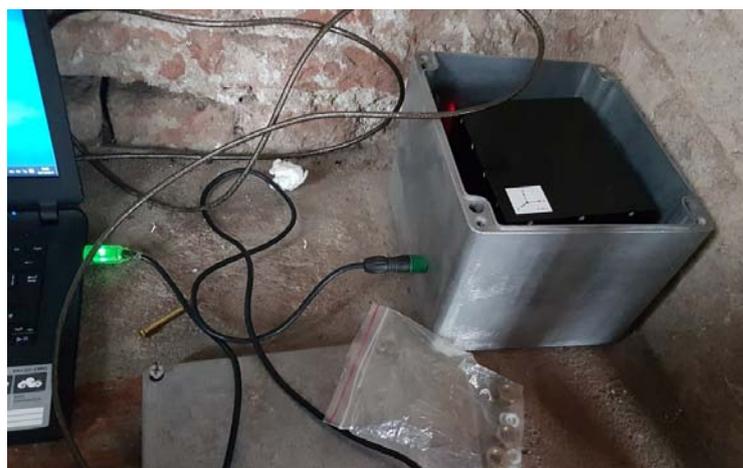
Figure 4. Sensor S.2 at level +37 m inside the tower.

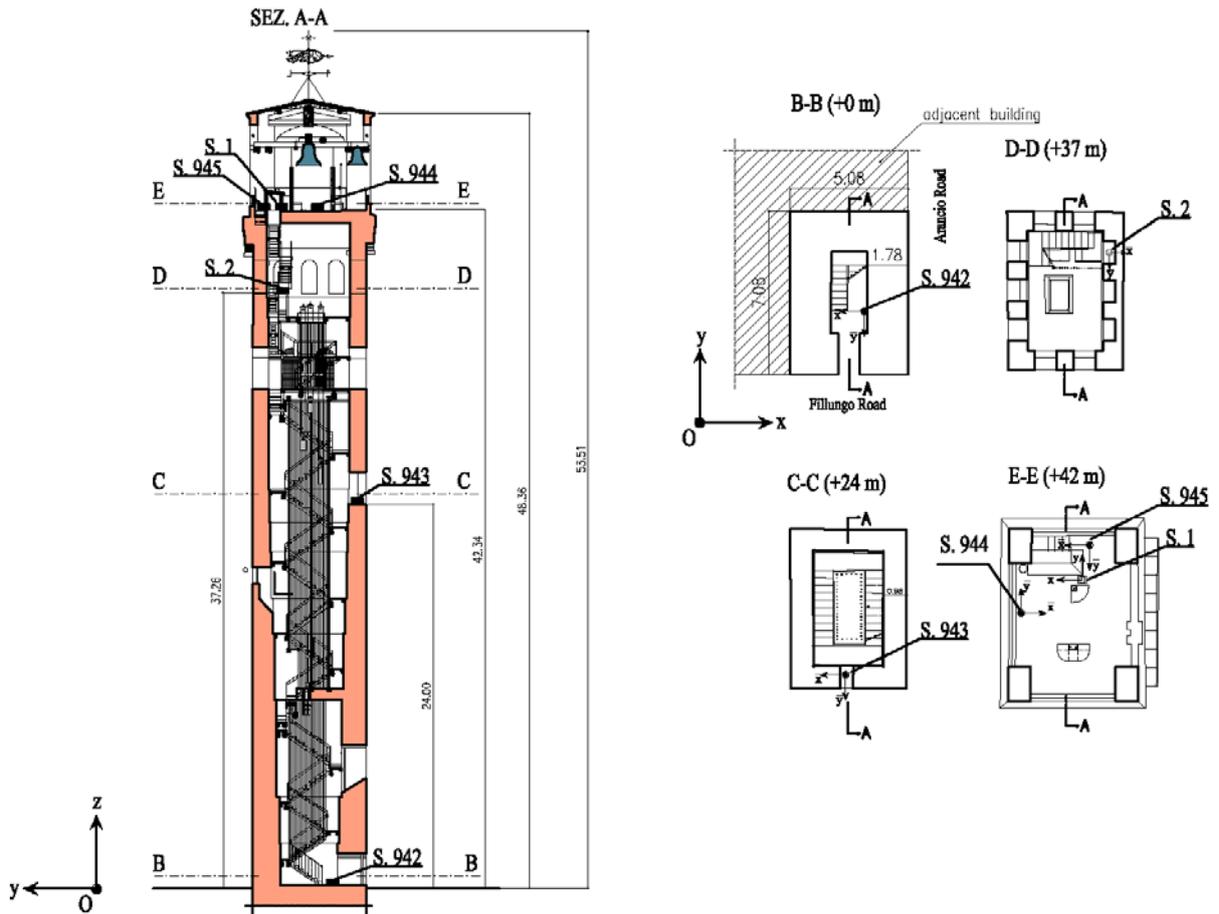
Figure 5. Sensor arrangement on the Clock tower: sensors S.942, S.943, S.944, S.945 (INGV), sensors S.1, S.2 (AGI).

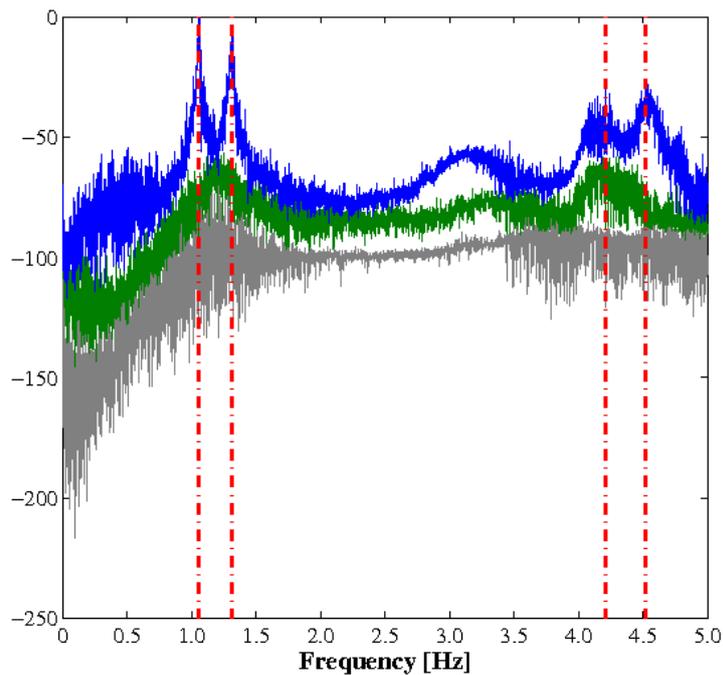
Figure 6. The three eigenvalues of the matrix  $H[j\omega]^H H[j\omega]$  vs. the frequency on a log-magnitude scale.

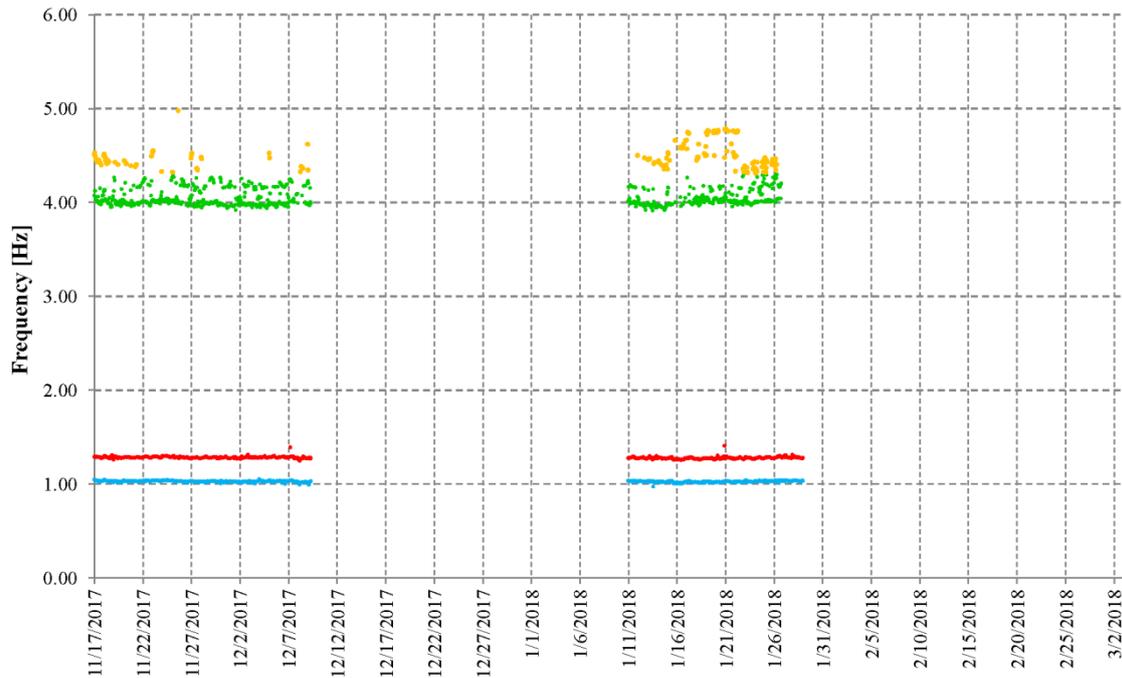
Figure 7. The tower's first four natural frequencies [Hz] detected by SS20 velocimeters during the monitoring period.

The tower's frequencies are reported in Table 1, where the mean values (evaluated over the entire monitoring period from November 2017 to March 2018) of the four frequencies are reported, together with their relative differences (evaluated on the 1<sup>st</sup> and 99<sup>th</sup> percentile) for the two different instruments. The frequencies values measured on the Clock Tower are in good agreement with those of other towers with similar geometries (Bartoli et al., 2017). The dataset from the SS20 seismic stations includes 970 hours of recordings, while the AGI instrumentation yielded 1110 hours of tower measurements. The frequency values vs. time are reported in Figures 7 and 8 for the SS20 and the AGI instruments, respectively. The mean values evaluated by the two instruments are in very good agreement. The first and the second frequencies were detected by the two instruments in all records, and the variation in the two frequencies is on the order of 3%. This variation is also in good agreement with the findings of another long-term dynamic monitoring conducted on the San Frediano bell tower in Lucca (Azzara et al., 2018a). The third frequency was also detected by the seismic stations in almost all records, while the fourth frequency only appears when the excitation level in the tower's structure was increased (it was detected in about the 30% of the records), and its values appear to be widely dispersed. A fifth frequency at about 5.7 Hz was also detected in about 30% of the records. With regard to the modal damping ratios, reported in Table 2, they are widely dispersed with variations on the order of hundreds of percentage points. Their values vary from 4% for the highest frequency, to 0.5% for the first. The values yielded by the seismic stations are generally higher than those from the accelerometers.

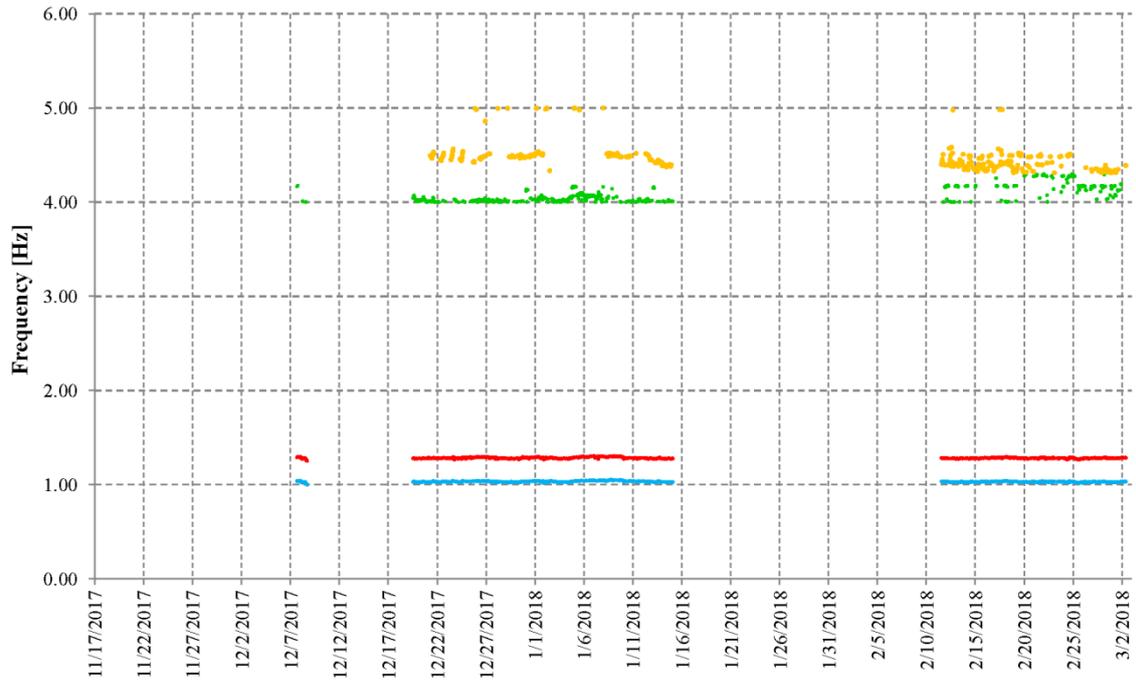
Figure 8. The tower's first four natural frequencies [Hz] detected by AGI accelerometers during the monitoring period.

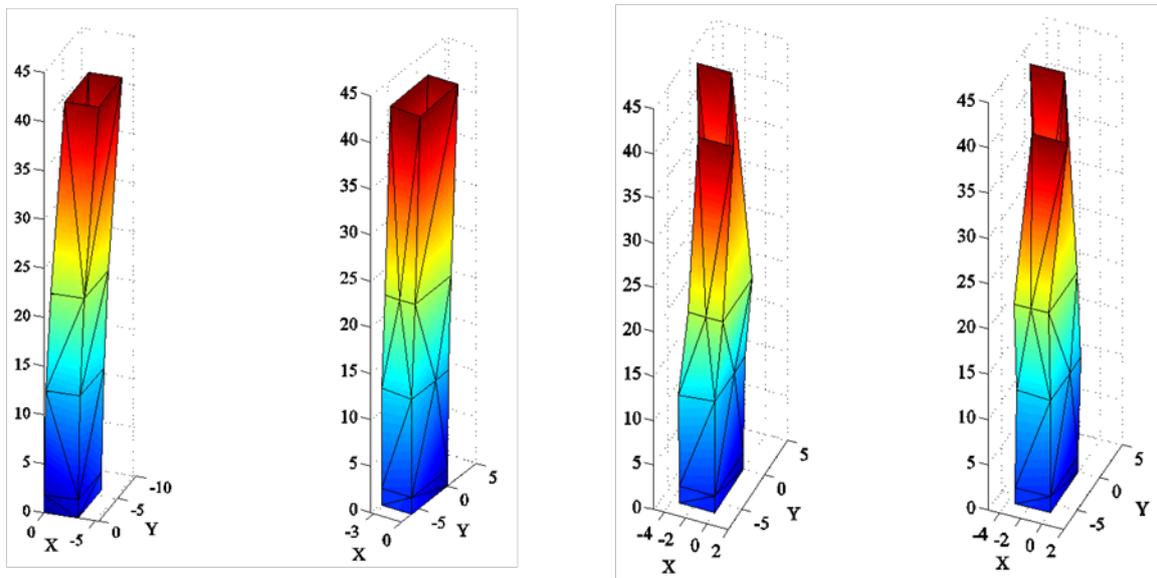
Figure 9. The tower's first four mode shapes [Hz] corresponding (from the left) to the frequencies  $f_1$ ,  $f_2$ ,  $f_3$ ,  $f_4$ .

The mode shapes of the tower corresponding to the four frequencies  $f_1, f_2, f_3, f_4$  are shown in Figure 9; these have been extracted from the data recorded in November 2016 by taking advantage of the different layouts used for mapping the tower's vibrations. The first two frequencies refer to bending modes along the  $x$  (first) and  $y$  (second) directions, while the third is a torsional mode and the fourth is a torsional-bending mode involving movements of the structure's upper parts.

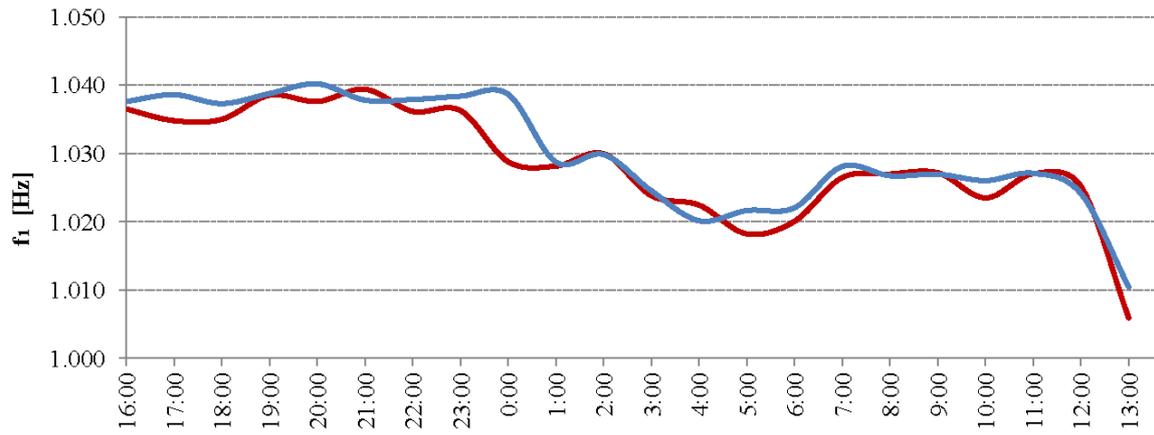
Figure 10. The tower's fundamental frequency obtained via AGI stations (blue) and SS20 stations (red) data from 7 to 8 December 2017 (respectively at 16:00 and 13:00).

Figures 10 and 11 show further comparisons of the results obtained via the two instruments. In particular, Figure 10 shows the trend of the tower's fundamental frequency from 7 to 8 December 2017, extracted from the AGI (blue) and the SS20 (red) devices. The very good agreement between the two measurements indicates that the fluctuations exhibited in the frequency values do not depend on the instruments' functioning, but are rather due to environmental factors. Figure 11 shows a comparison of the hourly maximum accelerations (absolute values) recorded by the instruments during that same period. The differences between the amplitudes are mainly due to the different positions of the instruments, which were placed at slightly different levels along the tower. It is worth noting that maxima in the acceleration values correspond to minima in the frequency values. In fact, a look at the weather those days revealed very bad conditions, with strong wind velocities (see also Figure 15), thereby suggesting a connection between the frequency reduction shown in Figure 10 and the action of the wind, which due to the masonry's inability to withstand large tensile stresses, tends to decrease the tower's stiffness.

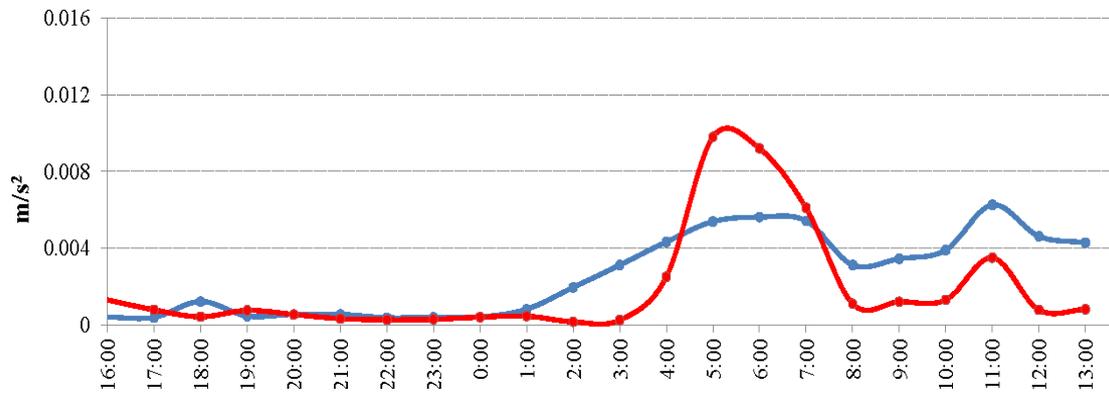
Figure 11. Maximum absolute accelerations recorded by the S.2 station (blue, +37 m) and the S. 945 station (red, +42 m) from 7 to 8 December 2017 (respectively at 16:00 and 13:00).

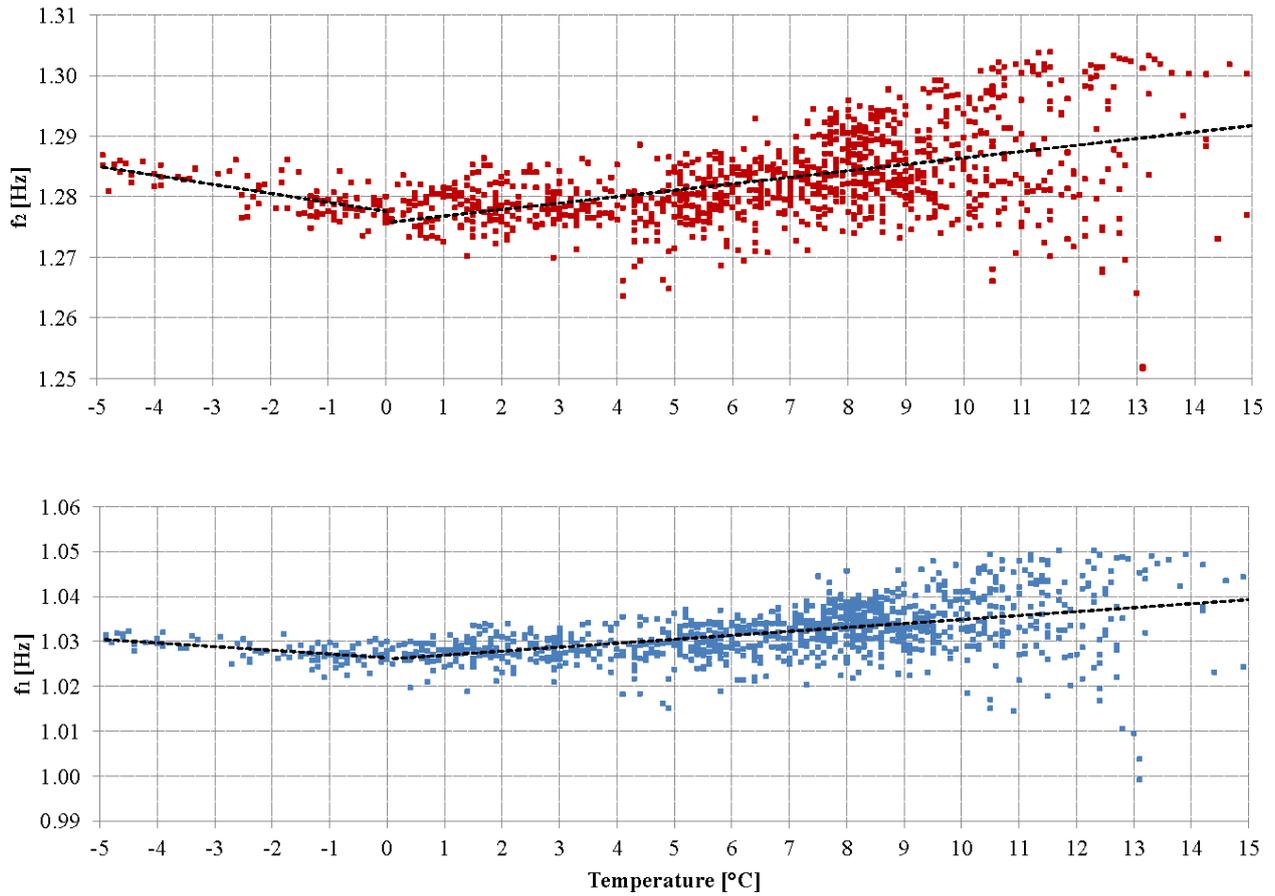
Figure 12. The first (blue) and second (red) natural frequencies of the tower [Hz] vs. temperature [°C].

With regard to the influence of temperature on the tower's dynamic behaviour, Figure 12 shows the correlation of the first two natural frequencies with air temperature, measured by a sensor located in the Lucca Botanical Gardens, in Lucca's historic centre. The figure confirms the findings of other

long-term vibration monitoring campaigns on historical towers (Cabboi et al., 2017), (Ubertini et al., 2017), including that carried out on the San Frediano bell tower in Lucca (Azzara et al., 2018a): frequencies tend to increase with temperature. This behaviour is confirmed by the results described in (Girardi et al., 2017), which reports on a nonlinear FE analysis of the Clock Tower conducted by modelling the effects of the thermal variations on the structure's frequencies. The numerical simulation supports the hypothesis that an increase in temperature induces a reduction in the fracture strains inside masonry, thus increasing the global stiffness of the structure. With regard to negative temperature values, Figure 12 reveals opposite trend for frequencies, which turn out to increase when the temperature decreases. This phenomenon was mainly observed in the latter part of February 2018, when temperatures persistently decreased below zero, as highlighted by Figure 13. Correspondingly, the figure shows the change in the frequency trend. The behaviour below freezing has also been reported for similar weather conditions in (Ubertini et al., 2017) and (Cabboi et al., 2017). It is also worth noting that, as long as the temperature remains above zero, frequencies respond to temperature variations with a phase shift in time, while, below zero, the frequency and temperature appear to be in phase.

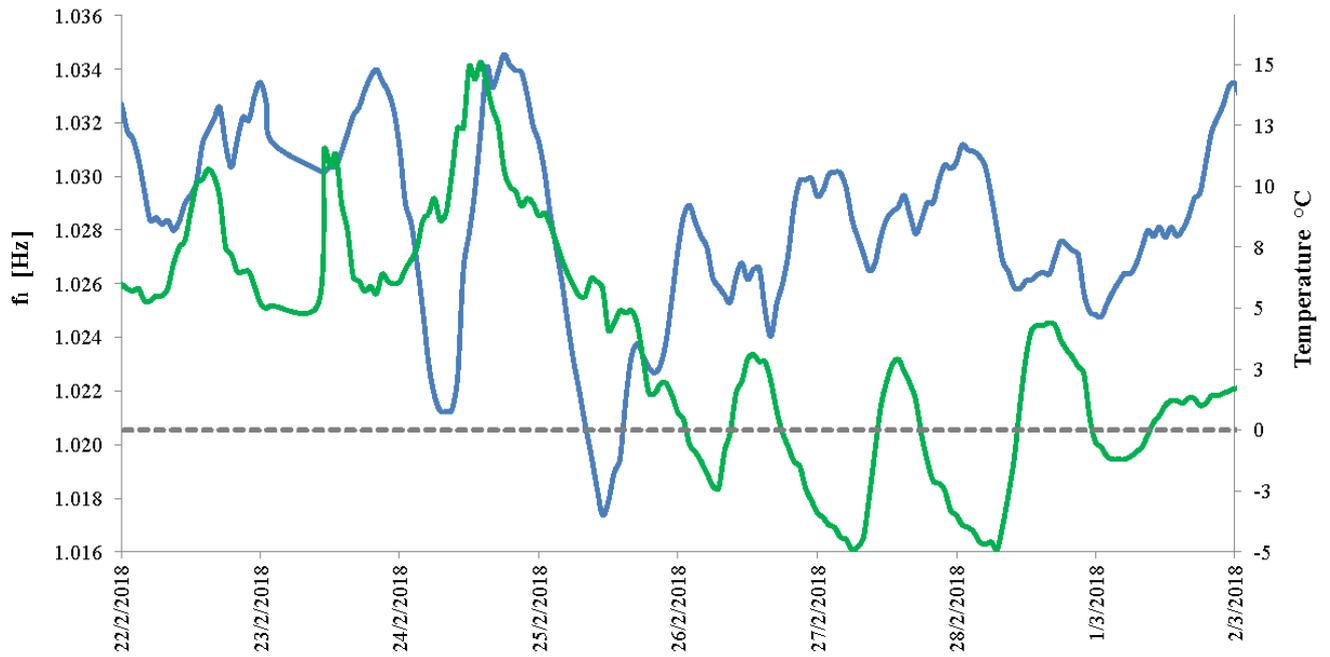
Figure 13. The tower's first (blue line) natural frequency [Hz] vs. temperature [°C] (green line), during February 2018.

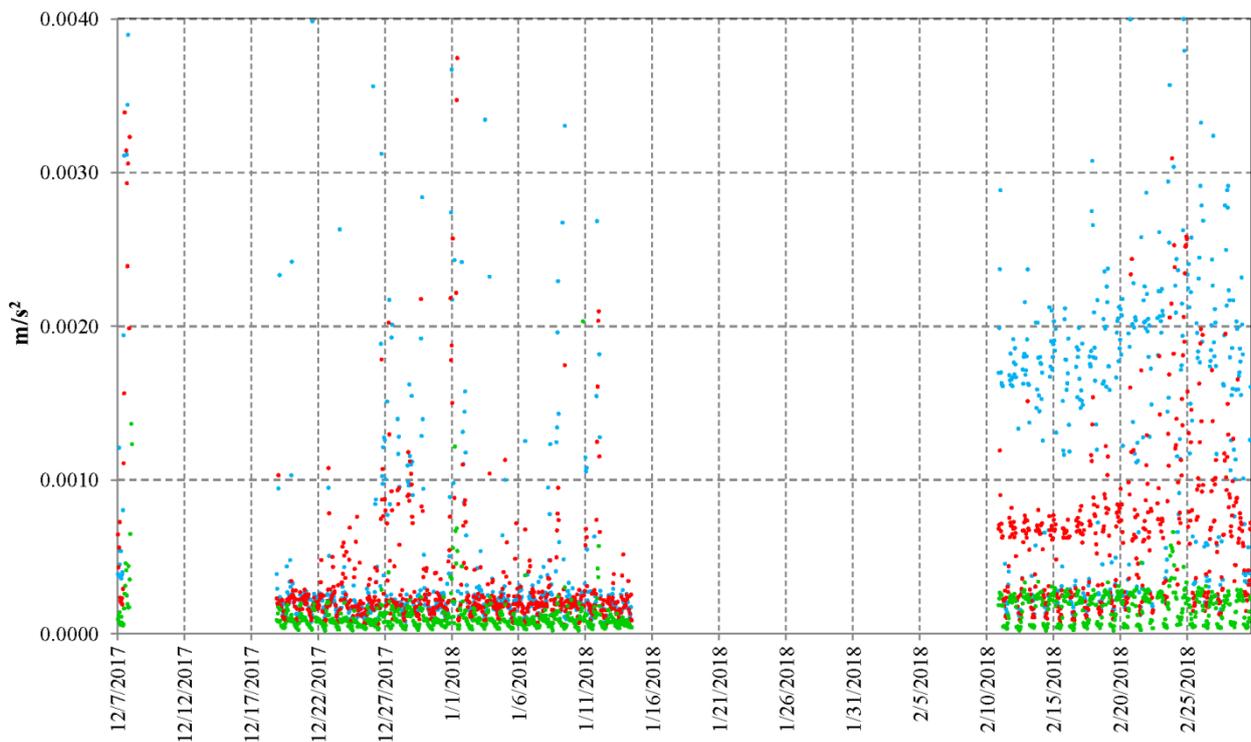
Figure 14. Maximum absolute values per hour of the accelerations recorded by AGI stations (S.2, +37 m) in the  $x$  (blue dots),  $y$  (red dots) and  $z$  (green dots) directions.

The trend over time of the maximum accelerations recorded by AGI sensors is shown in Figure 14. The vibration level in the tower is very low, generally under  $2 \cdot 10^{-3} \text{ m/s}^2$ , thanks to restrictions to vehicular traffic in force in the Lucca historic centre. The figure highlights an increase in the tower's vibration level during the Christmas holiday period (from 22 December to 1 January), connected to the increased pedestrian traffic in the historic centre, with a peak on New Year's Day. The figure also reveals a systematic increase in the accelerations, on average of one order of magnitude, from 9 February onward. This is due to the ringing of the tower bells, which had been suspended for restoration of the ancient clock and was restarted on 16 January 2018. The bell system is composed of three bronze bells, fixed at their supports and rung by hammers each quarter an hour in the  $x$  direction (along Via Fillungo). Indeed, Figure 14 shows significant amplification along  $x$  (blue dots).

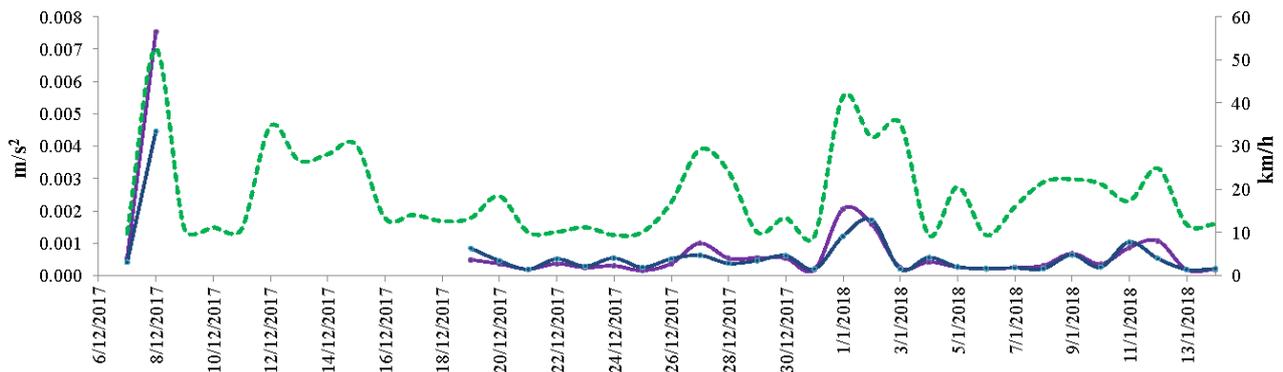
Figure 15. Daily average of the maximum hourly accelerations measured by S.2 vs. time along the  $x$  (blue) and  $y$  (red) directions. The dashed green line stands for the daily maximum wind speed.

With regard to the environmental parameters that could influence the acceleration levels on the tower, Figure 15 plots the daily average values of the maximum hourly accelerations in the  $x$  (blue) and  $y$  (red) directions, for about a month, together with the daily maximum wind speed recorded at Pieve di Compito, about 10 km from the Lucca historic centre (data available at [www.sir.toscana.it](http://www.sir.toscana.it)). The figure clearly shows a correspondence between the peaks in the acceleration levels and those in the wind speed.

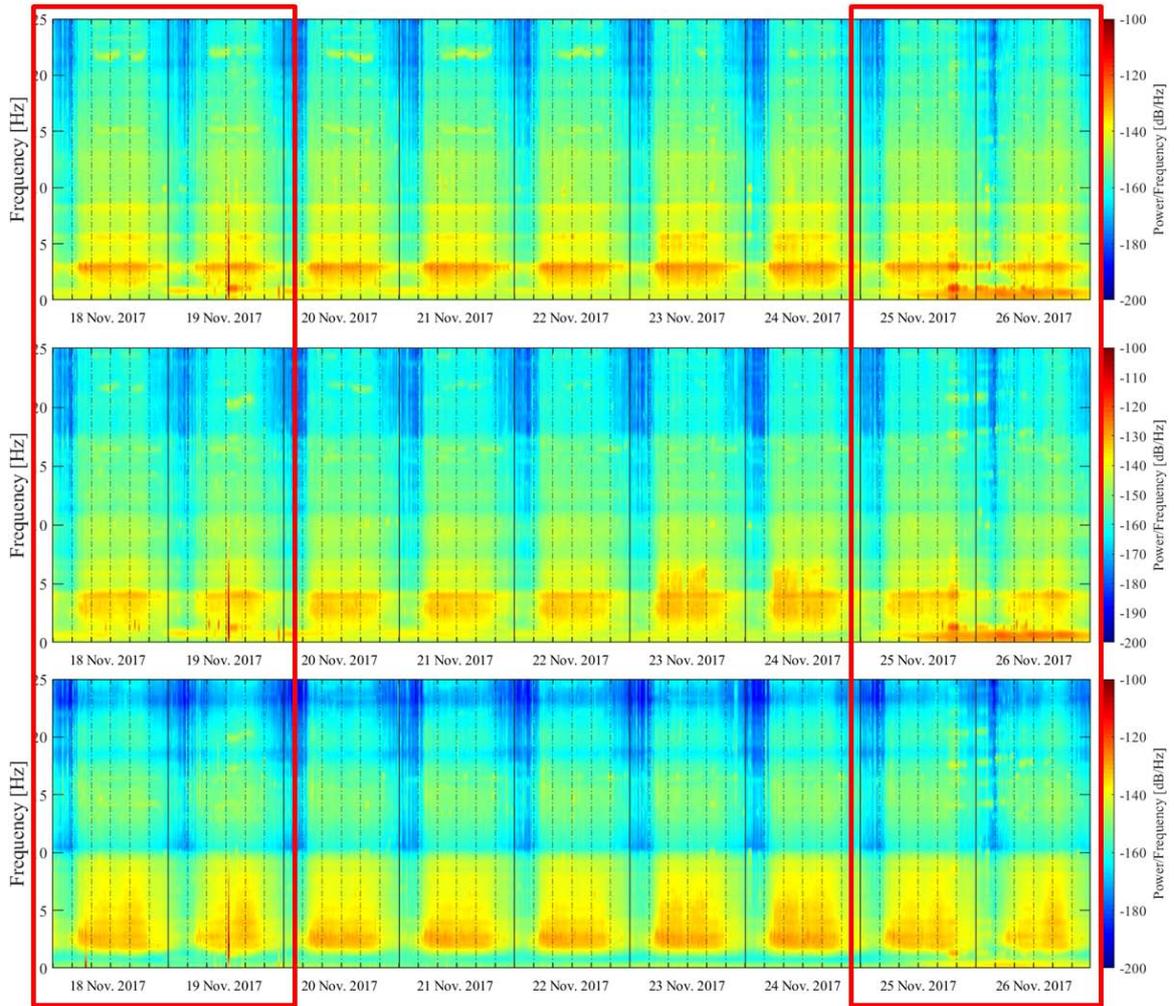
Figure 16. Spectrogram of the signal recorded by S.942 (+ 0,00 m) in the  $x$  (up),  $y$  and  $z$  (bottom) directions from 18 to 26 November 2017. Week-ends are highlighted by the red boxes.

Figures 16 and 17 provide information on the tower's vibrations over time in the band  $[0, 25]$  Hz. In particular, Figure 16 shows the spectrogram of the signal recorded by S. 942, at the base of the tower, in the period 18 November to 26 November 2017, for the three channels  $x$  (up),  $y$  and  $z$  (bottom). The tower's natural frequencies are clearly visible in the band  $[0, 10]$  Hz (horizontal lines), as well as the 3 Hz frequency of the building adjacent to the tower, along the  $x$  direction. As a result of anthropogenic activity, the power frequency increases in the entire band during the daytime, in particular during week-ends (18-19 November, 25-26 November). The three-dimensional spectrogram of channel  $x$  plotted in Figure 17 also highlights other anthropogenic activity between 20 and 25 Hz, which could be attributed to traffic in the historic centre. At about 12:30 (UTC) on 19 November, there is a clear frequency peak, which can be attributed to the M4.4 Parma earthquake reported in Table 3.

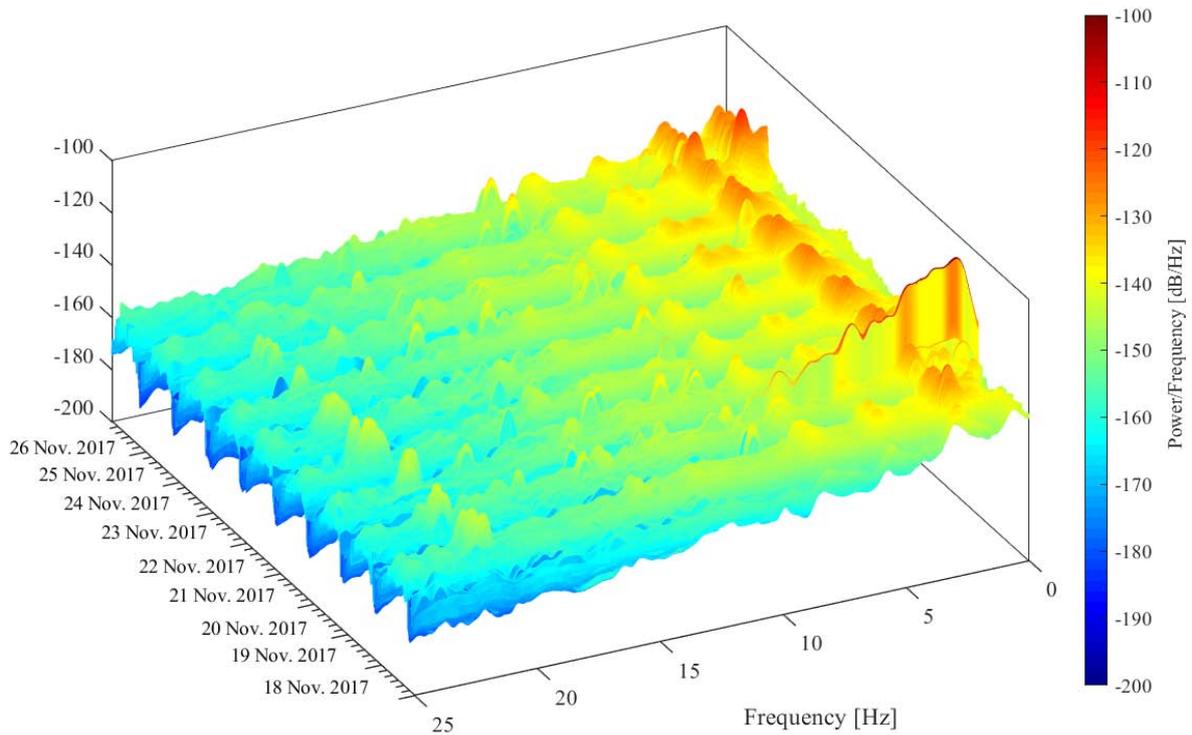
Figure 17. Three-dimensional spectrogram of the signal recorded by S.942 (+0,00 m) in the x direction from 18 to 26 November 2017.

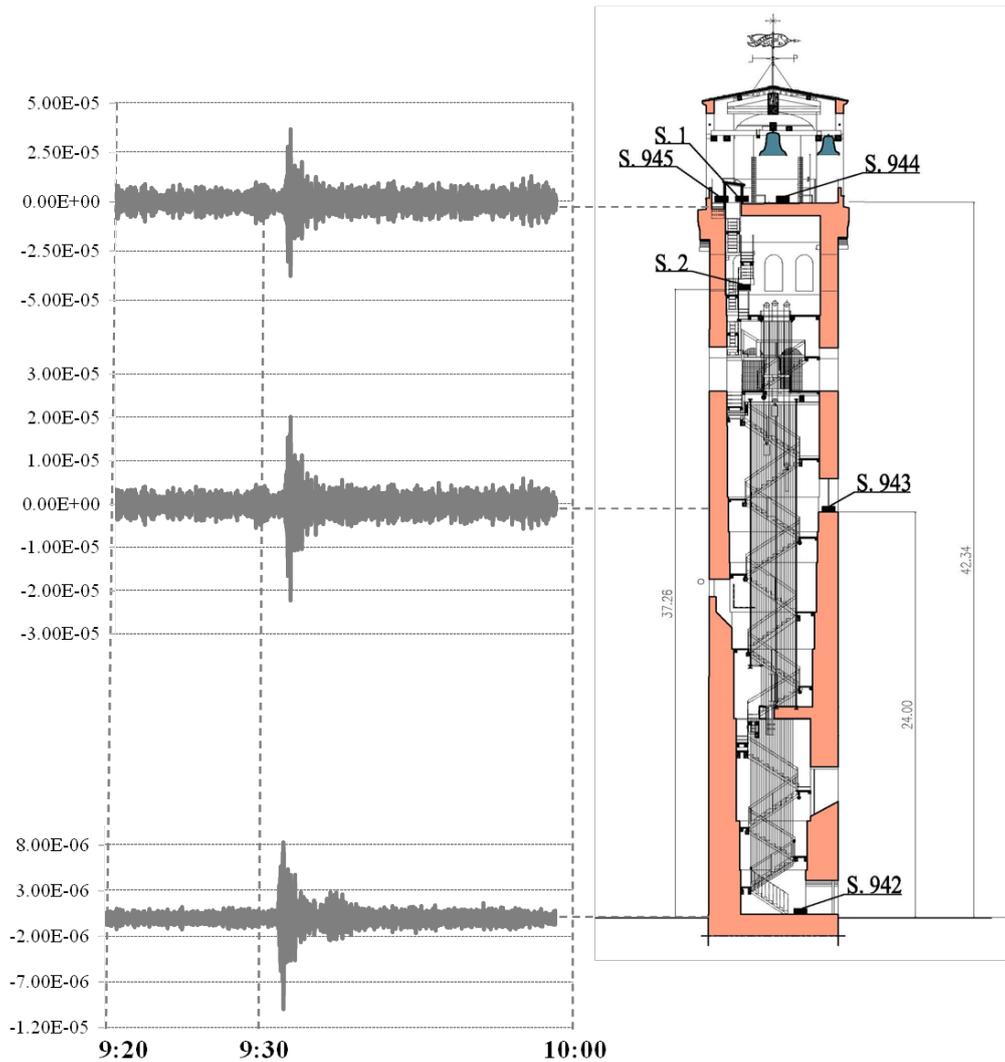
Figure 18. Signal of the Peru earthquake recorded on the tower in the  $x$  direction by S.942, S. 943, S.944 on 14 January 2018 from 9:33 (UTC) onward. Signal amplitude is in  $\text{m/s}^2$ .

Many seismic events have been detected on the tower during the monitoring period. Table 3 shows the main earthquakes recorded, while Table 4 reports the teleseismic events identified in the signals. Figure 18 shows the teleseismic record of the Peru earthquake, which occurred at 09:18.44 (UTC) with a magnitude of 7.1, and was recorded at about 09:33 (UTC) by the instruments on the tower. In particular, the figure shows the signals recorded by the SS20 seismic stations at different levels along the tower's height in the  $x$  direction. The same event was also recorded by the S.2 accelerometer. At such a considerable distance from the epicentre, the seismic signal loses its high frequency content and becomes recognizable only at low frequencies. The records in the Figure were obtained by filtering the signals via a Butterworth band-pass filter with lower cut-off frequency of 0.04 Hz and a higher cut-off cut at 1 Hz. It is worth noting that after the first arrival of the waves the event remains clearly recognizable in the signals for long time.

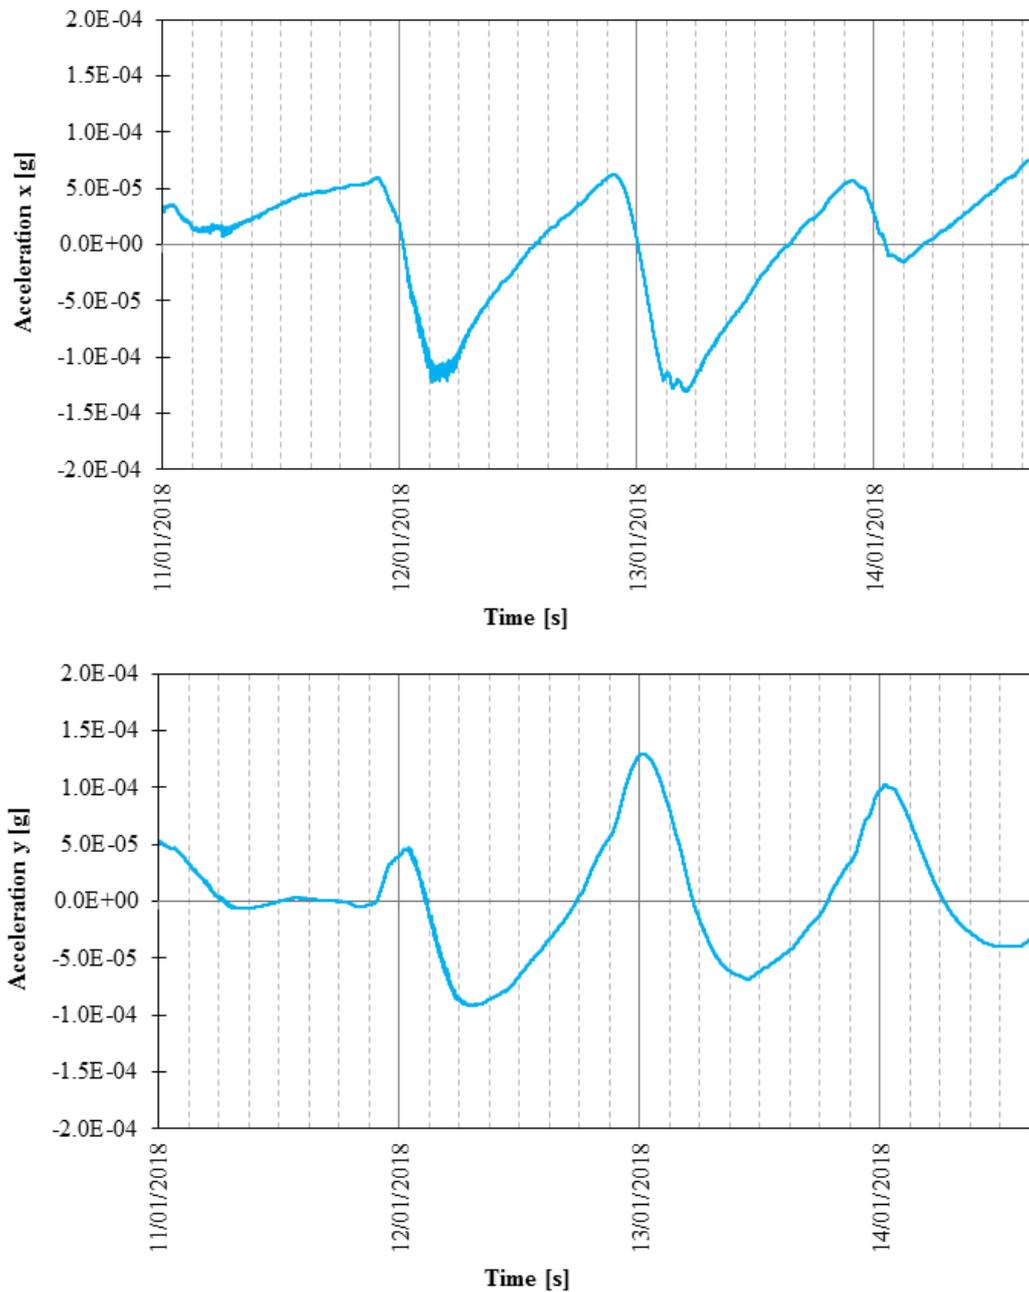
Figure 19. Low-pass filtered accelerations recorded by S.2 along the  $x$  and  $y$  (bottom) directions from 11 to 14 January 2018.

Analyzing the low frequency content of the recorded signals can provide further information on movements of the tower. Figure 19 shows the signals recorded by the S.2 accelerometer from 11 to 14 January 2018 along the  $x$  (up) and  $y$  (bottom) directions. The signals in the figure were low-pass filtered with a cut-off frequency of 0.5 Hz, and clearly reveal a slow oscillation with period of about 24 hours. The same oscillations can be detected in the temperature signal (Figure 20) measured by the sensor inside the instrument. The temperature signal is however not in phase with the accelerations, thus demonstrating that the oscillations of the accelerometric signal are not a direct effect of temperature on the instrument. It is also worth noting that the signals along the  $x$  (North-South direction) and  $y$  (East-West direction) directions present a phase shift of 3 to 6 hours, and the  $y$  signal is delayed with respect to that along  $x$ . A possible interpretation of these oscillations lies in the daily temperature variations caused by exposure of the tower to the sun. As the exposure of the façades changes during the day, the tower appears to twist as shown in the figures. A measure of the displacements induced by this effect at the top of the tower can be easily obtained from the figures. In fact, for small oscillations, the modulus of the tangential acceleration expressed in  $g$  coincides with the inclination angle of the tower in radians. Thus, taking into account the actual position of the instrument (at +37 m), horizontal displacements turn out to be on the order of 3-4 mm for both

directions. These daily movements appear to be the largest that the tower undergoes under normal conditions, as an effect of environmental factors.

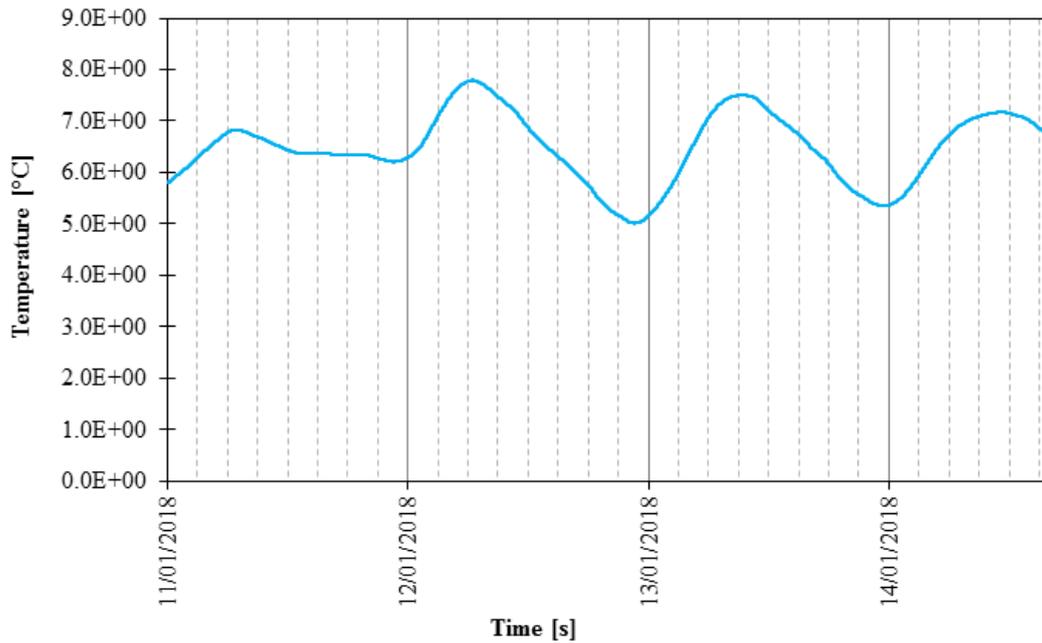
Figure 20. Temperatures recorded by the sensor installed inside S.2 from 11 to 14 January 2018.
