<b>Number</b>	240
<b>Publication Year</b>	2023
<b>Acceptance in OA@INAF</b>	2023-02-01T15:19:58Z
<b>Title</b>	MAJIS Shutter QM and FM Thermo-vacuum Test Report
<b>Authors</b>	STEFANI, STEFANIA; PICCIONI, GIUSEPPE; BIONDI, David; BOCCACCINI, Angelo
<b>Affiliation of first author</b>	IAPS Roma
<b>Handle</b>	<a href="http://hdl.handle.net/20.500.12386/33107">http://hdl.handle.net/20.500.12386/33107</a> ; <a href="https://doi.org/10.20371/INAF/TechRep/240">https://doi.org/10.20371/INAF/TechRep/240</a>

# **MAJIS Shutter QM and FM Thermo-vacuum Test Report**

This test report provides a summary of the Thermo-Vacuum Test results on the QM and FM shutter units, a mechanical part of the spectrometer MAJIS (Moon And Jupiter Imaging Spectrometer), a payload instrument on board of the JUICE (JUperiter ICy moons Explorer) mission. The shutter actuator is composed by an electromagnetic brushless actuator mounted with an aluminium blade. The aims of the actuator are to maintain the blade in two stable positions (open and closed), to rotate the blade from one position to other in a time less than 300ms and a low power consumption. These tests have been conducted to demonstrate the capability of t

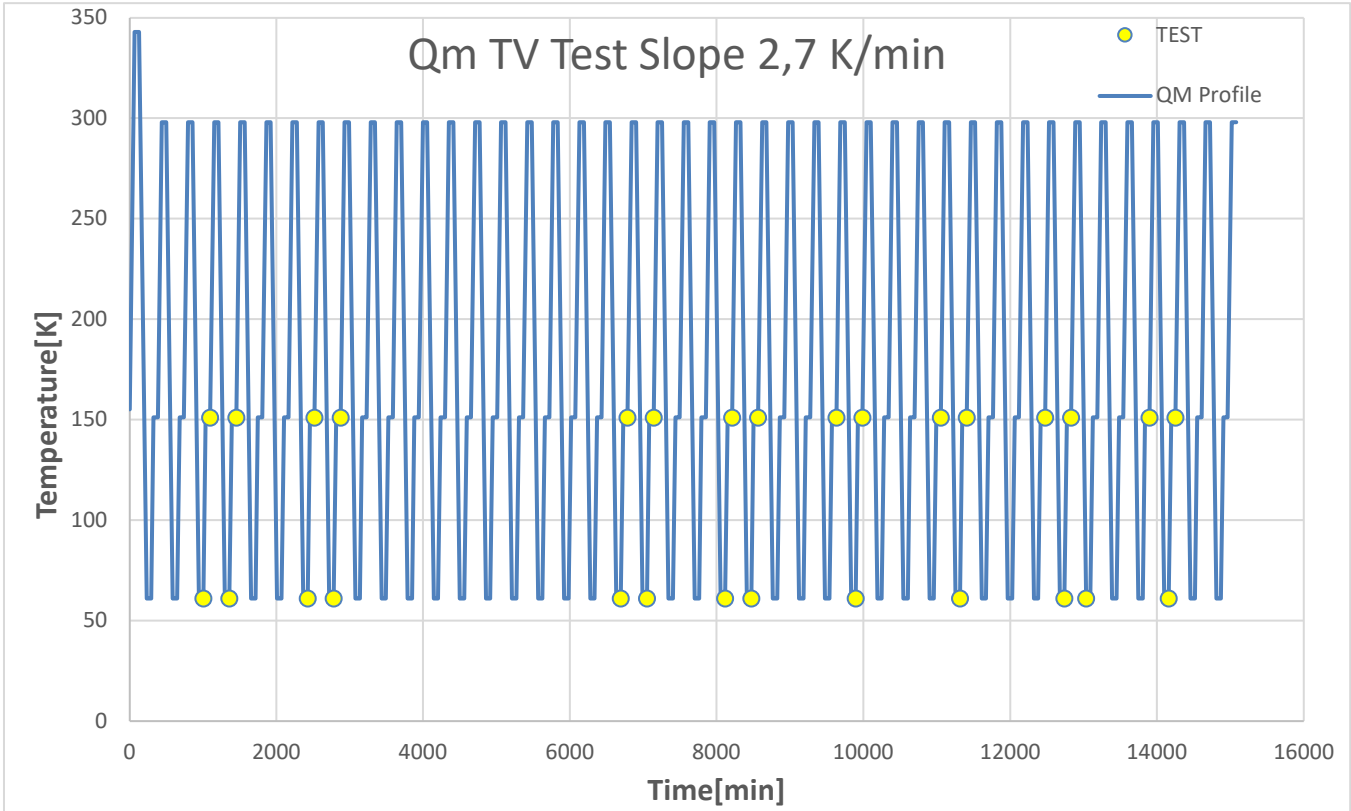
Figure 7: Temperature set point plot for the overall cycles of the QM

To comply with these motor temperatures, the temperature set point of the controller has been set at 61K, 151K for the above key points and 343K for the hot point. The overall cycles for the temperature set points are shown in Figure 7 where there are also indicated the points (yellow dots) where the shutters shall be activated. Notice that not all the activations are performed for all the cycles due to the exclusion of the night-time working hours and sometime only a single test for a cycle has been executed for the same reason.

The temperature difference between the motors and the set point temperatures is mainly due to the thermal flux from the ambient to the motor coils.

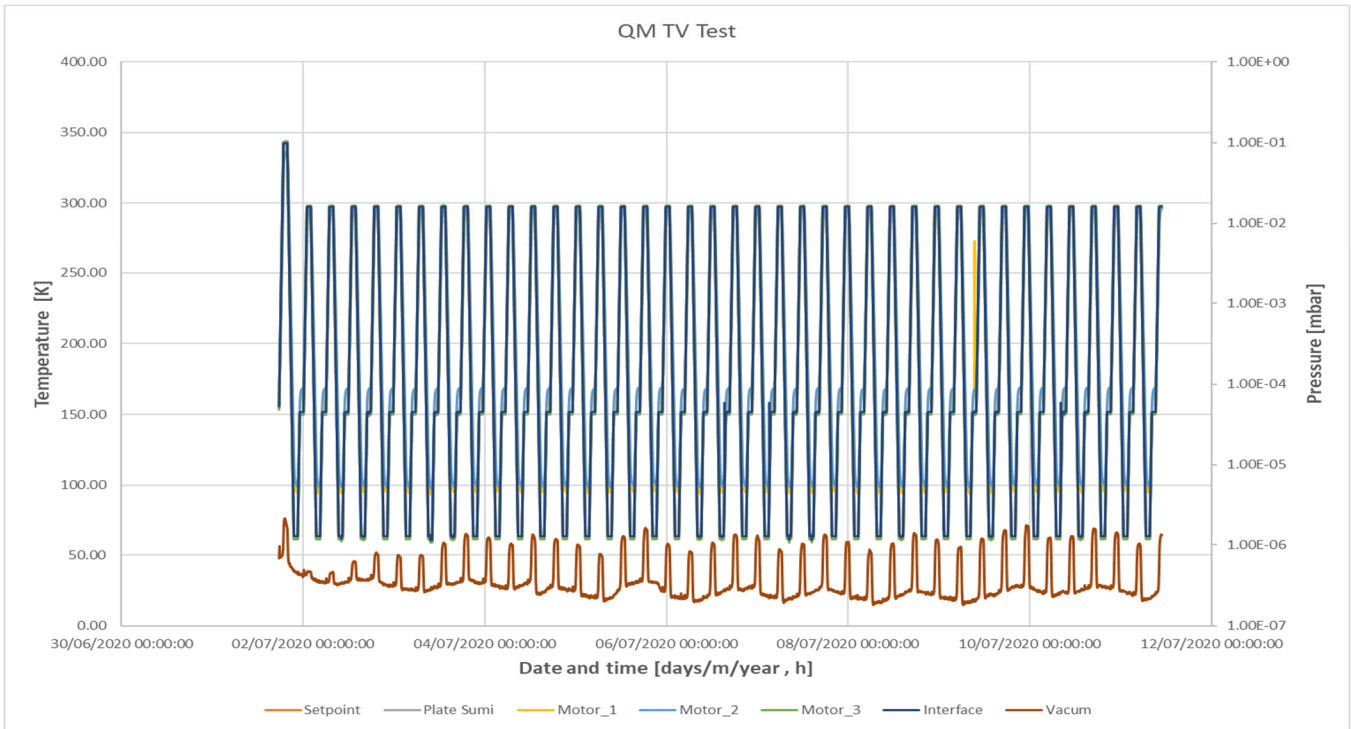
Figure 8: Temperature and vacuum plots for the QM test

In Figure 8 a plot of the temperatures and vacuum data acquired during the thermo-vacuum cycles is shown. For the performance test 42 thermo-vacuum cycles have been performed but only data of 40 cycles have been saved due to a software problem of the setup.

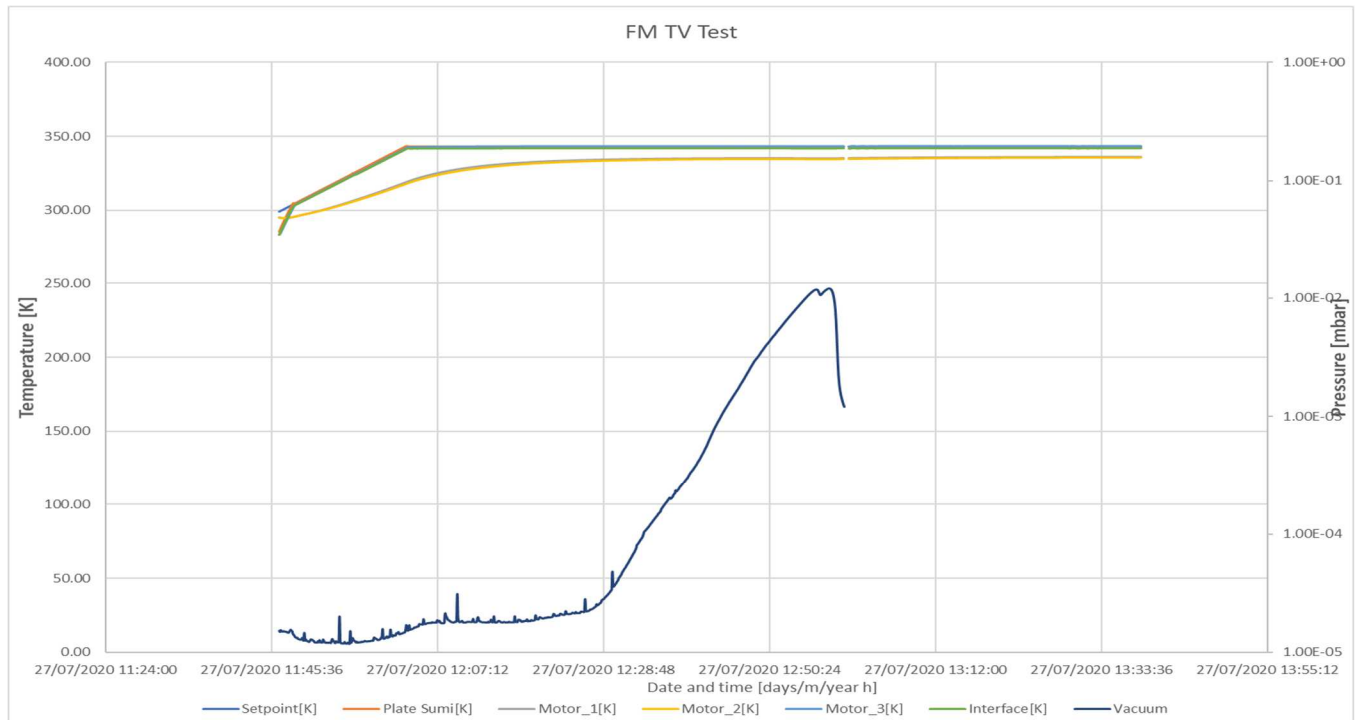
**Figure 13: temperature and vacuum data plot for the FM test**

The data acquired during the heating are shown in Figure 13 and these are the only available acquired data due to a software problem. Nonetheless all the cycles have been performed regularly. The only data available are in an excel file named IAPS-PLAB-TV-RP-001\_Iss1\_rev0\_FM-data.xlsx. The temperature values recorded by hands during the activations are instead reported in Table 4.

The temperature and vacuum data acquired during the tests were lost due to a software bug and they have not been recovered. Only the temperatures manually recorded are available in the table.
