Zero Bias Configuration validation test using the NI-PLM setup

Ref : EUCL-IBO-TN-7-031
Issue : 1.0
Date: 04/01/2021
Page: 1/27

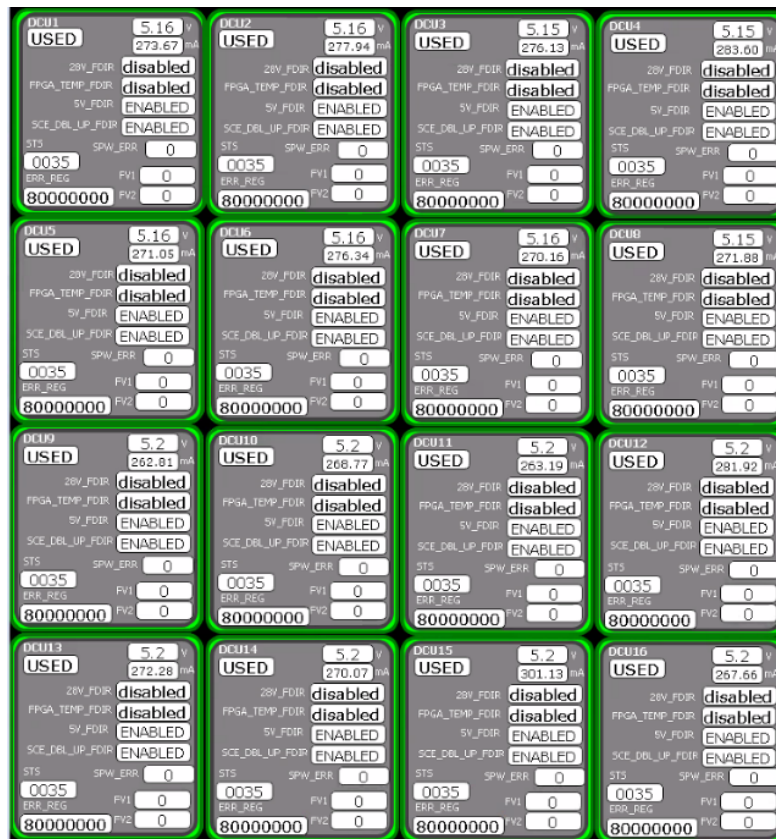
Figure 2, entire NI-Focal Plane under ZBC, all telemetries correspond to nominal values. The image is the Focal Plane's display of the TASI synoptic.

- Tested with 16 DCUs/SCEs all OK see Figure 2; each ZBC register was tested correctly using a memory DUMP; 2 x repetitions of the ZBC configuration (1) were done, for each one a single broadcast nominal dither cycle was acquired.

- Procedure correctly set to 16 DCUs/SCEs, DCUs status were the same ones showed in Figure 2 (all nominal values). In Figure 3 are represented the signal images of the entire focal plane under ZBC.

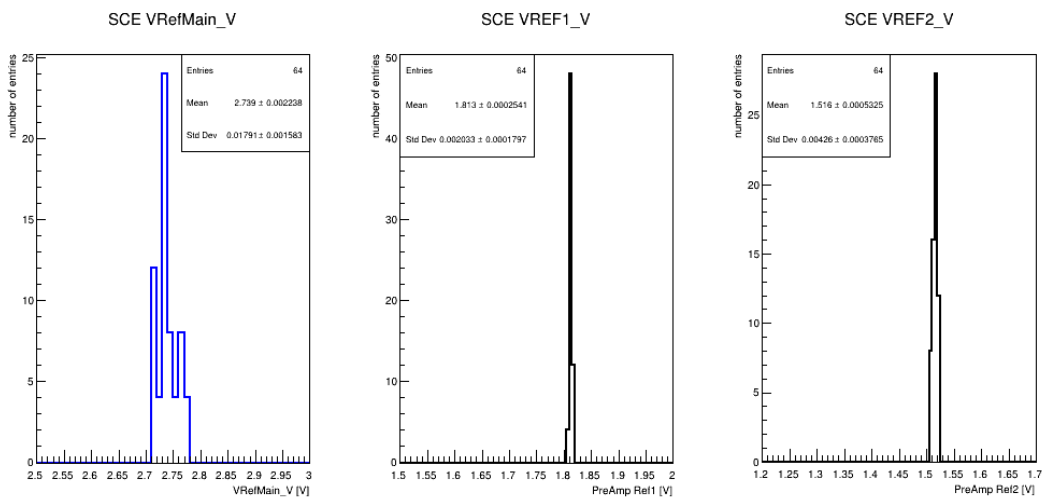
Figure 10, nominal SCE power supply voltages, V_{RefMain} (left), V_{Ref1} (center) and V_{Ref2} (right), of the Focal Plane under ZBC

Figures 10, 11, and 12 shows examples of nominal SCE's operational biases (internal):

$$V_{\text{RefMain}}_{\text{ZBC}} = 2.74 \pm 0.02 \text{ [V]},$$

$$V_{\text{ref1}}_{\text{ZBC}} = 1.813 \pm 0.002 \text{ [V]},$$

$$V_{\text{ref2}}_{\text{ZBC}} = 1.516 \pm 0.004 \text{ [V]}$$

The SCA biases set to null values were verified, see for example Figures 8 and 9; also, nominal operations of the SCEs were verified, for example see the distributions of Figures 10, 11, and 12.

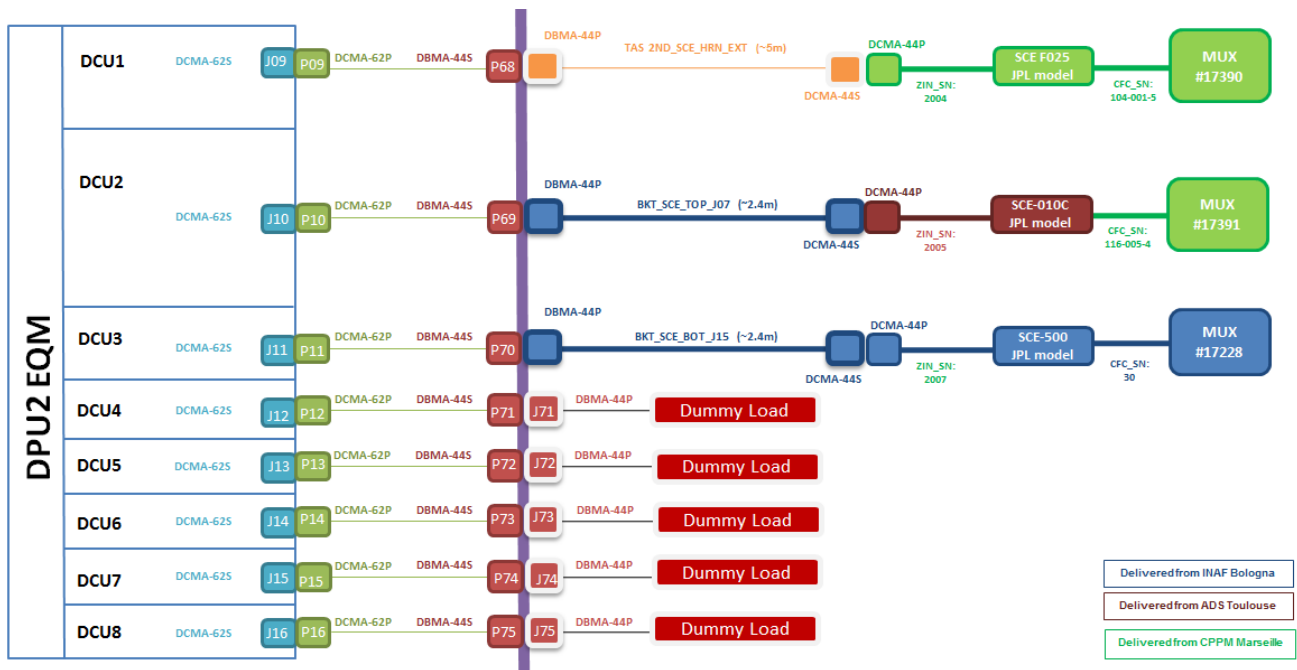
Figure 14, NI-AVM setup in a flight-like configuration (using 2 type-B and 1 type-A SCEs and MUXs (scheme provided by TASI).

At TASI premises using the NISP AVM setup using only the DPU-EQM and 3 DCUs (DCU1, DCU2, and DCU3) equipped with one type-A SCE (DCU1) and two type-B SCEs (DCU2 and DCU3) interfaced with two MUXs through flight-like Zin flex cables; to connect the DCUs with the SCEs flight like harnesses (used during the NI-TV3 tests), Figure 1.

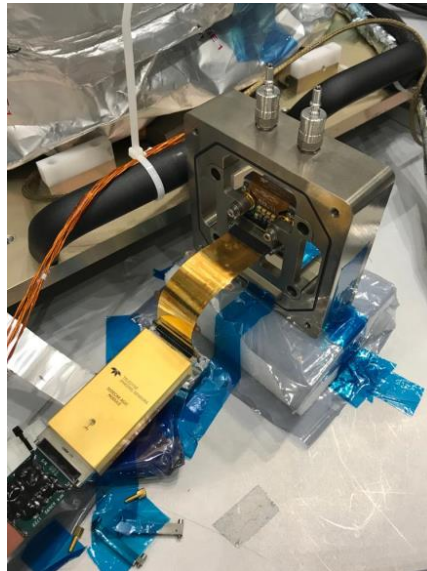
Figure 16- SCE SN033 setup for ZBC validation (photograph provided by TASI).

NOTE 1: Exactly the same procedure was working correctly at the validation tests of the OLD ZBC at TASI in July, but the grounding setup was different. Setup of the SCE Teledyne (SN-033) used to validate ZBC in July is shown in Figure 3 (GND connect on SCE case using screw on the SCE bottom)

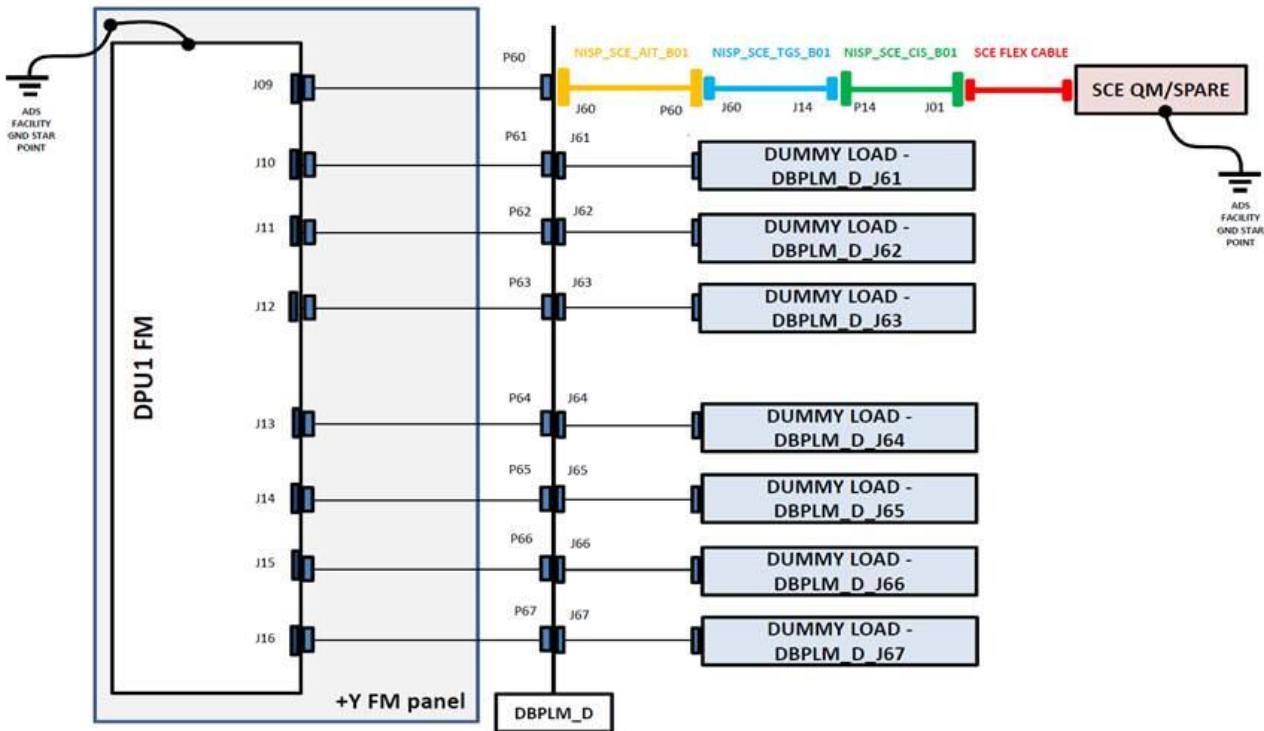
Figure 22 - Test in ADS using all harness and SCE-010C unloaded (scheme provided by TASI).

An investigation test campaign was performed in ADS on the 15th of October.
The test setup used SCE-010C installed on bench and using all harness as connected to NIOMADA FM. DPU1 FM units was used and no MUX installed on SCE connected to DCU1.

Test setup below in Figure 9:
