TITLE: **Quick Look Data Analysis of LFI
During EMC Test**

DOC. TYPE: **Test Report**

PROJECT REF.: **PL-LFI-PST-RP-030** **PAGE:** I of IV, 16

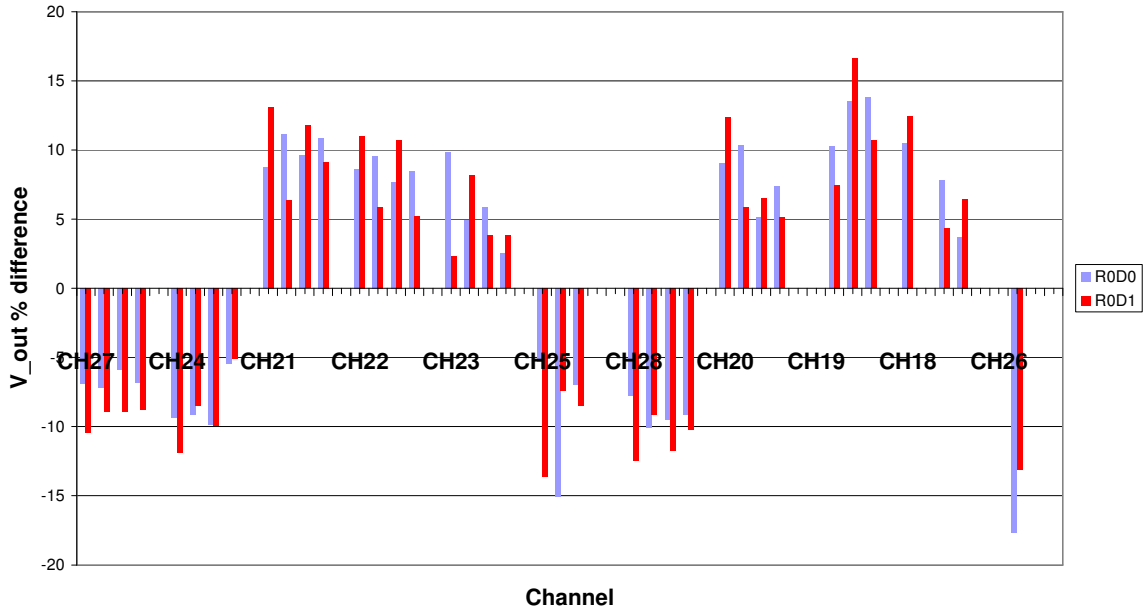
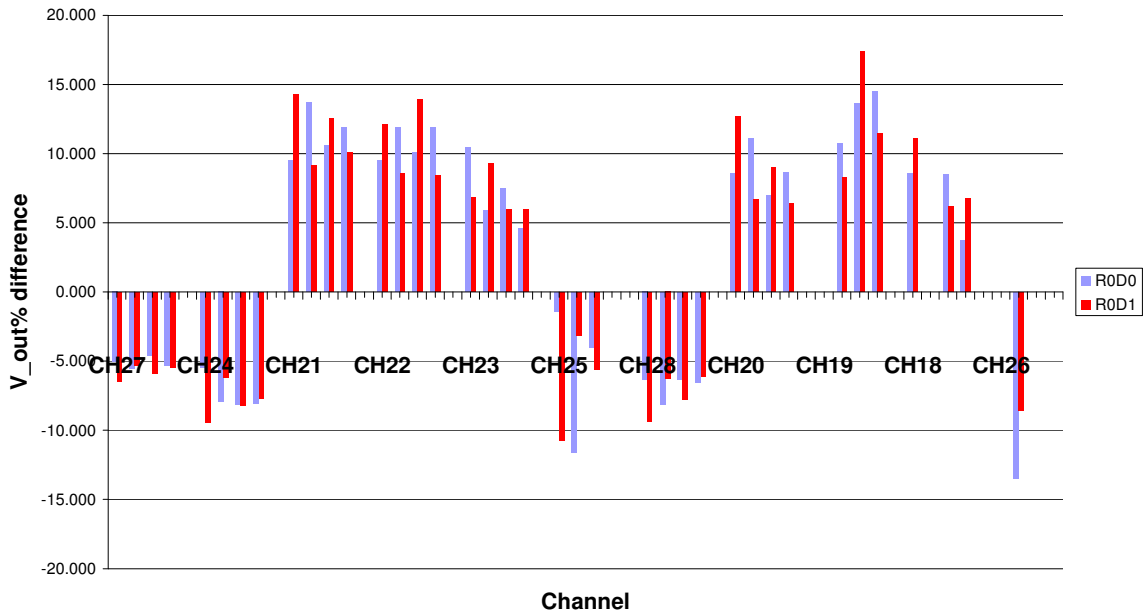
LFI ON: scientific output w.r.t. RAA

LFI ON: scientific output w.r.t. WFT

From the two figures above you can see that the scientific output of the radiometers is sometimes surmounting the limit of the pass fail criteria. It could be

possible, from a quick analysis, that the reason of this could be found in a higher temperature of the BEU. This temperature is inside the soft limit, nevertheless LFI never operated at this temperature before. Indeed during previous tests there were at least 10 degree less at the same interface.
