AMBIENT VIBRATIONS OF AGE-OLD MASONRY TOWERS: RESULTS OF LONG-TERM DYNAMIC MONITORING IN THE HISTORIC CENTRE OF LUCCA.

The paper presents the results of an ambient vibration monitoring campaign conducted on so-called “Clock Tower” (Torre delle Ore), one the best known and most visited monuments in the historic centre of Lucca.

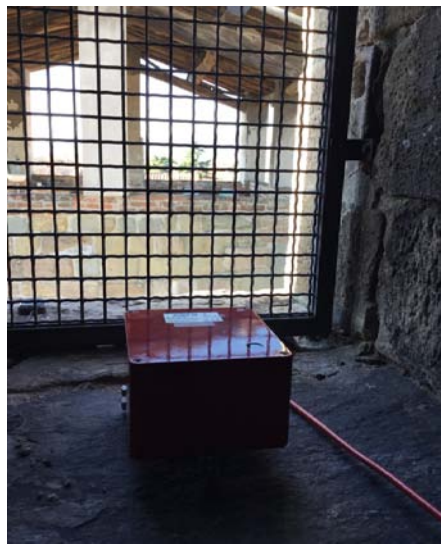
Figure 3. Sensor S.943 at level +24 m

In November 2017 a long-term ambient vibration monitoring experiment was begun with the fitting of six instruments along the tower's height: four Sara SS20 seismometric stations (tri-axial velocimeters, Fig. 3) from the INGV, named in the following S.942, S.943, S.944, S.945, and two tri-axial accelerometers (Fig. 4) provided by the firm Assist in Gravitation and Instrumentation (AGI S.r.l.), named in the following S.1 and S.2. The INGV sensors were coupled with a 24-bit digitizer and the signal was sampled at 100 sps. The AGI data were acquired by a laptop at a sampling frequency of 20 Hz using a 24-bit digitizer. With regard to the main characteristics of the instruments used in the monitoring campaign, the SS20 velocity transducers have a nominal sensitivity of 200 V/m/s, eigenfrequency of 2 Hz, and usable band from 0.1 to 250 Hz. The AGI accelerometers have an acceleration noise density of $2 \cdot 10^{-8} \text{ g}/\sqrt{\text{Hz}}$ and usable band from 10^{-5} to 50 Hz. It is worth noting that together the instruments can cover a very wide band of frequencies. The instrumentation was kept running on the tower up to March 2018. Figure 5 shows the layout of the sensors along the tower during the experiment: seismic station S.942 was placed at the base, collecting data from the ground, S.943 was at the height of 24 m above street level, the remaining two stations S.943 and S.944 were placed on the bell chamber, at about +42 m above street level. The AGI stations were both installed in the upper part of the structure, S.2 at +37 m and S.1 on the bell chamber level.

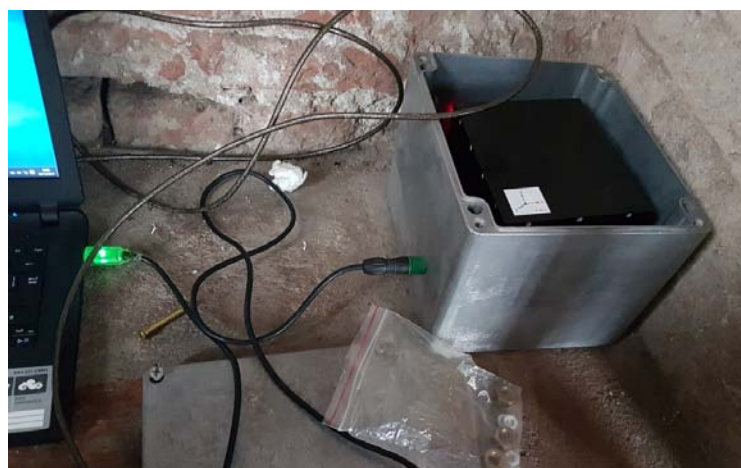
Figure 4. Sensor S.2 at level +37 m inside the tower.

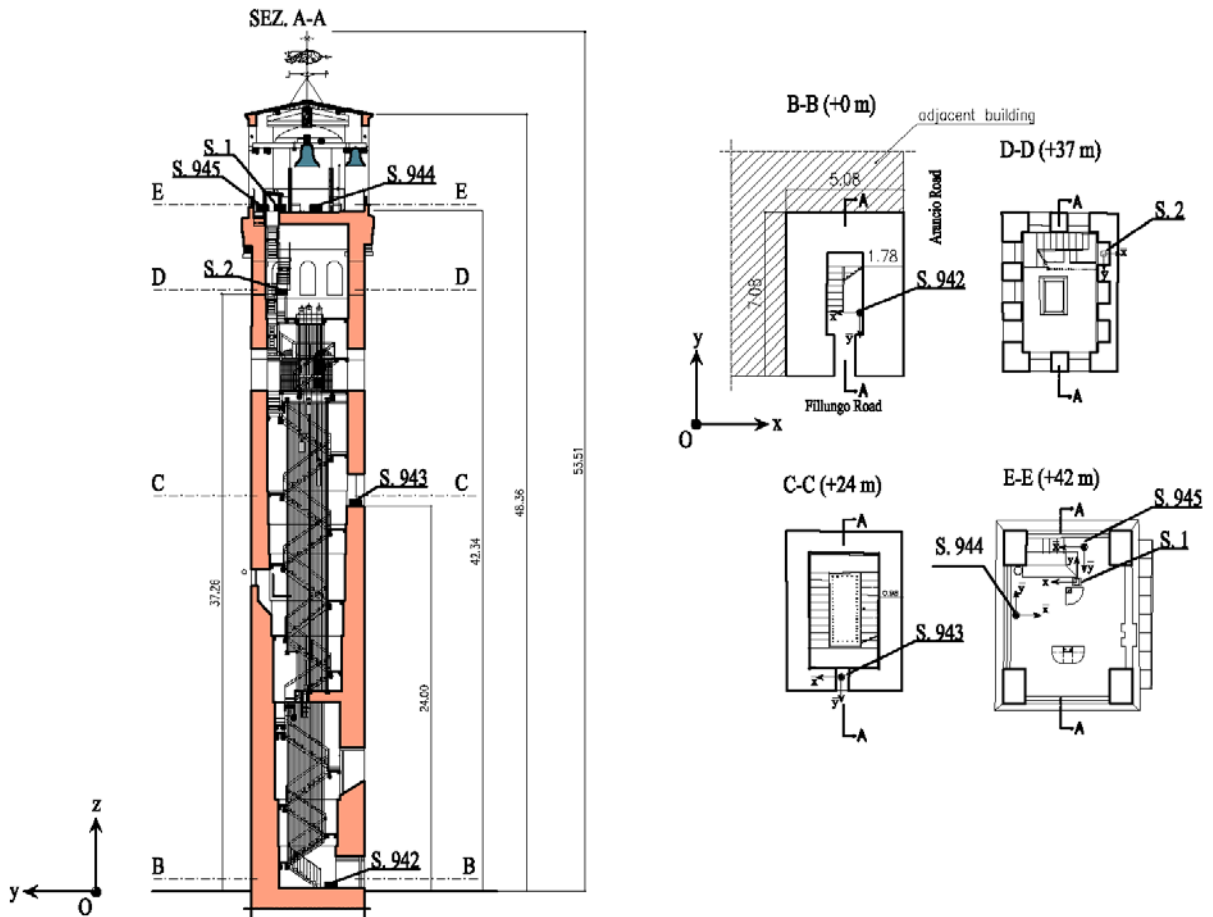
Figure 5. Sensor arrangement on the Clock tower: sensors S.942, S.943, S.944, S.945 (INGV), sensors S.1, S.2 (AGI).

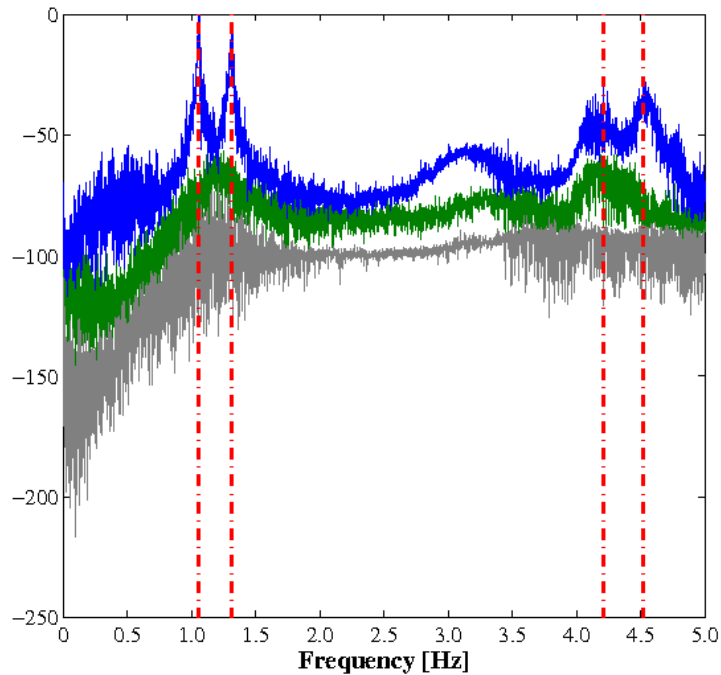
Figure 6. The three eigenvalues of the matrix $H[j\omega]^H H[j\omega]$ vs. the frequency on a log-magnitude scale.

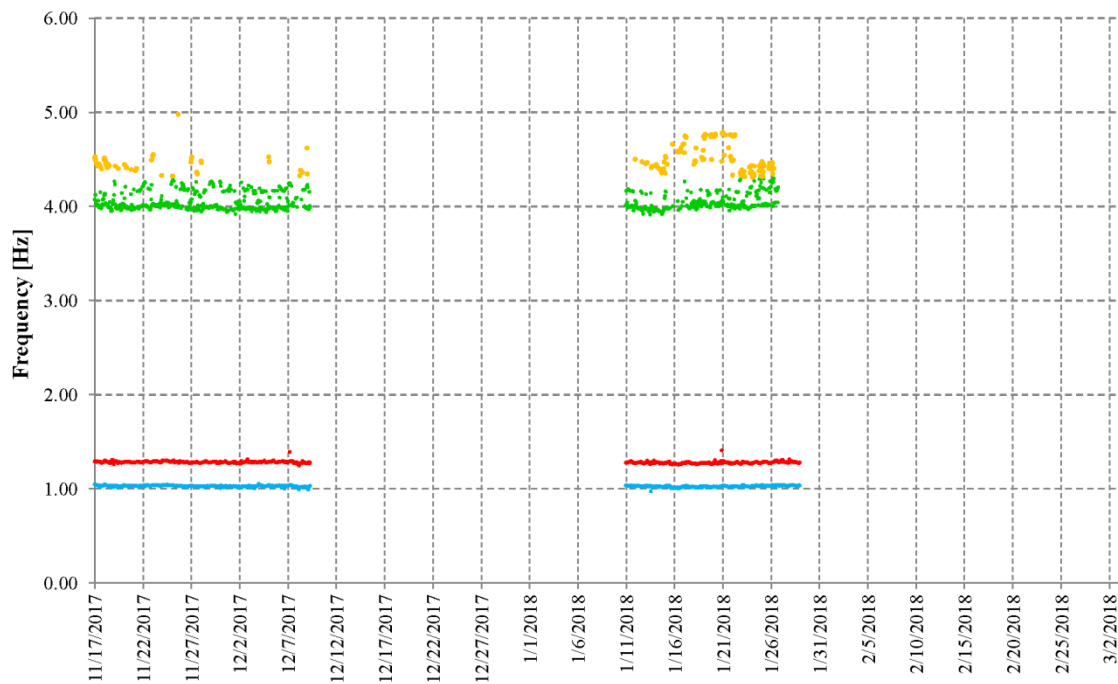
Figure 7. The tower's first four natural frequencies [Hz] detected by SS20 velocimeters during the monitoring period.

The tower's frequencies are reported in Table 1, where the mean values (evaluated over the entire monitoring period from November 2017 to March 2018) of the four frequencies are reported, together with their relative differences (evaluated on the 1st and 99th percentile) for the two different instruments. The frequencies values measured on the Clock Tower are in good agreement with those of other towers with similar geometries (Bartoli et al., 2017). The dataset from the SS20 seismic stations includes 970 hours of recordings, while the AGI instrumentation yielded 1110 hours of tower measurements. The frequency values vs. time are reported in Figures 7 and 8 for the SS20 and the AGI instruments, respectively. The mean values evaluated by the two instruments are in very good agreement. The first and the second frequencies were detected by the two instruments in all records, and the variation in the two frequencies is on the order of 3%. This variation is also in good agreement with the findings of another long-term dynamic monitoring conducted on the San Frediano bell tower in Lucca (Azzara et al., 2018a). The third frequency was also detected by the seismic stations in almost all records, while the fourth frequency only appears when the excitation level in the tower's structure was increased (it was detected in about the 30% of the records), and its values appear to be widely dispersed. A fifth frequency at about 5.7 Hz was also detected in about 30% of the records. With regard to the modal damping ratios, reported in Table 2, they are widely dispersed with variations on the order of hundreds of percentage points. Their values vary from 4% for the highest frequency, to 0.5% for the first. The values yielded by the seismic stations are generally higher than those from the accelerometers.

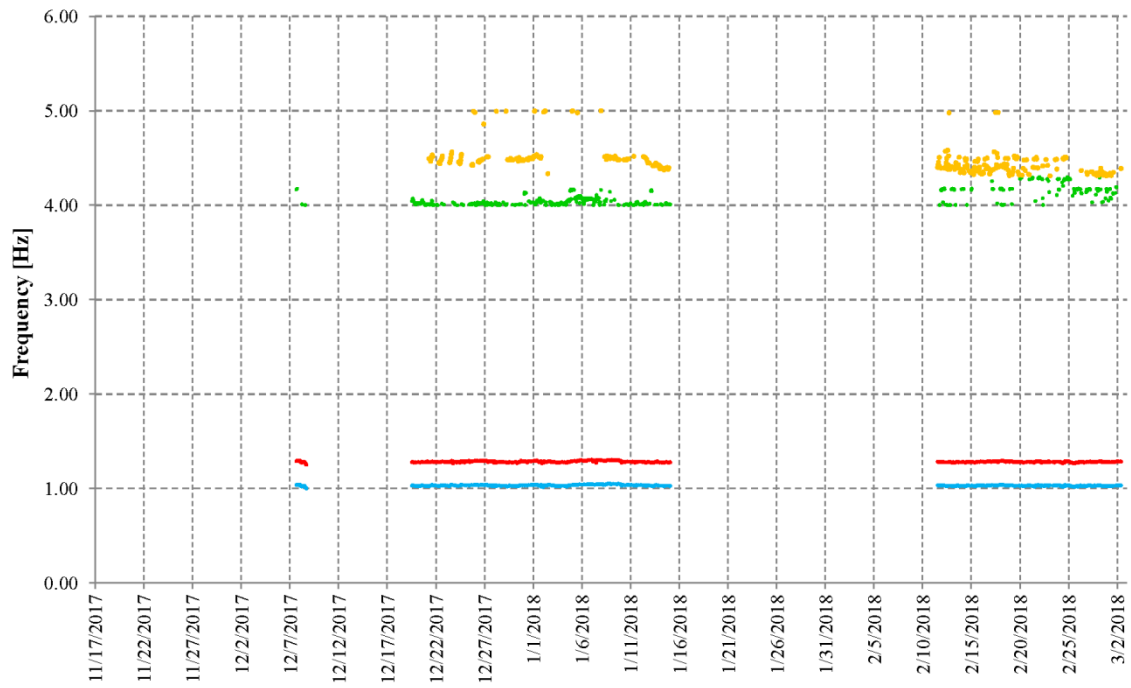
Figure 8. The tower's first four natural frequencies [Hz] detected by AGI accelerometers during the monitoring period.

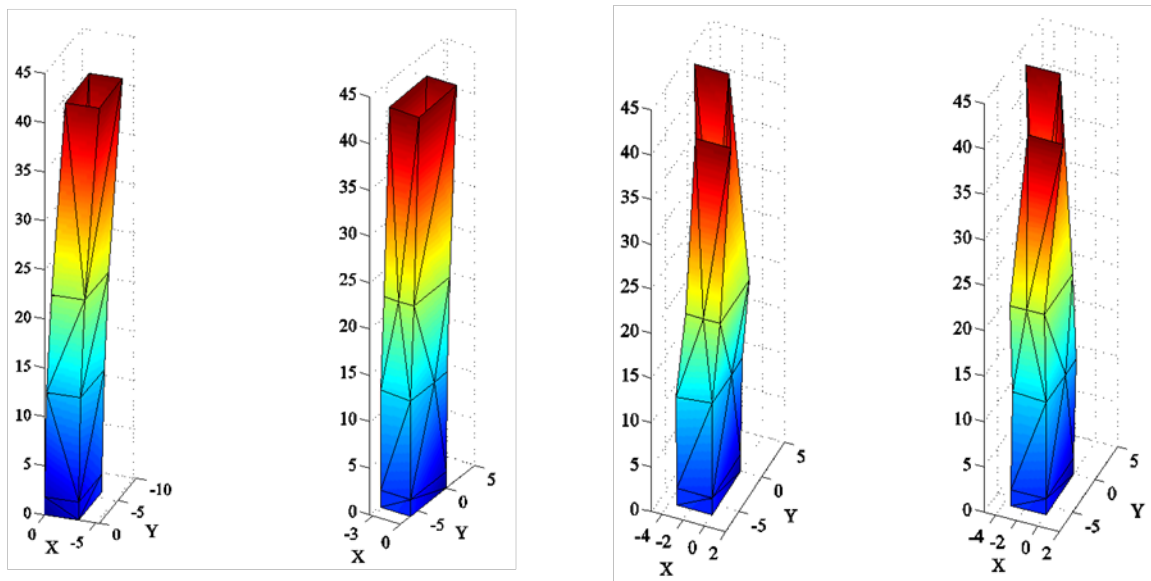
Figure 9. The tower's first four mode shapes [Hz] corresponding (from the left) to the frequencies f_1 , f_2 , f_3 , f_4 .

The mode shapes of the tower corresponding to the four frequencies f_1, f_2, f_3, f_4 are shown in Figure 9; these have been extracted from the data recorded in November 2016 by taking advantage of the different layouts used for mapping the tower's vibrations. The first two frequencies refer to bending modes along the x (first) and y (second) directions, while the third is a torsional mode and the fourth is a torsional-bending mode involving movements of the structure's upper parts.

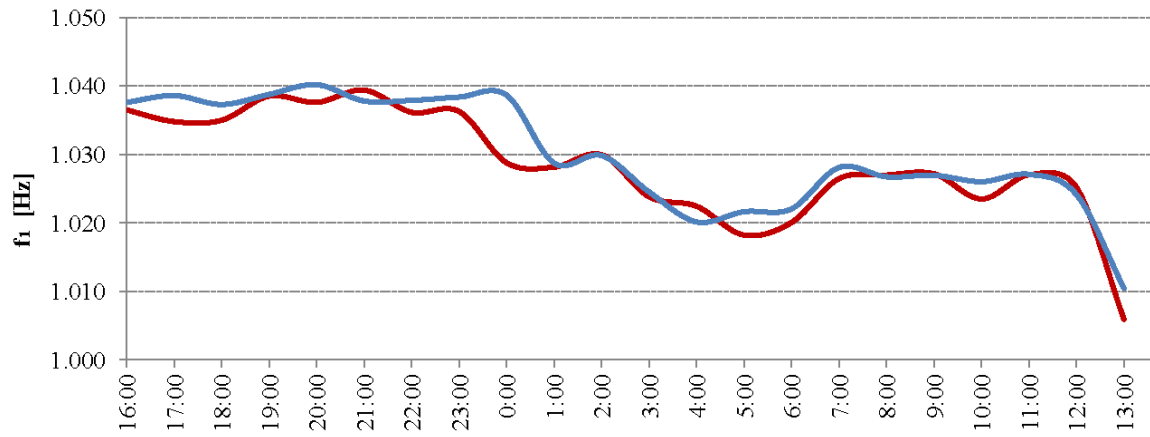
Figure 10. The tower's fundamental frequency obtained via AGI stations (blue) and SS20 stations (red) data from 7 to 8 December 2017 (respectively at 16:00 and 13:00).

Figures 10 and 11 show further comparisons of the results obtained via the two instruments. In particular, Figure 10 shows the trend of the tower's fundamental frequency from 7 to 8 December 2017, extracted from the AGI (blue) and the SS20 (red) devices. The very good agreement between the two measurements indicates that the fluctuations exhibited in the frequency values do not depend on the instruments' functioning, but are rather due to environmental factors. Figure 11 shows a comparison of the hourly maximum accelerations (absolute values) recorded by the instruments during that same period. The differences between the amplitudes are mainly due to the different positions of the instruments, which were placed at slightly different levels along the tower. It is worth noting that maxima in the acceleration values correspond to minima in the frequency values. In fact, a look at the weather those days revealed very bad conditions, with strong wind velocities (see also Figure 15), thereby suggesting a connection between the frequency reduction shown in Figure 10 and the action of the wind, which due to the masonry's inability to withstand large tensile stresses, tends to decrease the tower's stiffness.

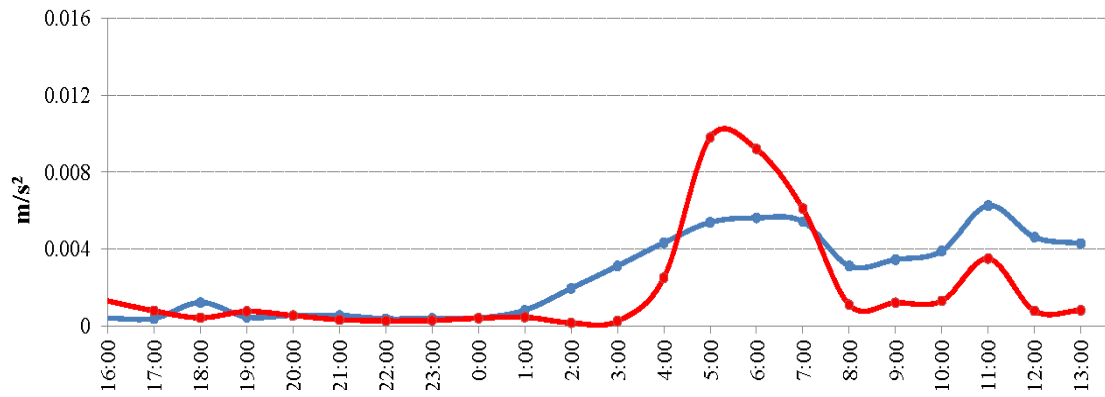
Figure 11. Maximum absolute accelerations recorded by the S.2 station (blue, +37 m) and the S. 945 station (red, +42 m) from 7 to 8 December 2017 (respectively at 16:00 and 13:00).

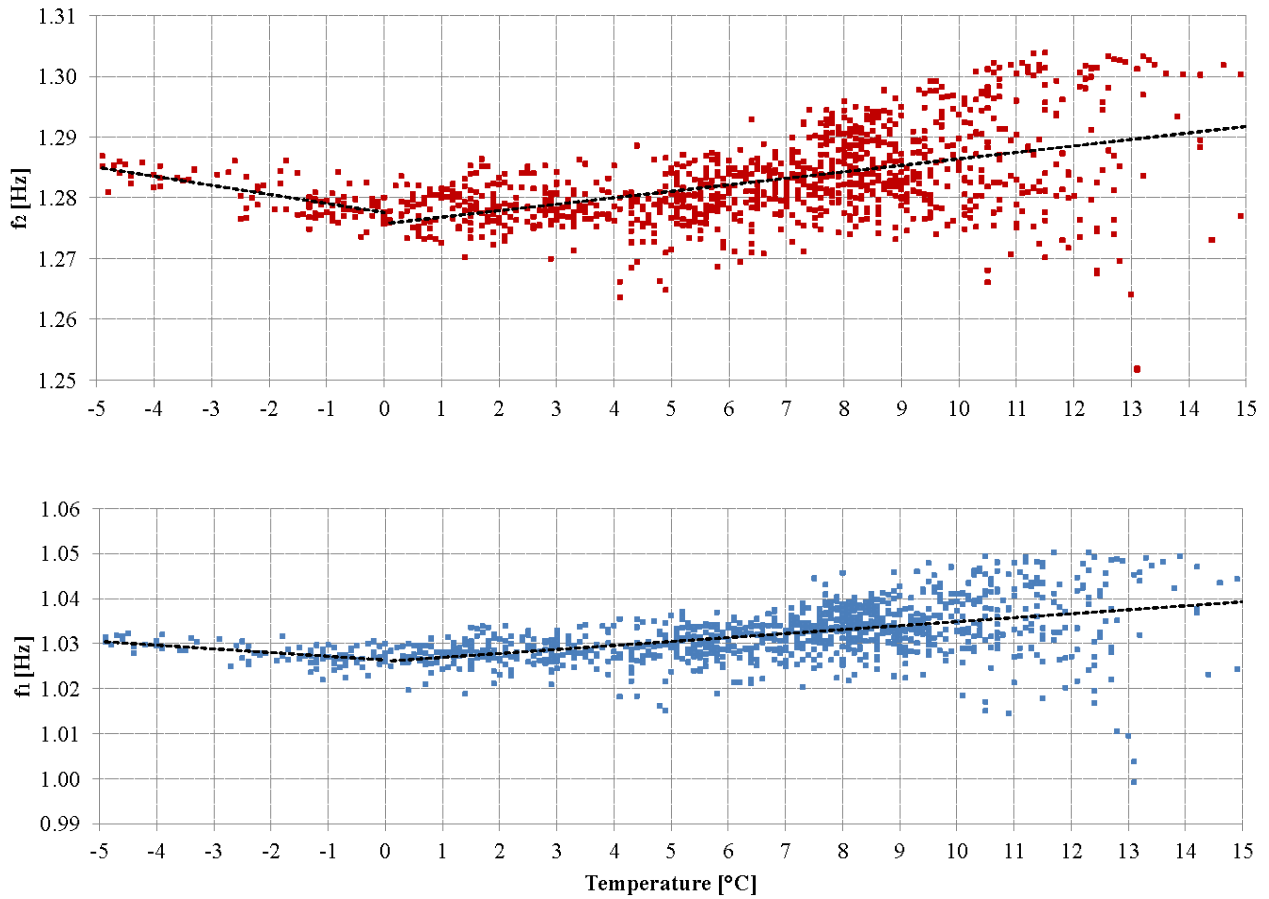
Figure 12. The first (blue) and second (red) natural frequencies of the tower [Hz] vs. temperature [°C].

With regard to the influence of temperature on the tower's dynamic behaviour, Figure 12 shows the correlation of the first two natural frequencies with air temperature, measured by a sensor located in the Lucca Botanical Gardens, in Lucca's historic centre. The figure confirms the findings of other

long-term vibration monitoring campaigns on historical towers (Cabboi et al., 2017), (Ubertini et al., 2017), including that carried out on the San Frediano bell tower in Lucca (Azzara et al., 2018a): frequencies tend to increase with temperature. This behaviour is confirmed by the results described in (Girardi et al., 2017), which reports on a nonlinear FE analysis of the Clock Tower conducted by modelling the effects of the thermal variations on the structure's frequencies. The numerical simulation supports the hypothesis that an increase in temperature induces a reduction in the fracture strains inside masonry, thus increasing the global stiffness of the structure. With regard to negative temperature values, Figure 12 reveals opposite trend for frequencies, which turn out to increase when the temperature decreases. This phenomenon was mainly observed in the latter part of February 2018, when temperatures persistently decreased below zero, as highlighted by Figure 13. Correspondingly, the figure shows the change in the frequency trend. The behaviour below freezing has also been reported for similar weather conditions in (Ubertini et al., 2017) and (Cabboi et al., 2017). It is also worth noting that, as long as the temperature remains above zero, frequencies respond to temperature variations with a phase shift in time, while, below zero, the frequency and temperature appear to be in phase.

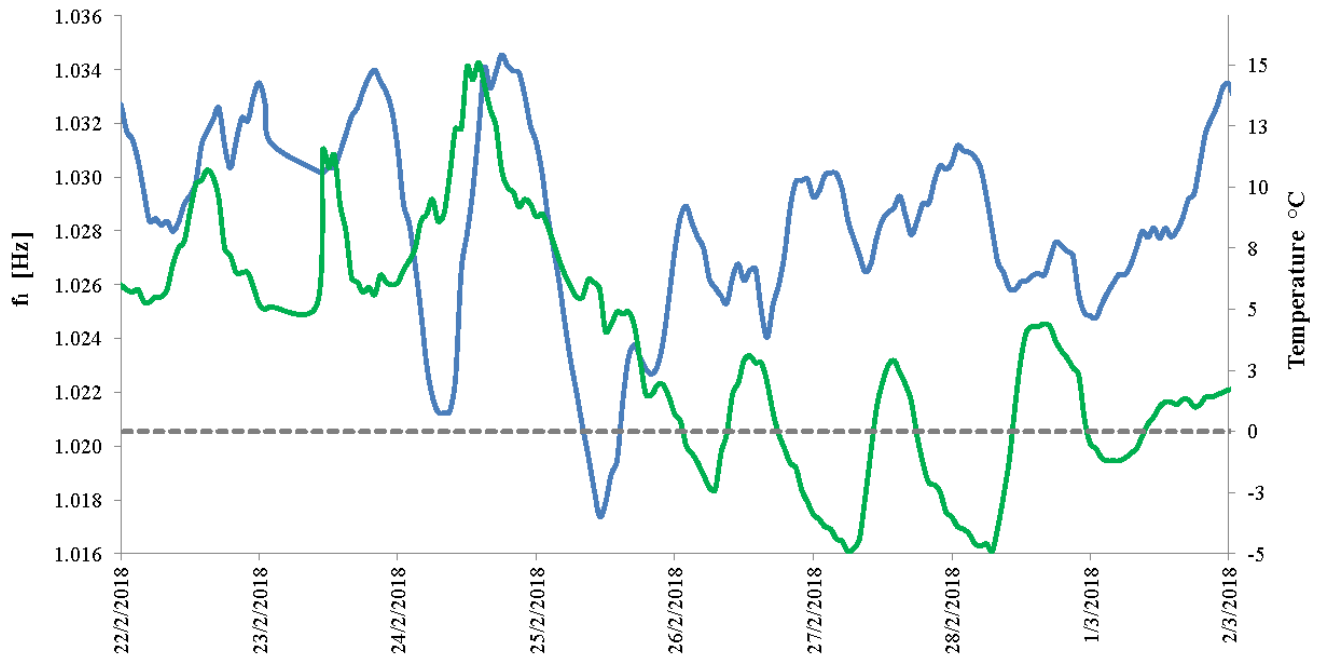
Figure 13. The tower's first (blue line) natural frequency [Hz] vs. temperature [°C] (green line), during February 2018.

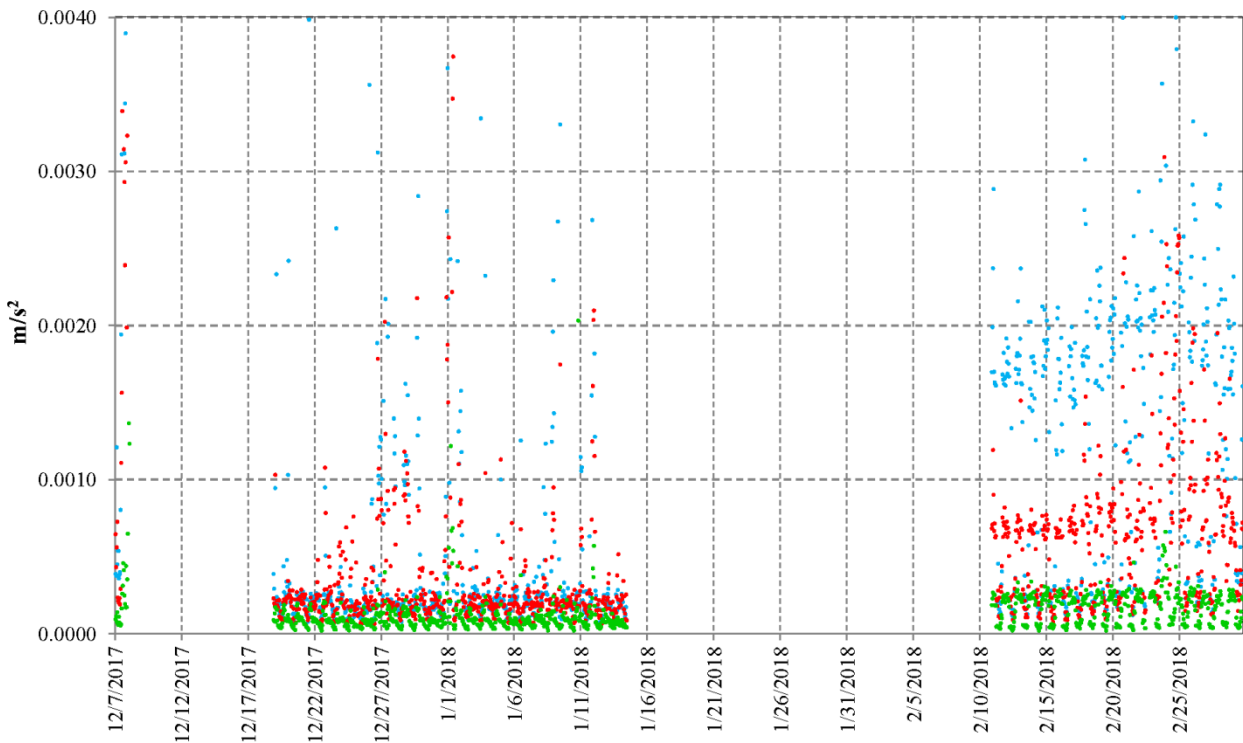
Figure 14. Maximum absolute values per hour of the accelerations recorded by AGI stations (S.2, +37 m) in the x (blue dots), y (red dots) and z (green dots) directions.

The trend over time of the maximum accelerations recorded by AGI sensors is shown in Figure 14. The vibration level in the tower is very low, generally under $2 \cdot 10^{-3} \text{ m/s}^2$, thanks to restrictions to vehicular traffic in force in the Lucca historic centre. The figure highlights an increase in the tower's vibration level during the Christmas holiday period (from 22 December to 1 January), connected to the increased pedestrian traffic in the historic centre, with a peak on New Year's Day. The figure also reveals a systematic increase in the accelerations, on average of one order of magnitude, from 9 February onward. This is due to the ringing of the tower bells, which had been suspended for restoration of the ancient clock and was restarted on 16 January 2018. The bell system is composed of three bronze bells, fixed at their supports and rung by hammers each quarter an hour in the x direction (along Via Fillungo). Indeed, Figure 14 shows significant amplification along x (blue dots).

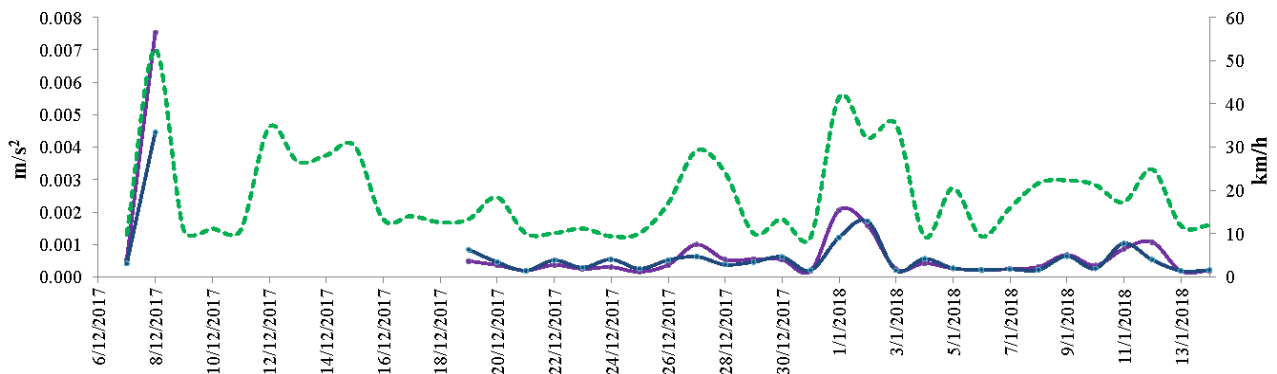
Figure 15. Daily average of the maximum hourly accelerations measured by S.2 vs. time along the x (blue) and y (red) directions. The dashed green line stands for the daily maximum wind speed.

With regard to the environmental parameters that could influence the acceleration levels on the tower, Figure 15 plots the daily average values of the maximum hourly accelerations in the x (blue) and y (red) directions, for about a month, together with the daily maximum wind speed recorded at Pieve di Compito, about 10 km from the Lucca historic centre (data available at www.sir.toscana.it). The figure clearly shows a correspondence between the peaks in the acceleration levels and those in the wind speed.

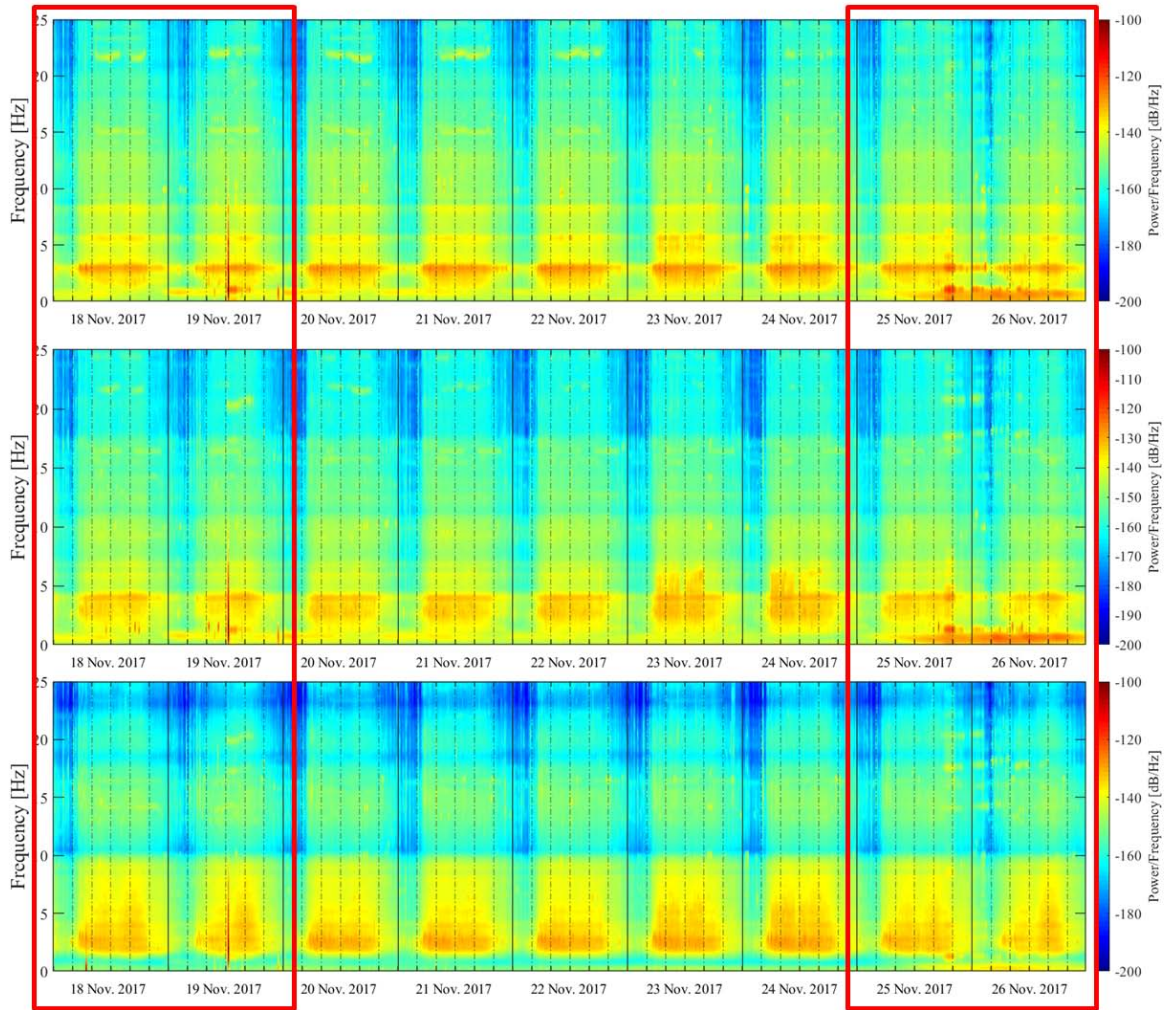
Figure 16. Spectrogram of the signal recorded by S.942 (+ 0,00 m) in the x (up), y and z (bottom) directions from 18 to 26 November 2017. Week-ends are highlighted by the red boxes.

Figures 16 and 17 provide information on the tower's vibrations over time in the band $[0, 25]$ Hz. In particular, Figure 16 shows the spectrogram of the signal recorded by S. 942, at the base of the tower, in the period 18 November to 26 November 2017, for the three channels x (up), y and z (bottom). The tower's natural frequencies are clearly visible in the band $[0, 10]$ Hz (horizontal lines), as well as the 3 Hz frequency of the building adjacent to the tower, along the x direction. As a result of anthropogenic activity, the power frequency increases in the entire band during the daytime, in particular during week-ends (18-19 November, 25-26 November). The three-dimensional spectrogram of channel x plotted in Figure 17 also highlights other anthropogenic activity between 20 and 25 Hz, which could be attributed to traffic in the historic centre. At about 12:30 (UTC) on 19 November, there is a clear frequency peak, which can be attributed to the M4.4 Parma earthquake reported in Table 3.

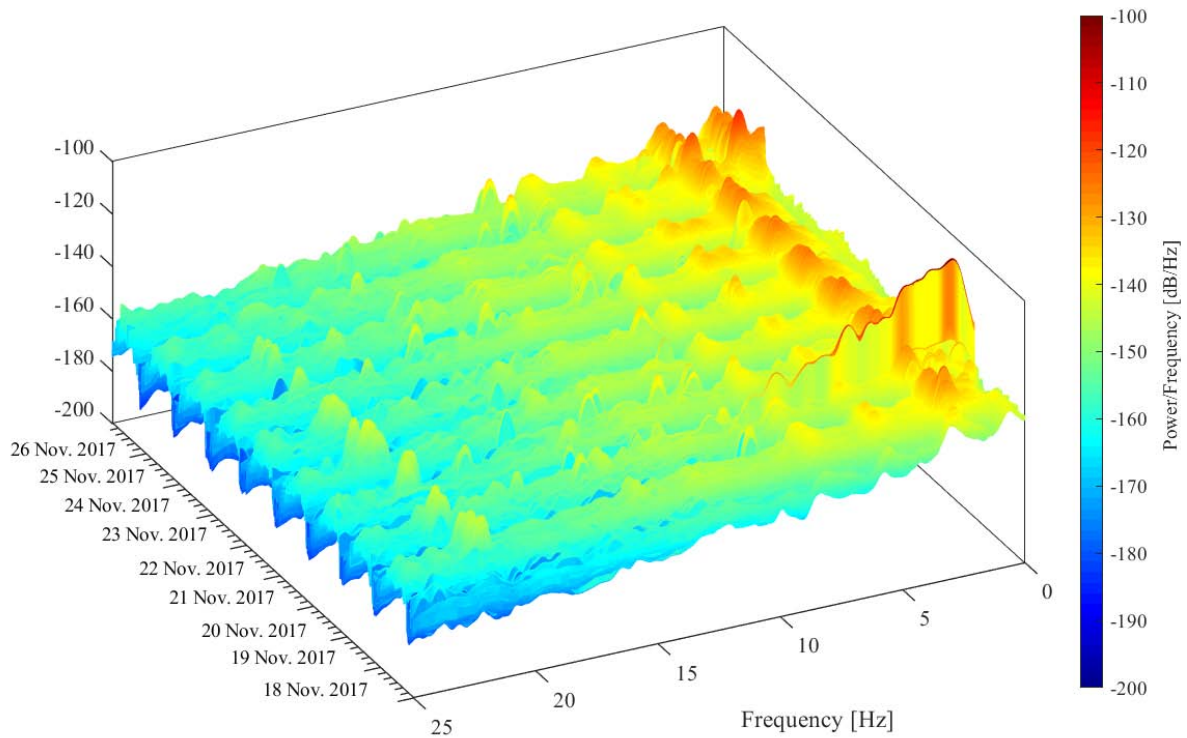
Figure 17. Three-dimensional spectrogram of the signal recorded by S.942 (+0,00 m) in the x direction from 18 to 26 November 2017.

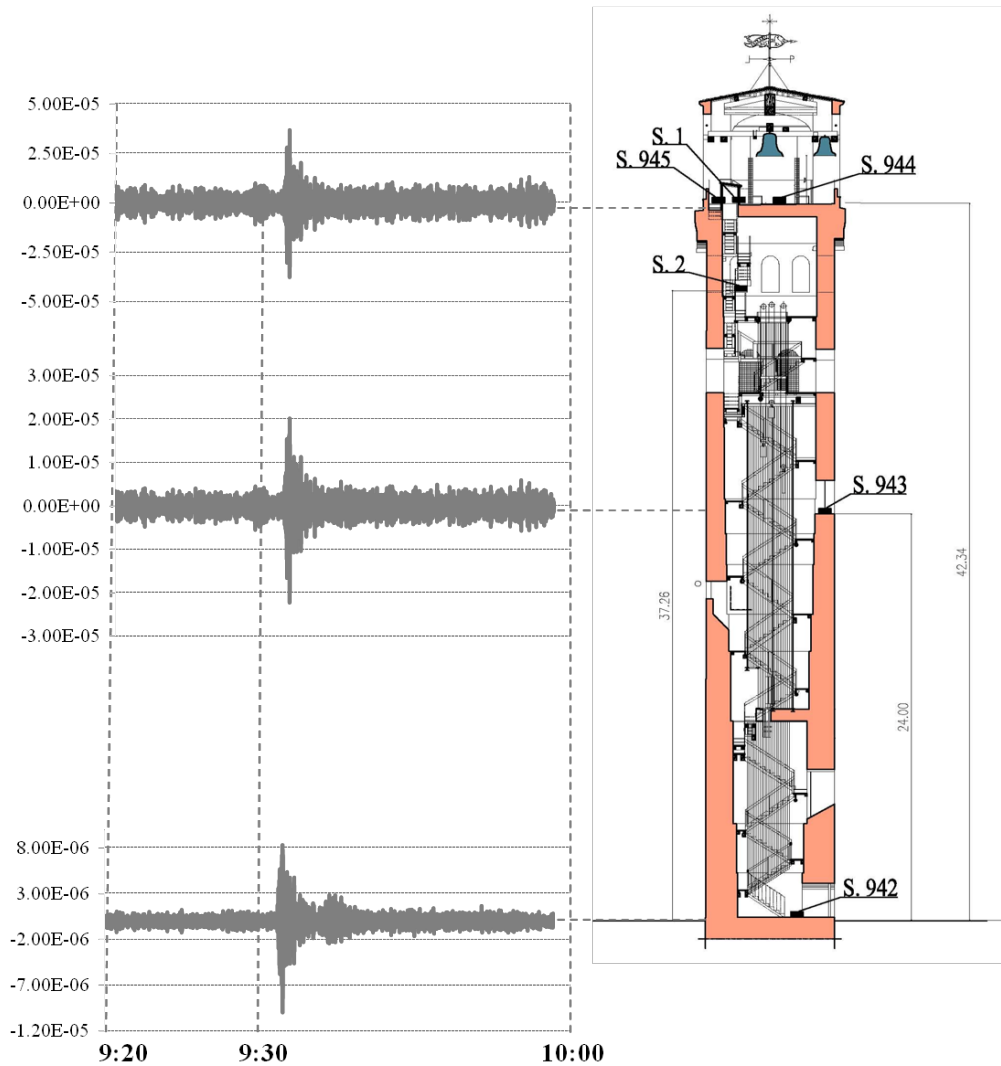
Figure 18. Signal of the Peru earthquake recorded on the tower in the x direction by S.942, S. 943, S.944 on 14 January 2018 from 9:33 (UTC) onward. Signal amplitude is in m/s^2 .

Many seismic events have been detected on the tower during the monitoring period. Table 3 shows the main earthquakes recorded, while Table 4 reports the teleseismic events identified in the signals. Figure 18 shows the teleseismic record of the Peru earthquake, which occurred at 09:18.44 (UTC) with a magnitude of 7.1, and was recorded at about 09:33 (UTC) by the instruments on the tower. In particular, the figure shows the signals recorded by the SS20 seismic stations at different levels along the tower's height in the x direction. The same event was also recorded by the S.2 accelerometer. At such a considerable distance from the epicentre, the seismic signal loses its high frequency content and becomes recognizable only at low frequencies. The records in the Figure were obtained by filtering the signals via a Butterworth band-pass filter with lower cut-off frequency of 0.04 Hz and a higher cut-off cut at 1 Hz. It is worth noting that after the first arrival of the waves the event remains clearly recognizable in the signals for long time.

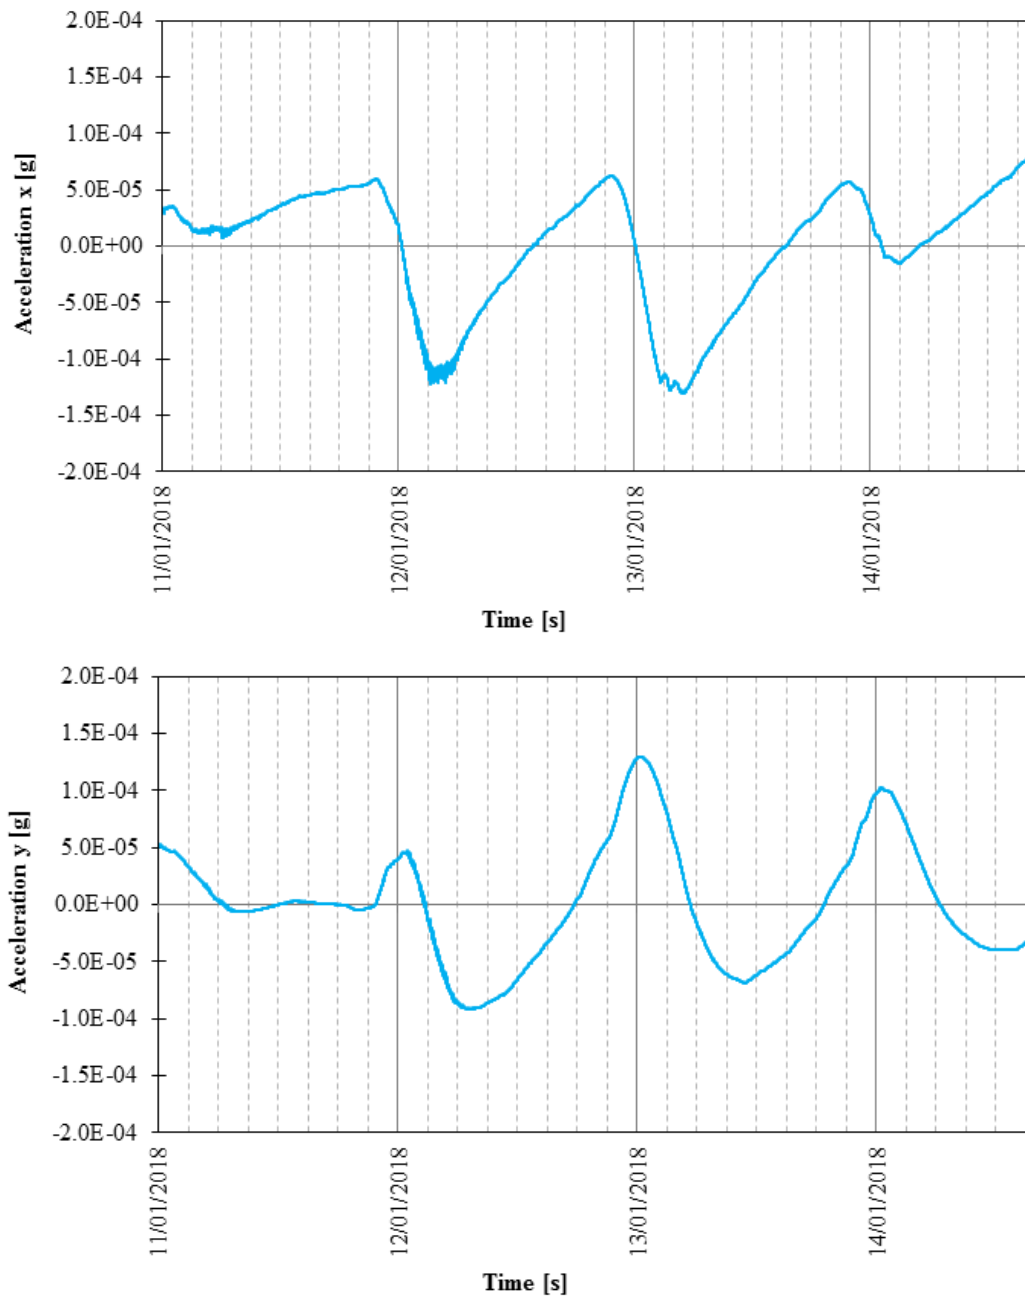
Figure 19. Low-pass filtered accelerations recorded by S.2 along the x and y (bottom) directions from 11 to 14 January 2018.

Analyzing the low frequency content of the recorded signals can provide further information on movements of the tower. Figure 19 shows the signals recorded by the S.2 accelerometer from 11 to 14 January 2018 along the x (up) and y (bottom) directions. The signals in the figure were low-pass filtered with a cut-off frequency of 0.5 Hz, and clearly reveal a slow oscillation with period of about 24 hours. The same oscillations can be detected in the temperature signal (Figure 20) measured by the sensor inside the instrument. The temperature signal is however not in phase with the accelerations, thus demonstrating that the oscillations of the accelerometric signal are not a direct effect of temperature on the instrument. It is also worth noting that the signals along the x (North-South direction) and y (East-West direction) directions present a phase shift of 3 to 6 hours, and the y signal is delayed with respect to that along x . A possible interpretation of these oscillations lies in the daily temperature variations caused by exposure of the tower to the sun. As the exposure of the façades changes during the day, the tower appears to twist as shown in the figures. A measure of the displacements induced by this effect at the top of the tower can be easily obtained from the figures. In fact, for small oscillations, the modulus of the tangential acceleration expressed in g coincides with the inclination angle of the tower in radians. Thus, taking into account the actual position of the instrument (at +37 m), horizontal displacements turn out to be on the order of 3-4 mm for both

directions. These daily movements appear to be the largest that the tower undergoes under normal conditions, as an effect of environmental factors.
