**Si TITLE:**                    **Analysis of Signal Swap in output  
of Channel 2510 (Action#4 H-P-  
TASF-MN-9737)**

**DOC. TYPE:**                **TECHNICAL NOTE**

**PROJECT REF.:**        **PL-LFI-PST-TN-082**        **PAGE: I of IV, 1 of 15**

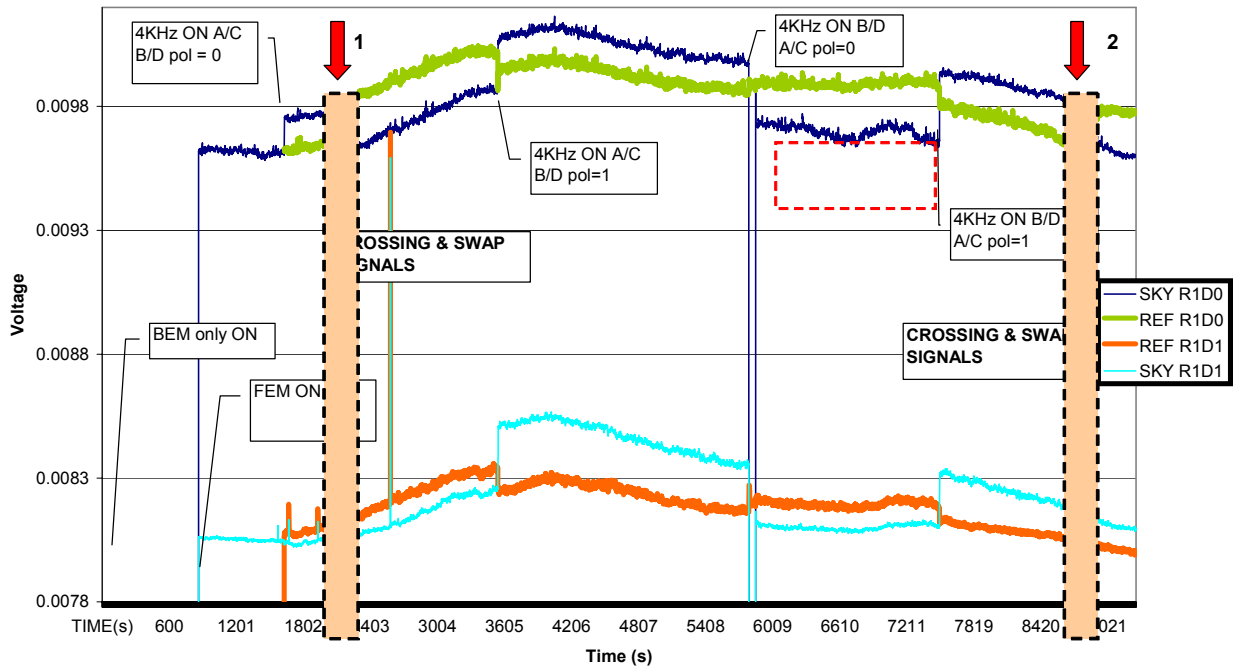
AMB0099: RCA25 - R1D0 & R1D1

During test AMB\_0099 the effect repeated twice following a very symmetric behaviour, as displayed in figure below. Inversions are indicated by the red arrows. Both channels (R1D0 and R1D1) are here displayed. The difference Sky-Ref is also displayed, for both the coupled channels, in Figure 2

Figure 1 Test AMB\_0099: inversions on sky and ref signals from RCA25R0D1 are highlighted by rectangles and arrows. Other changes, foreseen by the test, are commented by callouts. Signal from RCA25R1D1 seems to not be affected by the same effect.

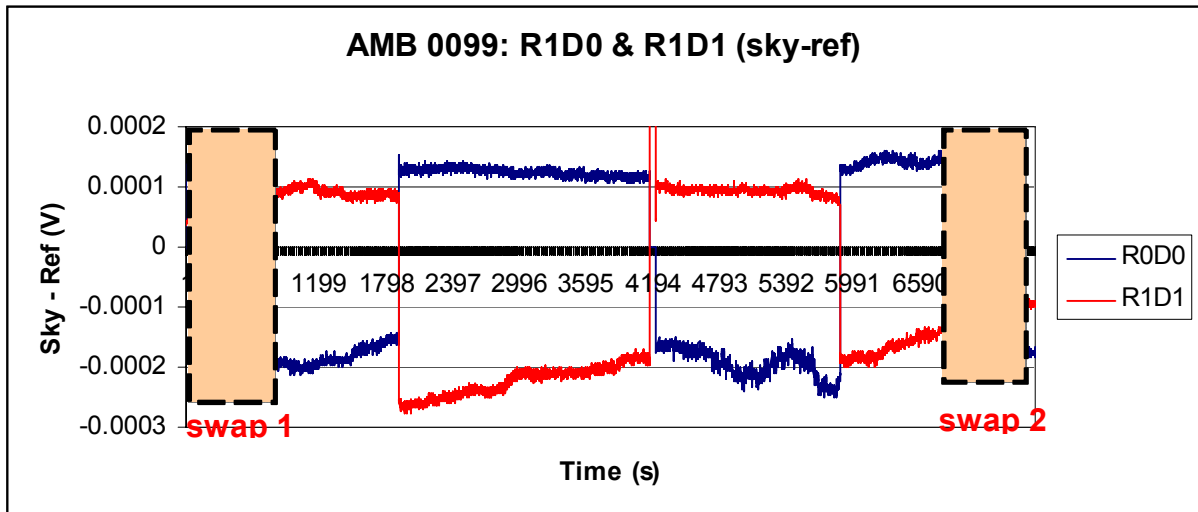
Figure 2 Test AMB\_0099 : Difference sky - ref is shown for R0D1 and R1D1.

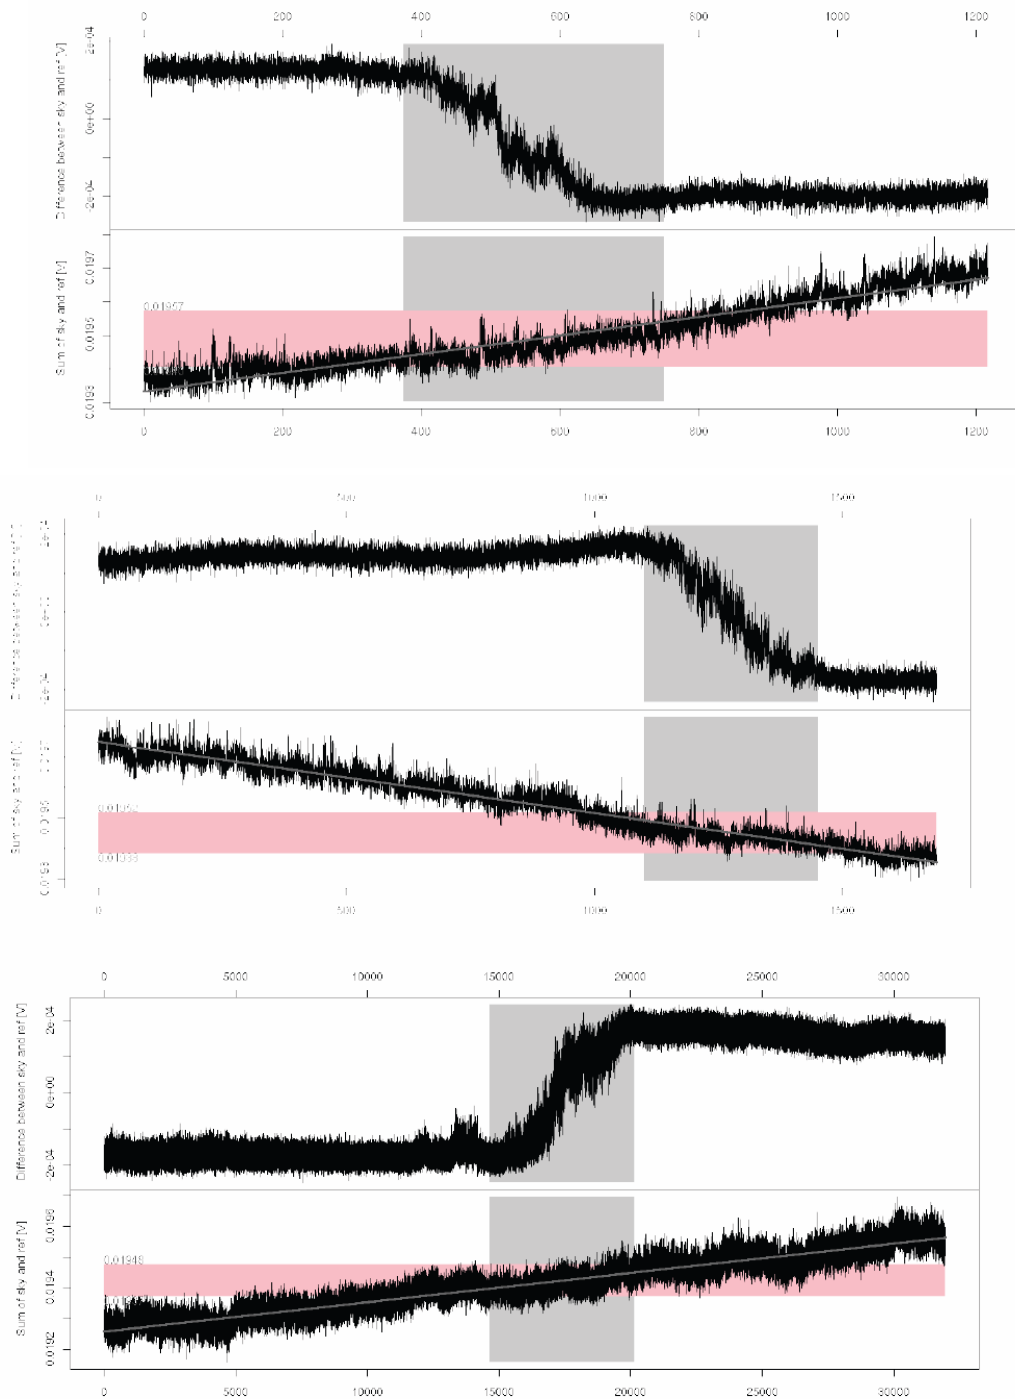
Figure 3 Difference and sum of the sky and reference signals for detector #2510 during tests AMB\_0099 (top, middle) and AMB\_0108 (bottom). The time window where the mixing happened is shown against a gray background. The pink rectangle indicates the voltage level of the sky+reference sum within the inversion time window. The thick gray line is a linear interpolation of the sum, and has been used to extract the boundaries of the pink rectangle.

Moreover, the inversion effect seems to appear always when the absolute level of the sky/reference signals crosses some boundary. This is evident from **figure 2**: the three inversions were observed when the sky/reference signals were around 10 mV.

In **figure 2** the upper and lower bounds of the pink rectangle are given by the crossing between the slope of the line (linear fit of the summed signal) and the grey rectangle (time window of the inversion). The bounds have been enlarged by the standard deviation of the summed signal minus its linear fit, in order to compensate for the linear fit approximation. These bounds are reported in the following table:

Inversion	Time [s]	Min [mV]	Max [mV]	Range [mV]
AMB_0099(a)	375	19.40	19.57	0.17
AMB_0099(b)	350	19.38	19.52	0.14
AMB_0108	5500	19.37	19.48	0.11

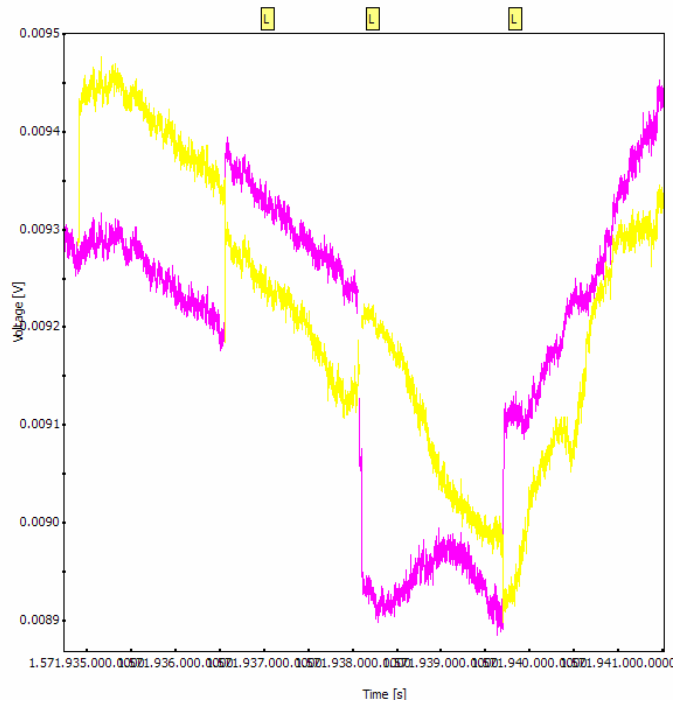
**Figure 4 AMB\_0114 (SIT) : RCA25 R1D0. Sky and ref signals seem to be going to invert but inversion is never reached. Here the Voltage is lower than the critical value found in the previous tests and producing the signal swap.**

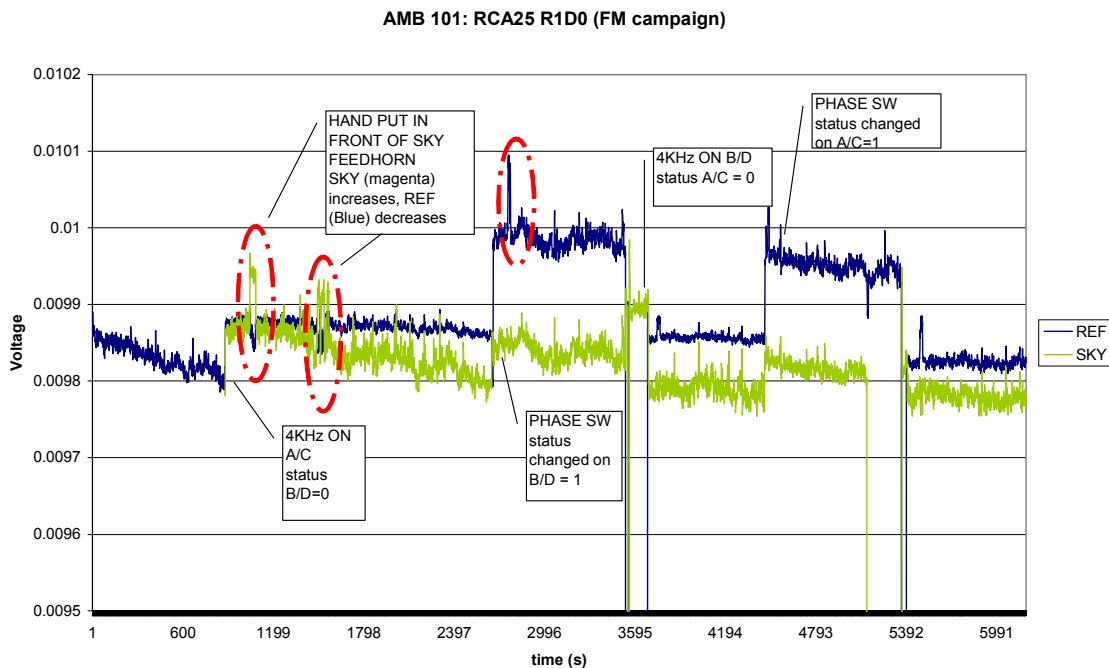
for some unwanted noise observed . In principle, if everything is fine, just the sky signal should increase : however, this is not what observed. Looking at Figure 5, Figure 6 and Figure 7 it is clear that , when the hand is put in front of the sky feed horn , an opposite effect is also observed in the Ref signal: however, the effect is also opposite with respect to what expected , since ref increases and ref decreases!

Figure 5 FM AMB\_0101 : effect of a thermal load put in front of the FPU. The effect is opposite on sky and ref and the very strange thing is that it is mainly visible on ref (R1D0) instead of sky (R1D0), as was instead expected. At the end of the test (last step) the effect is correctly visible on sky. To be noted that the PH/SW change is never able to swap the two signals, as instead appears in the other channel R1D1 (Figure 7)
