TITLE: **CSL ACA Matrix Tuning Report**

DOC. TYPE: **Test Report**

PROJECT REF.: **PL-LFI-PST-RP-043** **PAGE:** **I of IV, 57**

Planck LFI

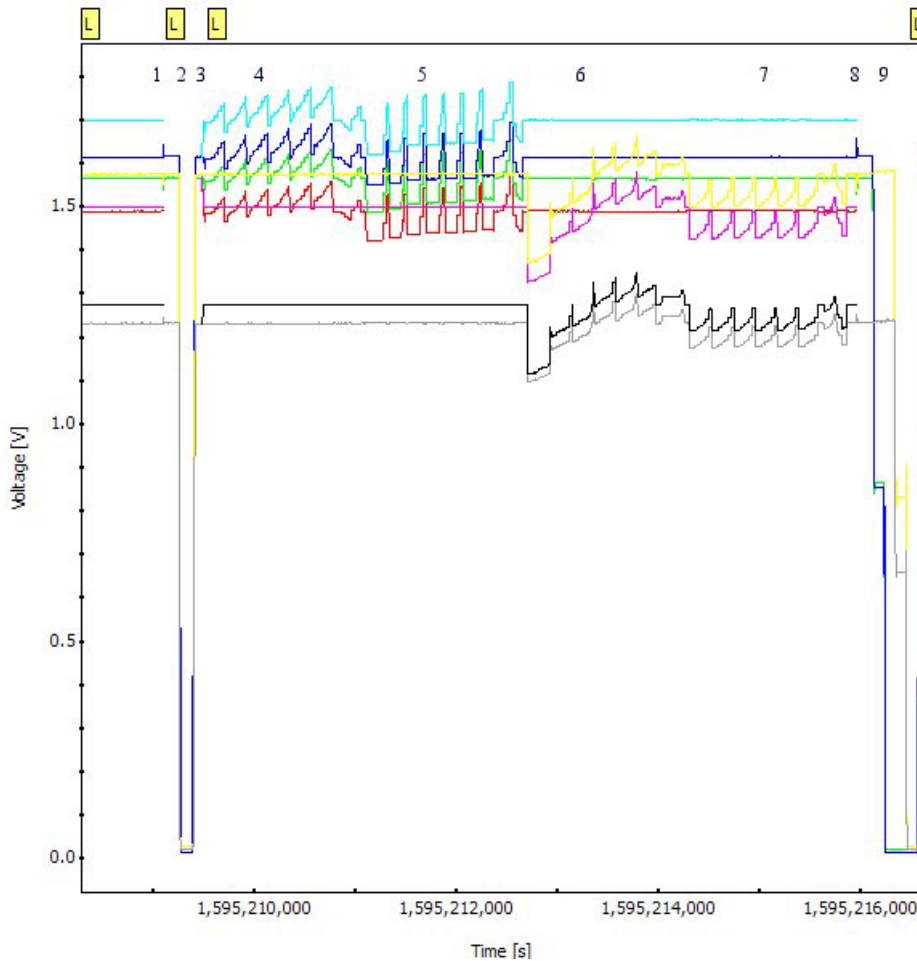
Figure 1: Lama_view graphical display of the RCA27 during TUN_0087 test.

In the Figure 1 a typical procedure ([AD5]) for a matrix tuning dataset is shown. Nine main steps are performed and visible in the plot:

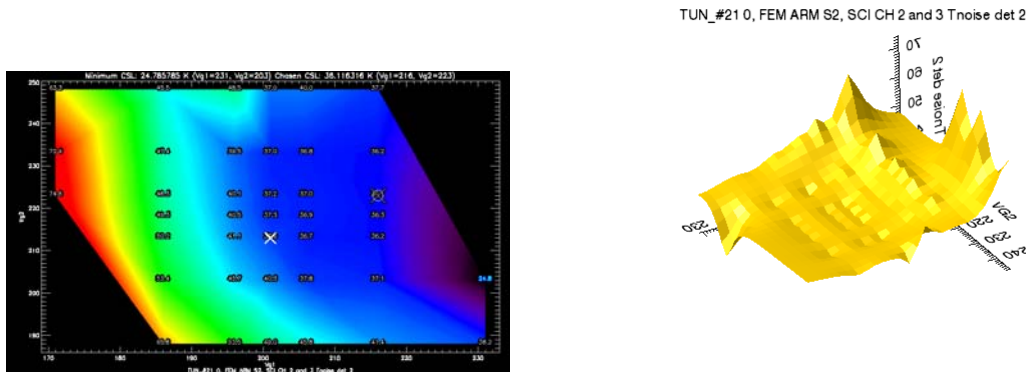
Figure 2: Typical contour plot of the ACA bias matrix tuning (left plot) and corresponding surface plot (right plot); it is evident as the dark blue minimum point at the right of the contour is a singularity minimum due to some fake effect in the selected data (see also[RD6])

In the next sections, the data analysis performed at CSL - Liege is reported and results of this analysis have been used to decide the best ACA VG1 and VG2 biases for the next tests. A first run of data analysis was performed at CSL - Liege to provide the best tuned biases for next level tests. This analysis, mainly based on automatic routine lama_tune_vg1vg2.pro. Some singularities and discontinuities in the values were found and displayed in the result plot. This did not affect the correct selection of biases because it was decided to choose minimum values within smooth and regular regions of the contour plots used to display results. In these cases the surface plot visualization was very useful. More discussion and examples on this is found in the comment section below.

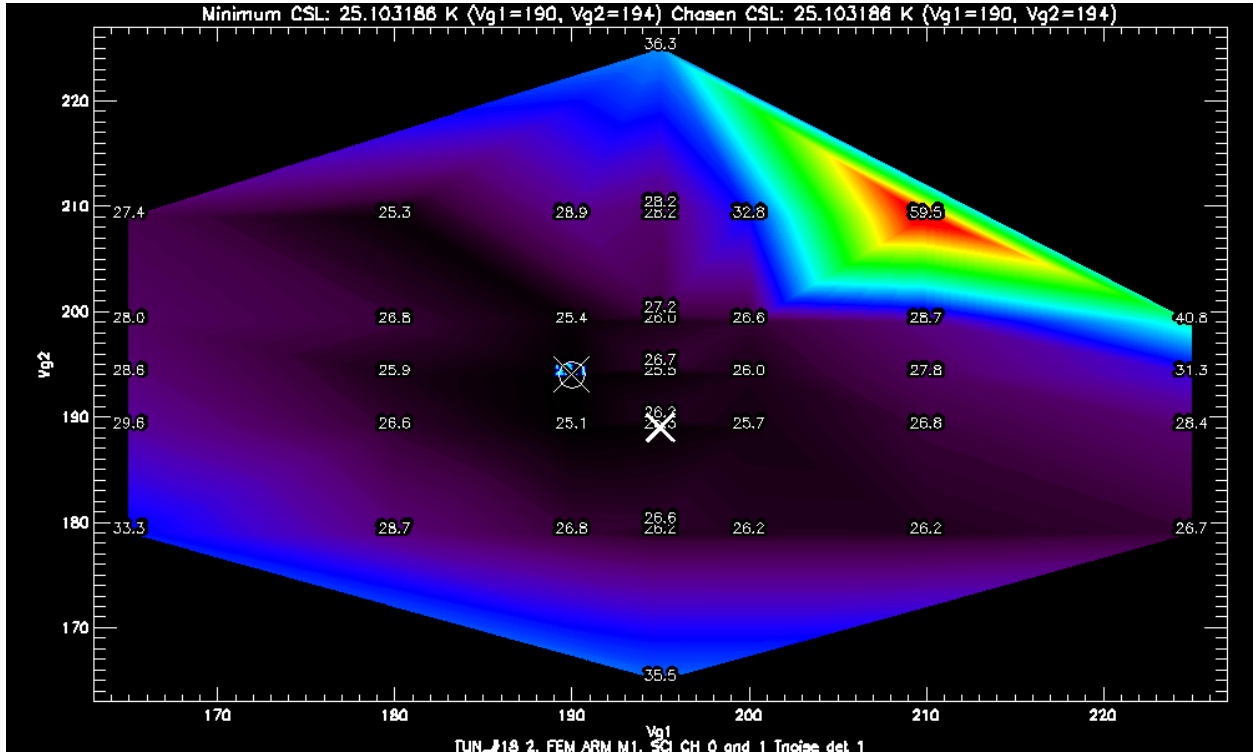
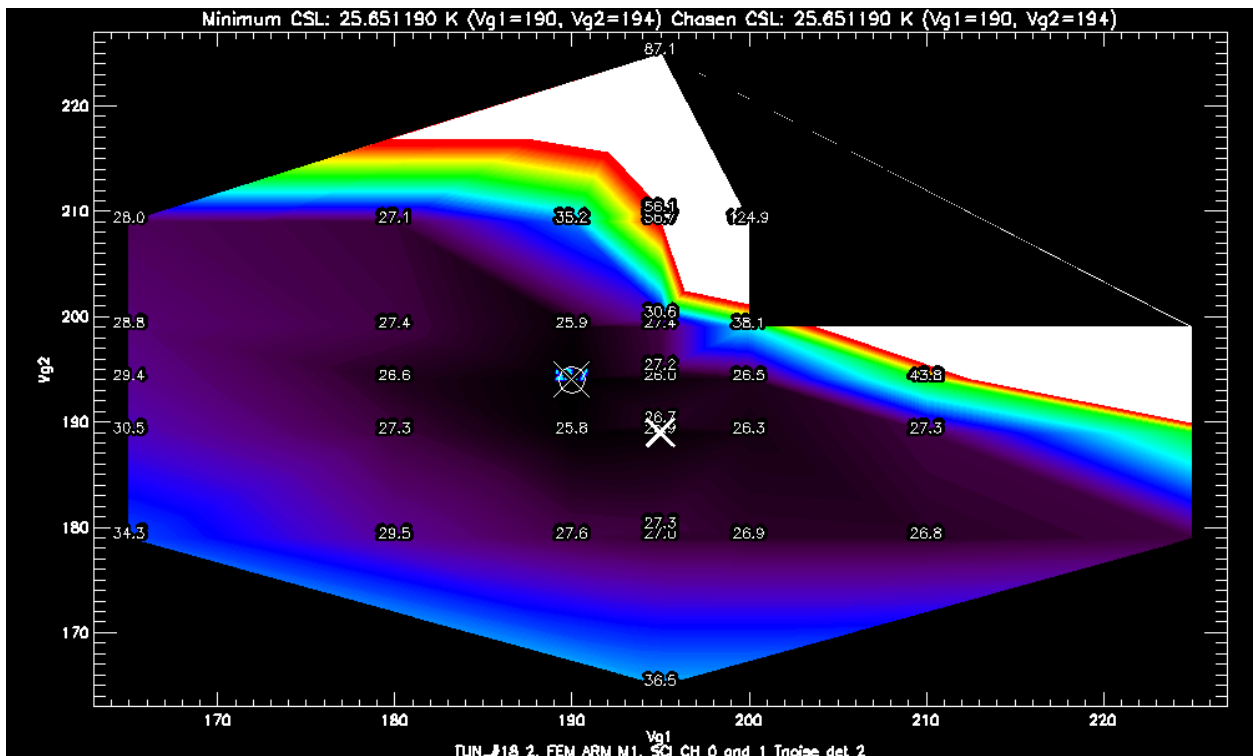
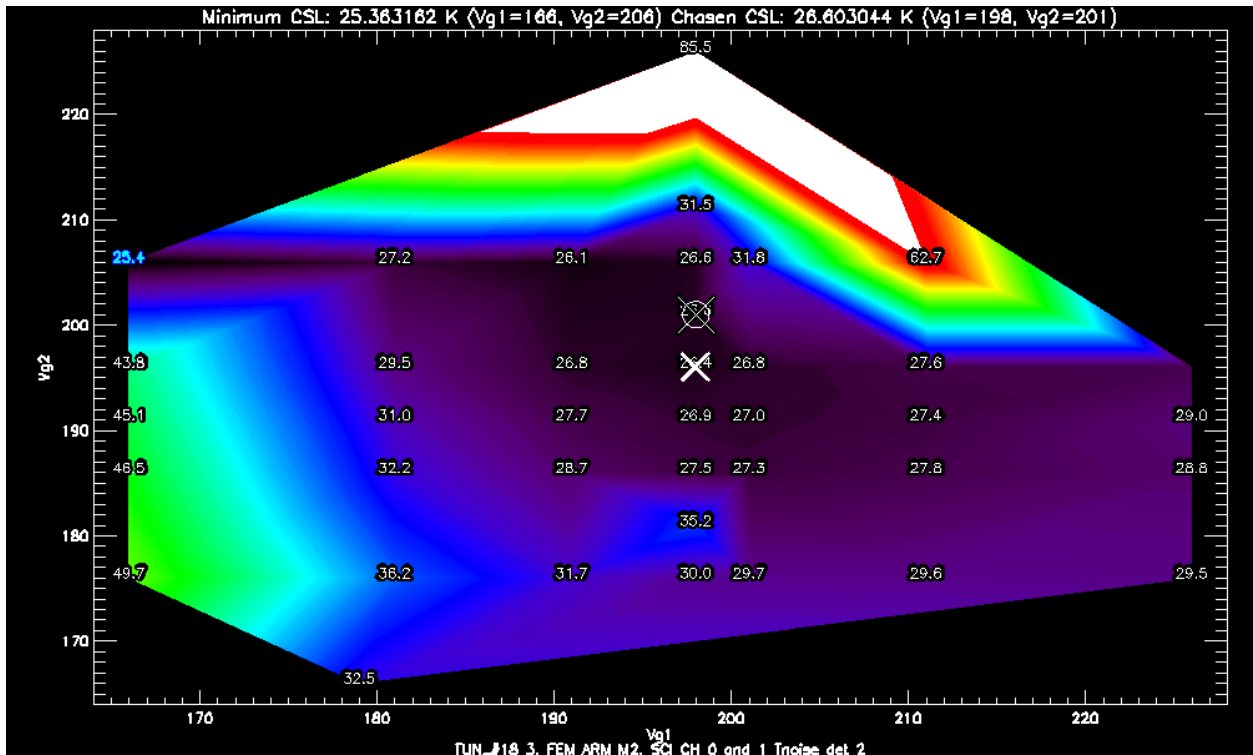
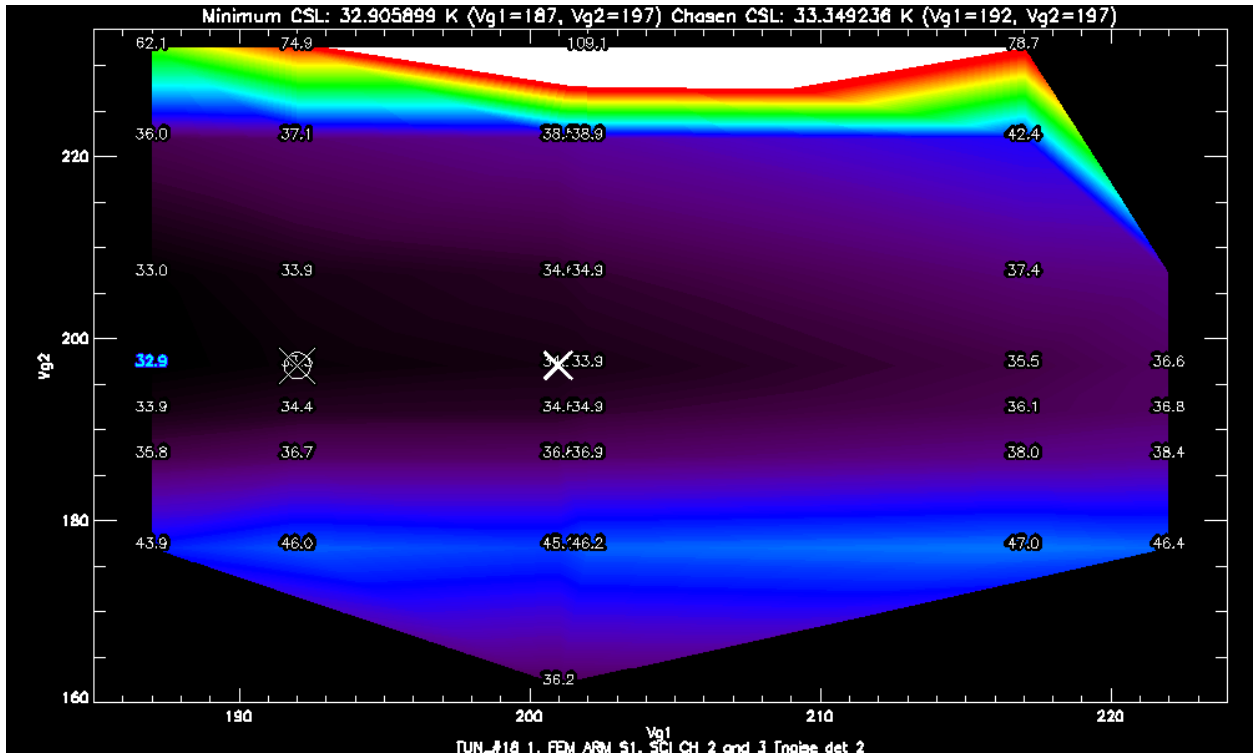
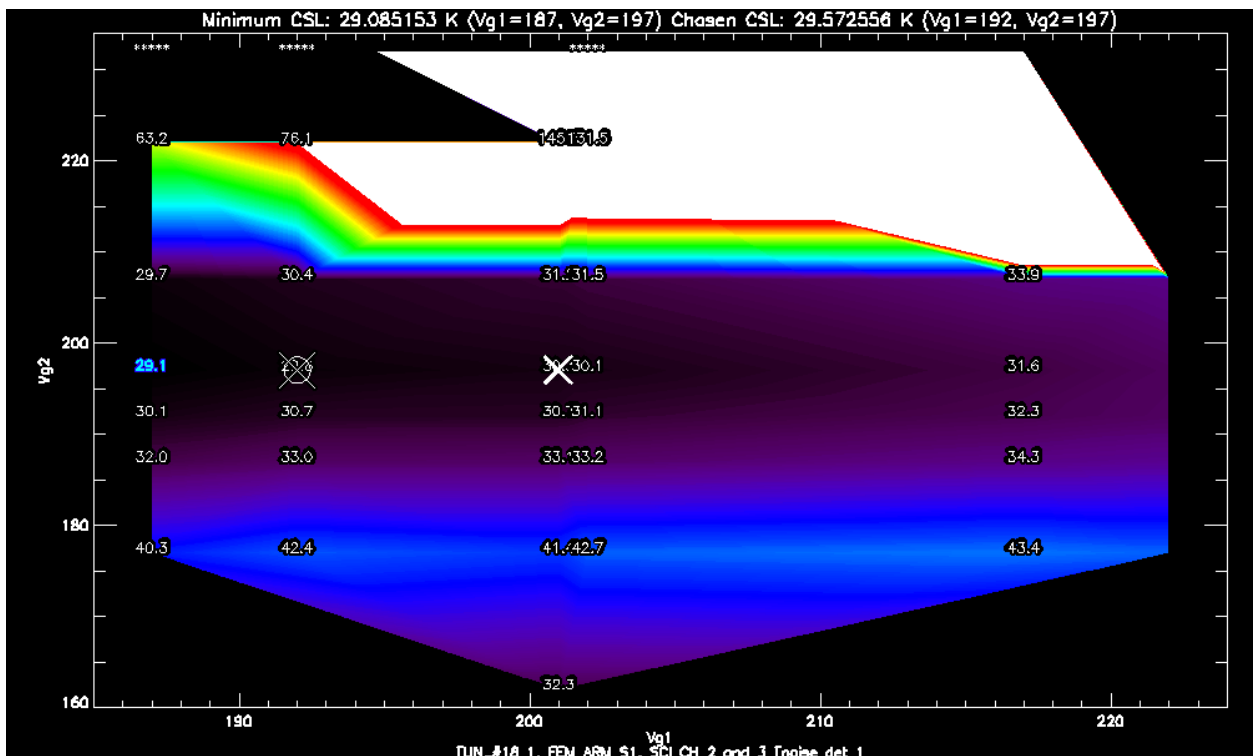
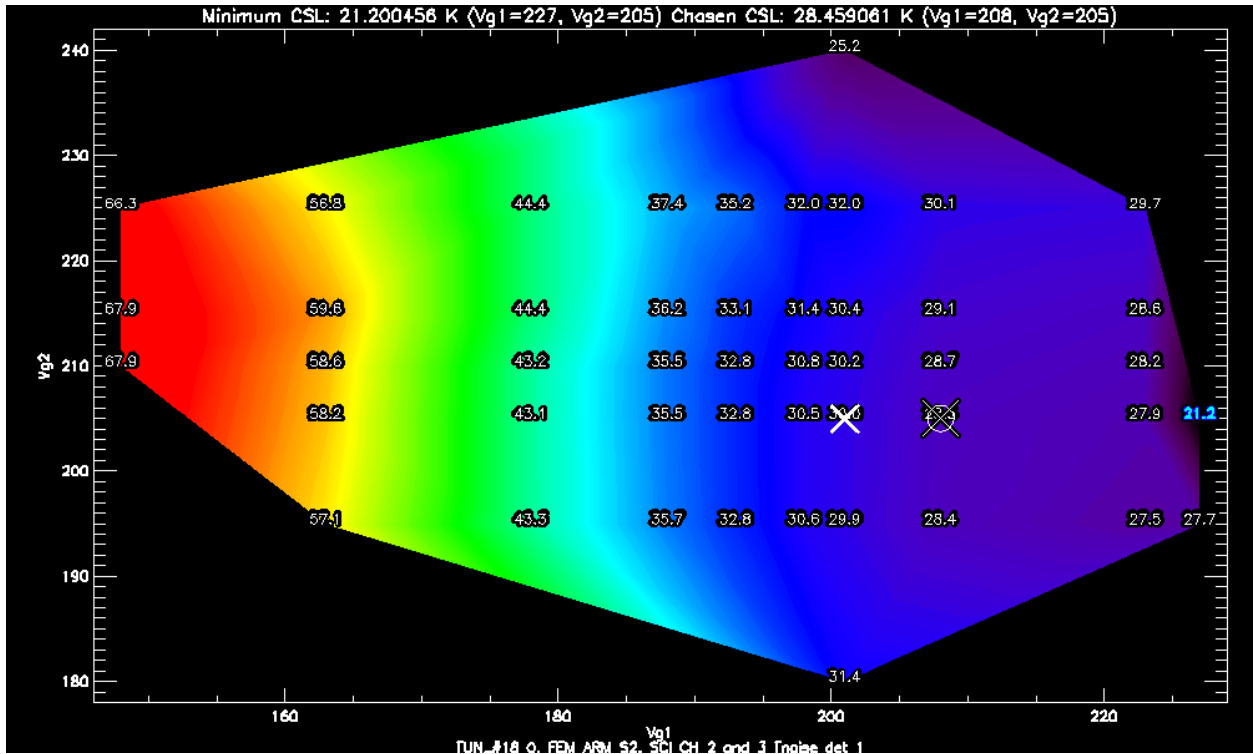
6.1.1 RCA18 Contour Plots

In the following the noise temperature contour plots for all the amplifiers (two plots each, referring to the two detectors associated to the amplifiers) are shown with values written on the points to have a better view of the results. Minimum found is in light blue, the chosen value is highlighted with a circle and cross, the old RAA value is highlighted with an X.

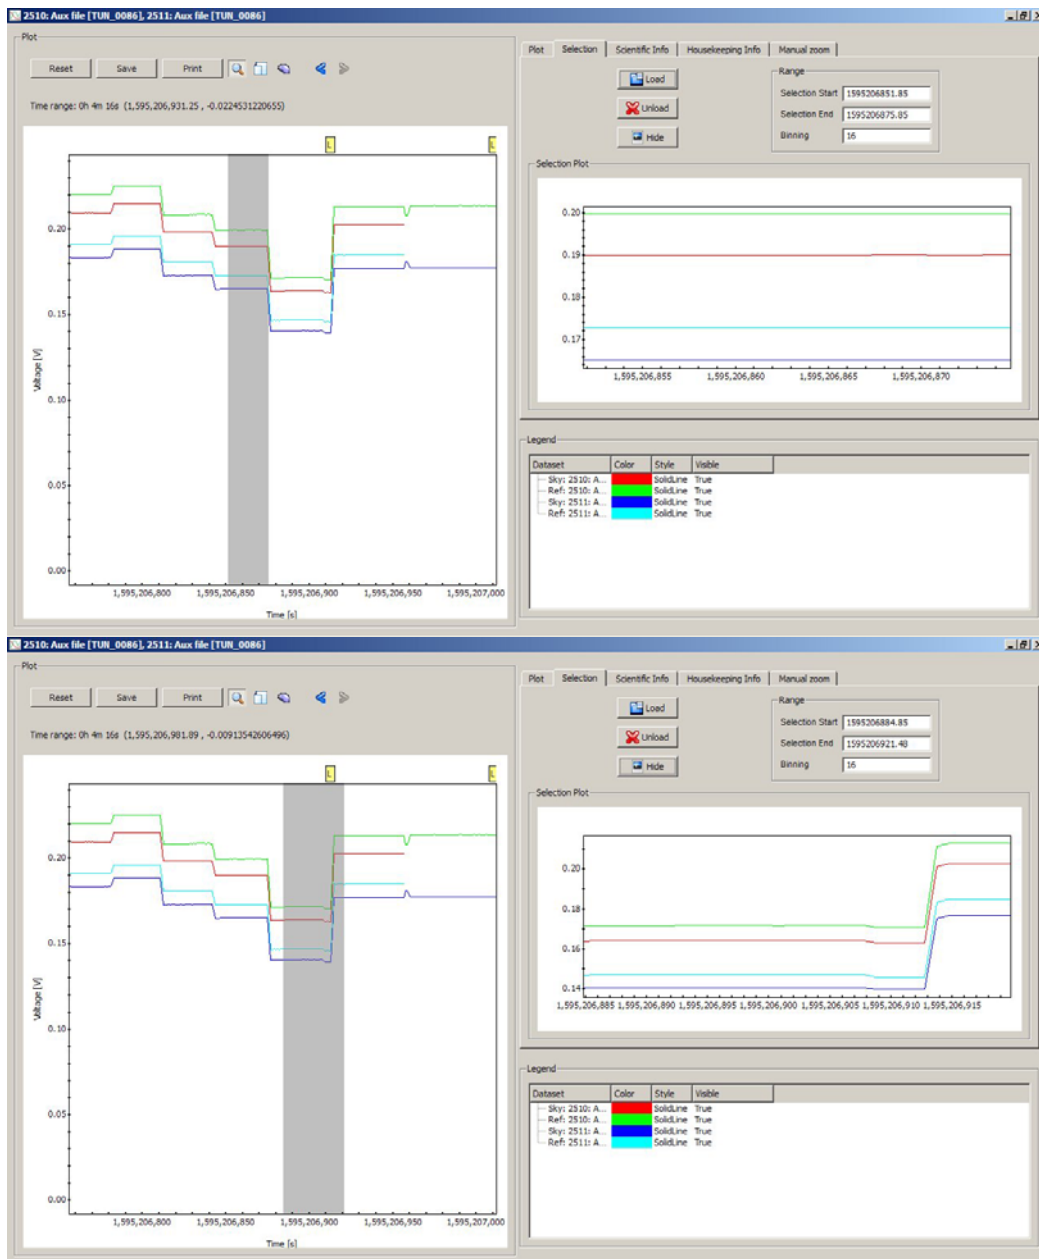
Figure 3 The last two steps in the RCA25 S2 amplifier tuning. The final step, before going back to nominal biases, is affected by a wrong selection due to the delay in recording the change of both V_{g1} , V_{g2} bias. This is not affecting previous steps because the smaller delay was covered by the cropping of last seconds before change.

There are still problems in data analysis which are not depending on the analysis script and routines. Mainly, as also reported in [RD6], the last point before a change in both the V_{g1} and V_{g2} often shows a wrong level due to the some delay in the recording of housekeeping with respect to scientific signal. Actually the scientific data of the last point is averaged over a time windows that includes also changes in amplifier biases. In the following plots an example from the last two steps in the RCA25 S2 amplifier tuning is reported, where a strong discontinuity is evident in the corresponding contour plot.

It is evident that the selection is systematically shifted towards the final part of the step.

This is not a problem when only one bias is changed also because the crop of starting and final period in the selection of scientific data was implemented in the data analysis.

It causes an actual wrong selection when both the biases are changed and the delay in the housekeeping recording increases.
