| <b>Title</b> | Zero Bias Configuration - validation test using the NI-PLM setup |

Ref : EUCL-IBO-TN-7-031  
Issue : 1.0  
Date: 04/01/2021  
Page: 1/27

## 3. Introduction

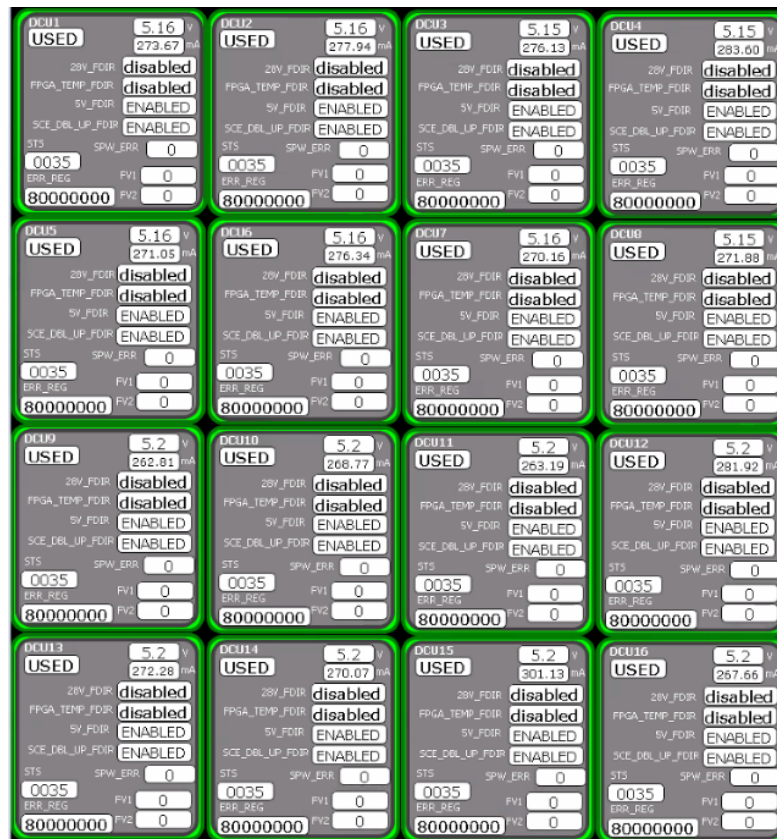
Figure 2, entire NI-Focal Plane under ZBC, all telemetries correspond to nominal values. The image is the Focal Plane's display of the TASI synoptic.

- Tested with 16 DCUs/SCEs all OK see Figure 2; each ZBC register was tested correctly using a memory DUMP; 2 x repetitions of the ZBC configuration (1) were done, for each one a single broadcast nominal dither cycle was acquired.

- Procedure correctly set to 16 DCUs/SCEs, DCUs status were the same ones showed in Figure 2 (all nominal values). In Figure 3 are represented the signal images of the entire focal plane under ZBC.
